U.S. ATOMIC ENERGY COMMISSION
REGION V
DIVISION OF COMPLIANCE

CO REPORT NO. 133/65-7

Title: PACIFIC GAS & ELECTRIC CO. (HUMBOLDT BAY)
LICENSE NO. DPR-7
Date of Visit: November 9, 10 and 11, 1965

By: A. D. Johnson, Reactor Inspector

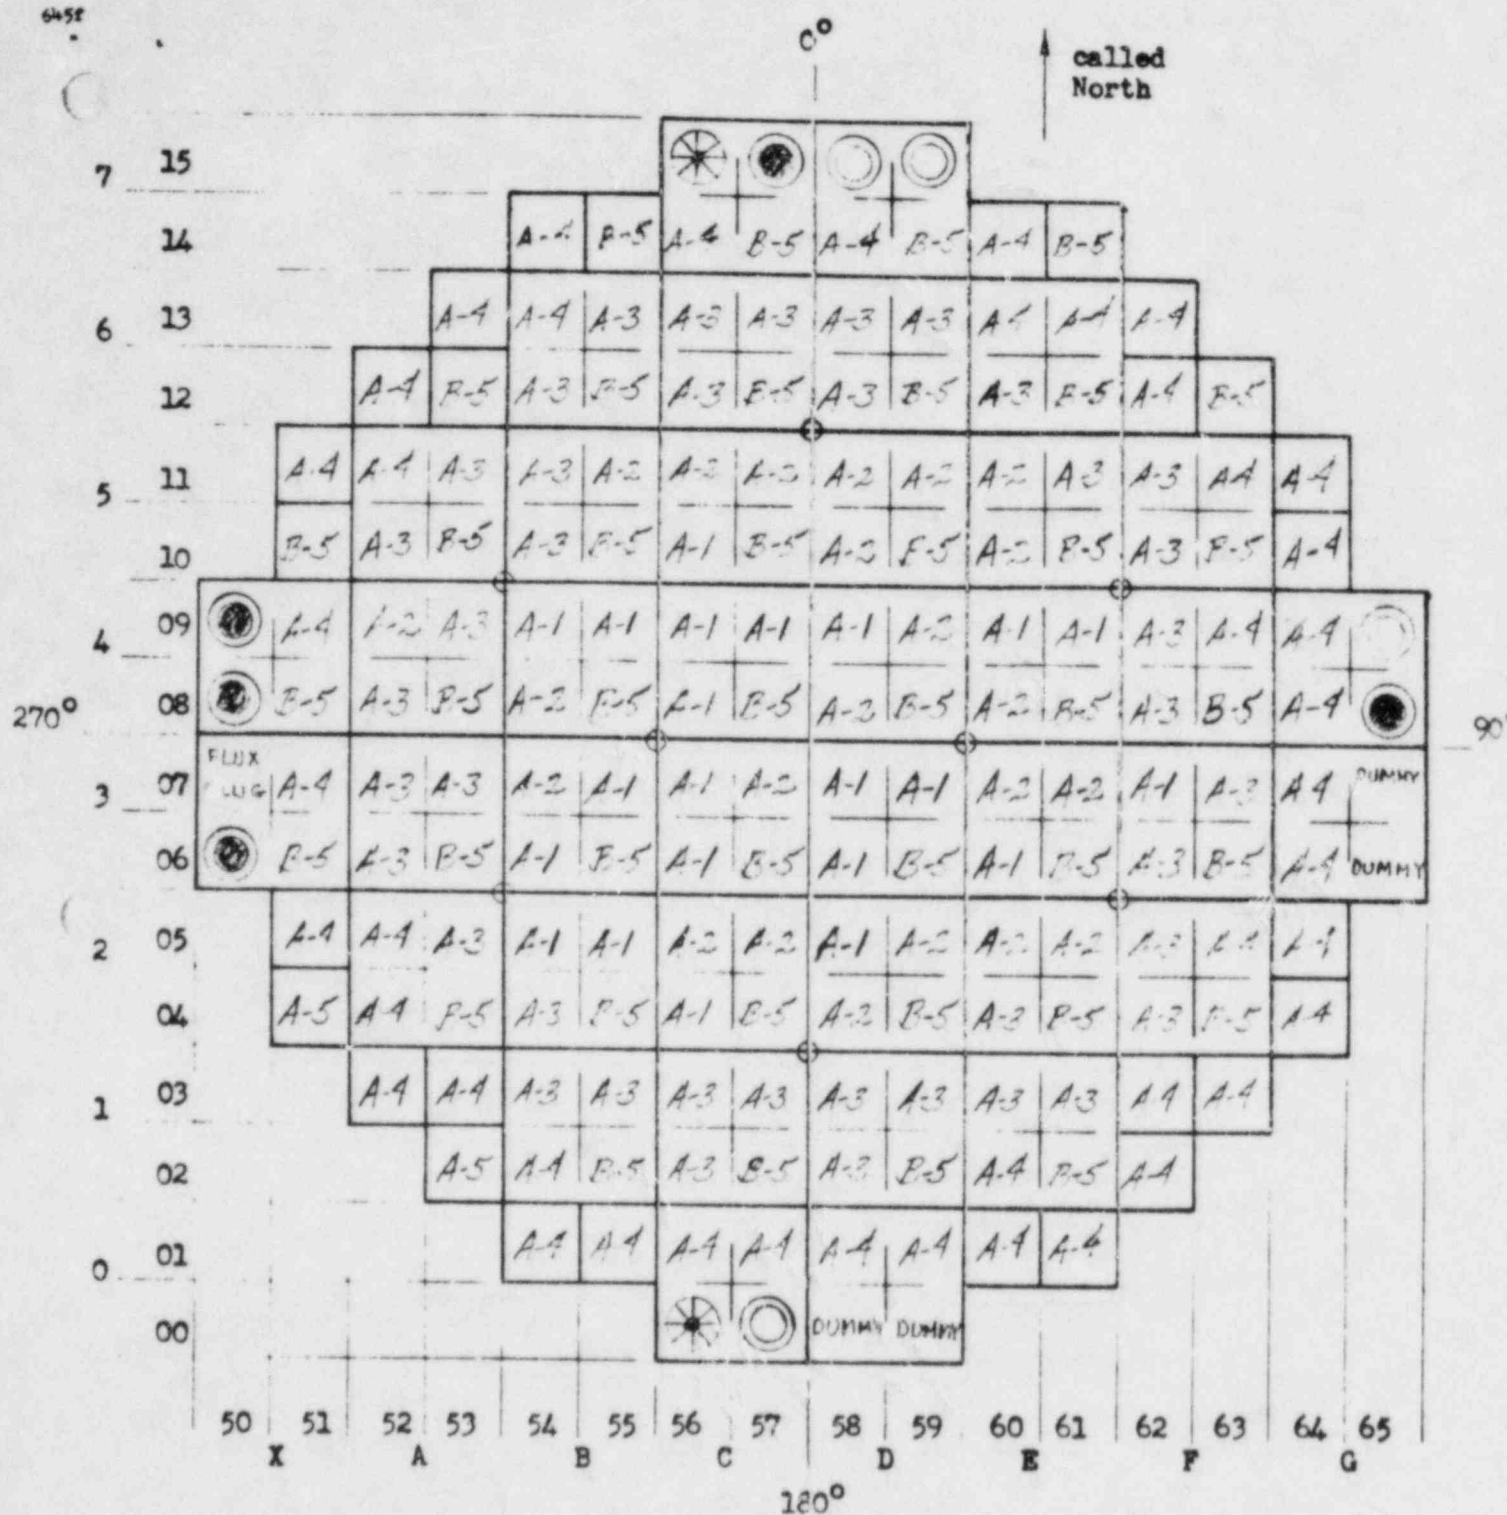
FIGURE 1

Figure 1 shows the final reload status of the core.

CORE II-A FINAL ARRANGEMENT (10-11-65)
