LICENSEE EVENT REPORT (LER)

FACILITY NAME (1) Waterford Steam Electric Station Unit 3	DOCKET NUMBER (2) 0 5 0 0 0 3 8 2	PAGE (3) 1 OF 1 0
--	--------------------------------------	----------------------

TITLE (4)
Blown Undervoltage Circuit Fuse Replacement Results in Technical Specification 3.0.3 Entry

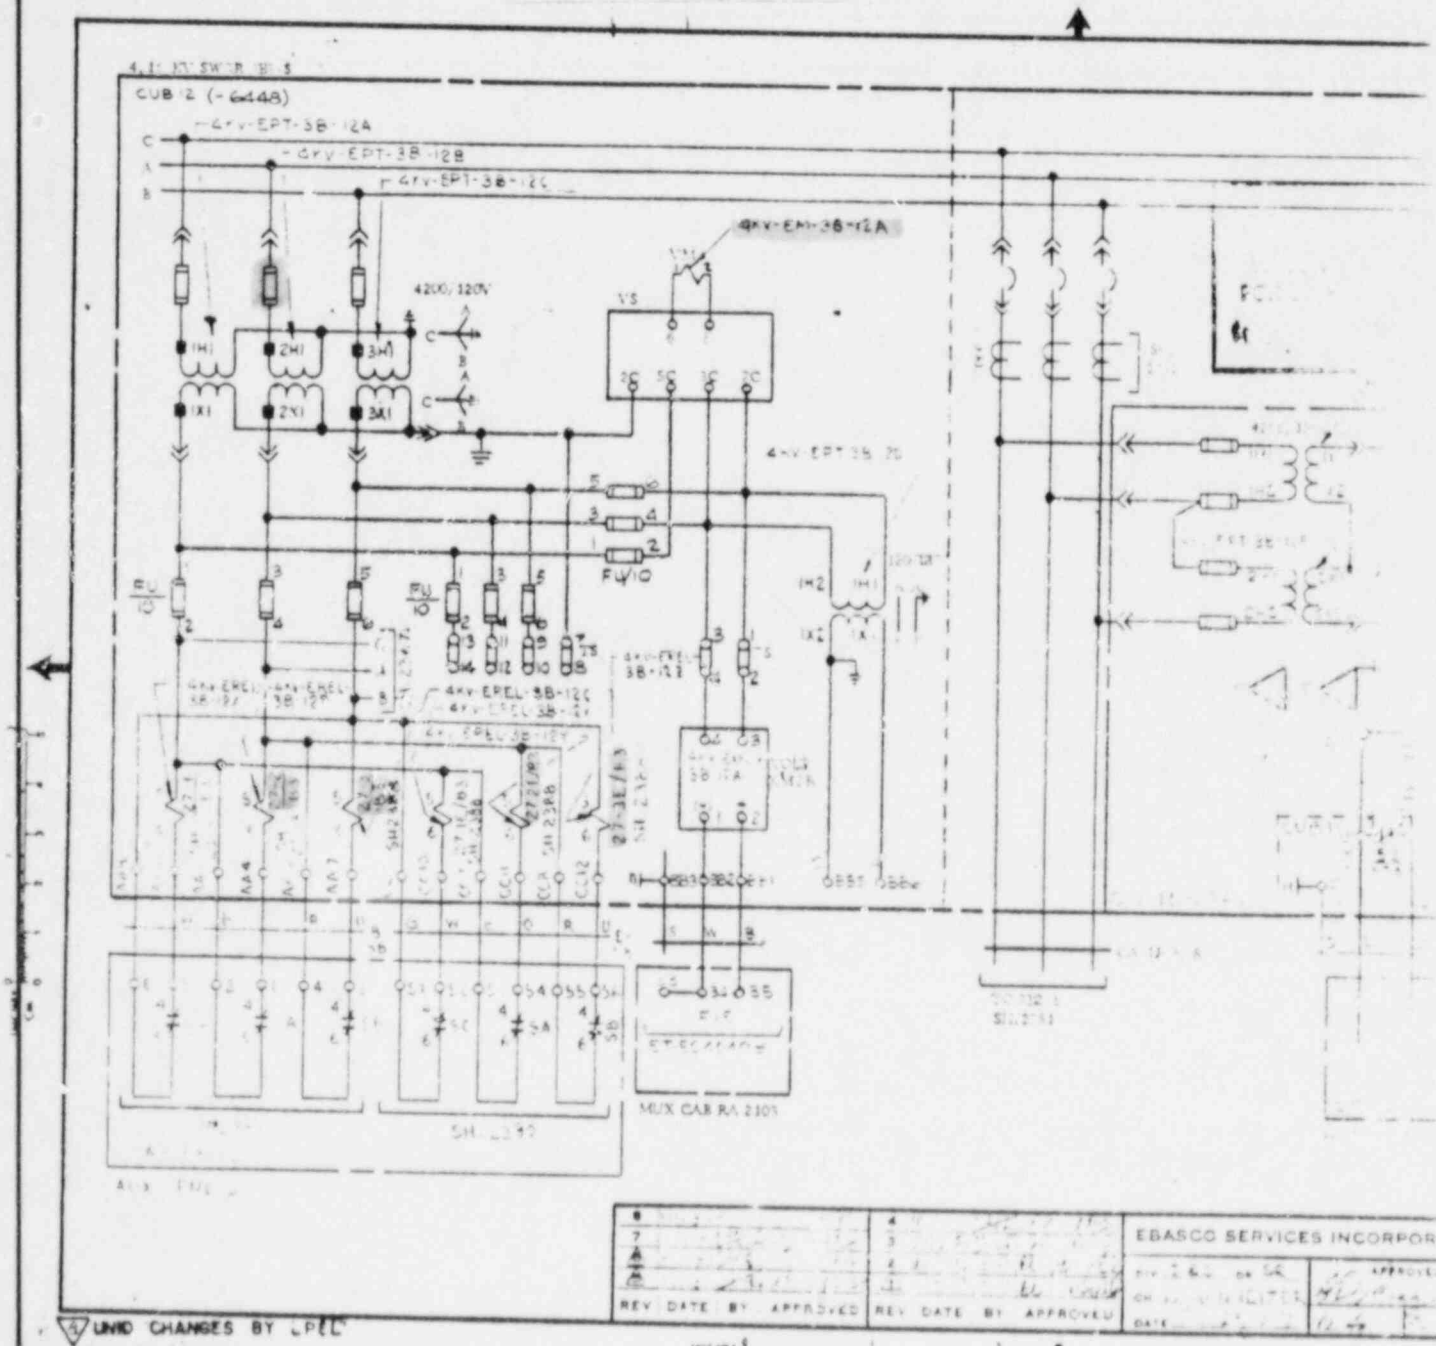
FIGURE 1

At approximately 0900 hours on March 21, 1988, Waterford Steam Electric Station Unit 3 was operating at 100% power when a Maintenance technician inadvertently allowed two wire connections to short while replacing a voltmeter selector switch (see Figure 1) (EIIS Identifier EA-EIS), 4KV-EM-3B-12A, causing the phase 'A' fuse for the primary winding of a 4160/120 VAC potential transformer (see Figure 1) (EIIS Identifier EA-XPT) to blow. The transformer supplies power to the 3B3-S 4160V Bus (EIIS Identifier EA-BU) undervoltage protection circuitry. The blown fuse caused two of the three undervoltage (UV) relays (EIIS Identifier EC-RLY), 27-2/B3 and 27-3/B3 (see Figure 1), and two of the three degraded voltage (DV) relays (EIIS Identifier EC-RLY), 27-2E/B3 and 27-3E/B3 (see Figure 1), to drop out, which resulted in actuation of the respective contacts (see Figure 2) (EIIS Identifier EJ-CNTR). This provided 125VDC power to the 27-2X and 27-3X relays (see Figure 2) (EIIS Identifier EJ-RLY). These DC energized relays, in conjunction with the 27-1X relay of phase C, provide 3 out of 3 coincidence logic to send an emergency start signal (see Figure 3) to the 'B' Emergency Diesel Generator (LDG) (EIIS Identifier EK-GEN) upon an undervoltage or degraded voltage condition in the 3B3-S 4160V bus. Since these relays were energized as a result of the blown fuse, they would not have prevented an emergency start of the 'B' EDG, but they effectively reduced the undervoltage signal coincidence logic to 2 out of 3 for phase C.

The root cause of this event was cognitive personnel error by a First Line Maintenance Supervisor since he rescheduled the voltmeter selector switch replacement without performing an adequate review of the work package. The work was originally scheduled to be completed during bus maintenance in the second refueling outage when the buswork including the UV protection circuitry would be deenergized. This job was rescheduled for completion prior to the outage in order to reduce the outage workload. Personnel responsible for this decision did not adequately consider the potential effects of slips during the job, or consider actions to minimize the effects of such slips such as removing the three fuses which isolate the 3B3-S voltmeter selector switch prior to the job.

A contributing cause was the inadvertent shorting of the two wire connections. The wires shorted as the technician was removing insulating tape to reterminate the wires. Additionally, the manner in which TS 3.3.2 is currently written does not allow for replacement of undervoltage channel circuit components without requiring entry into TS 3.0.3 or obtaining approval from the NRC for temporary relief from the action statement to effect repairs. It is now understood that voluntary entry in TS 3.0.3 is considered unacceptable for performance of corrective maintenance; therefore, TS 3.3.2 action requirements have been rewritten to improve their clarity and specificity and will be submitted for approval. Proper work practices on energized circuits and the responsibility for supervisory evaluation of scheduled work instructions were discussed with the Maintenance personnel involved in this incident.
