MEMORANDUM FOR: Charles E. Rossi, Director  
Division of Operational Events Assessment  
Office of Nuclear Reactor Regulation

SUBJECT: THE OPERATING REACTORS EVENTS MEETING  
August 2, 1988 - MEETING 88-31

OPERATING REACTORS EVENTS BRIEFING 88-31

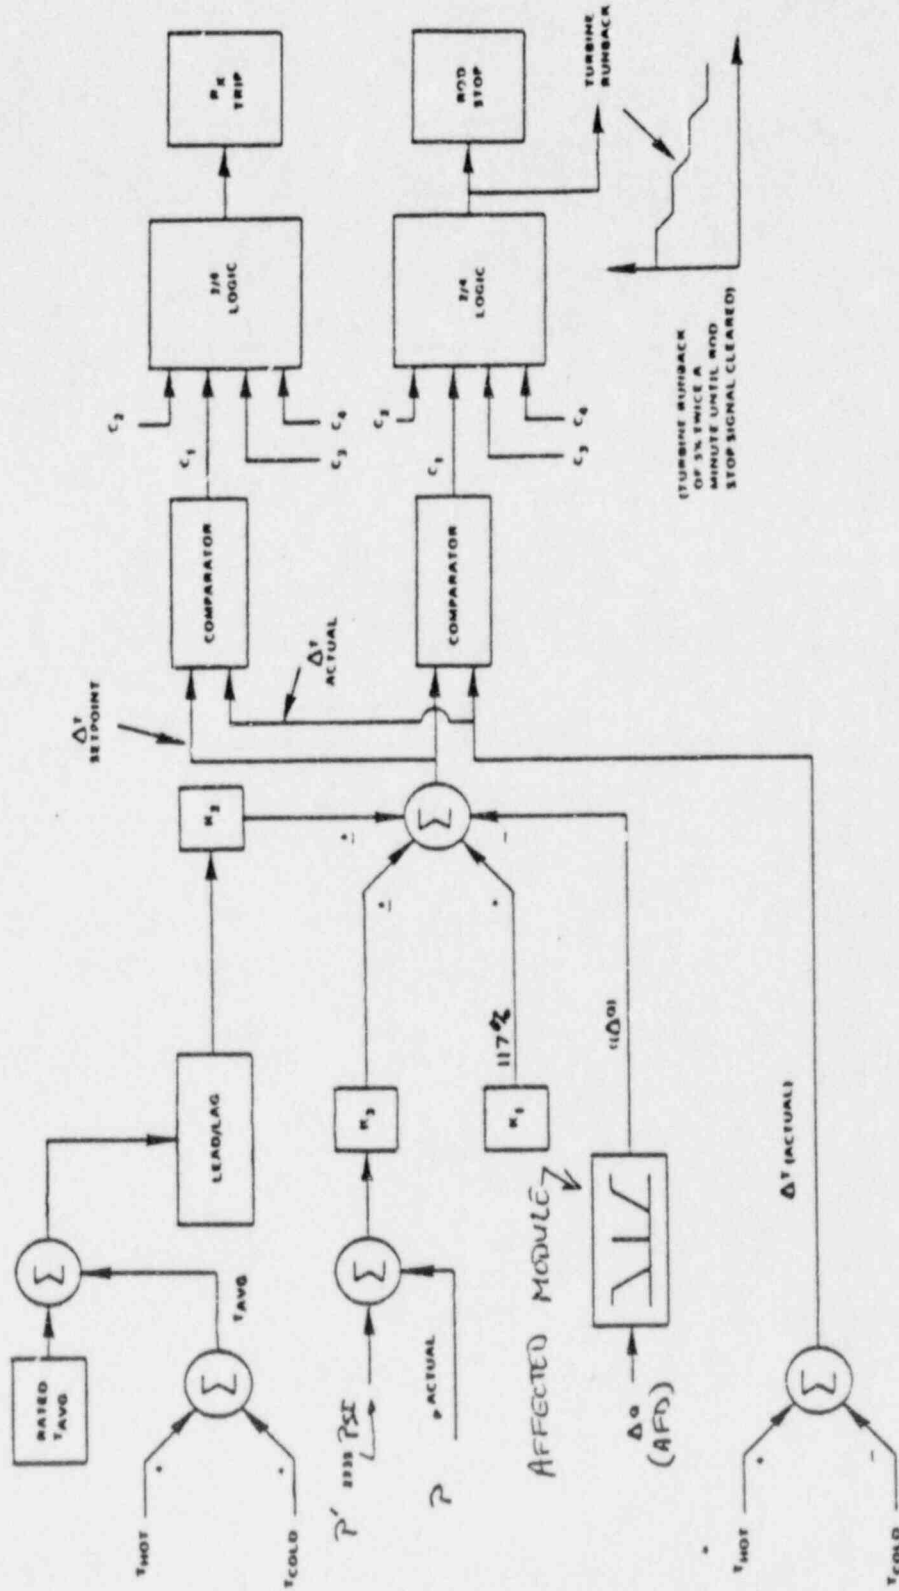
Overtemperature  $\Delta T$  Channel Block Diagram

OVERPOWER DELTA TEMPERATURE (OP $\Delta$ T) AND OVER TEMPERATURE DELTA TEMPERATURE (OT $\Delta$ T) TRIP SETPOINTS DO NOT COMPENSATE PROPERLY FOR HIGH AXIAL FLUX DIFFERENCE (AFD).

A DESIGN FLAW PREVENTS THE NEWER CIRCUIT MODULES FROM FUNCTIONING AS ORIGINALLY INTENDED.

- O 3 OUT OF 4 INSTRUMENT CHANNELS RESPONDED AS EXPECTED. THE ANOMALOUS CHANNEL HAD A FOXBORO 62H STYLE "C" CONTROLLER INSTALLED (THE THREE OPERABLE CHANNELS HAD STYLE "B" CONTROLLERS).

- O TESTING ON UNIT 2 REVEALED THAT ALL STYLE "C" MODULES FAILED TO RESPOND PROPERLY (3 OUT OF 4 CHANNELS).
- O THE LICENSEE ENTERED THE APPROPRIATE LCO.

- O UNIT 1 WAS SHUTDOWN AND UNIT 2 WAS RAMPED DOWN. UNIT 1'S STYLE "B" MODULES WERE TRANSFERRED TO THE UNIT 2 INSTRUMENT CHANNELS SO THAT UNIT 2 COULD RESUME FULL POWER OPERATION.

- O WESTINGHOUSE HAD PREVIOUSLY ADVISED THE LICENSEE THAT STYLE "C" MODULES WERE AN ACCEPTABLE REPLACEMENT FOR STYLE "B" MODULES.
- O THIS PROBLEM OCCURRED AT KEWAUNEE IN 1974 AND WAS SOLVED BY A SIMPLE MODIFICATION TO THE MODULE'S WIRING. THIS CHANGE WAS NOT COORDINATED WITH EITHER THE NRC OR WESTINGHOUSE.
- O PRAIRIE ISLAND MODIFIED THEIR STYLE "C" MODULES AND RESTARTED UNIT 1 FOR THE REMAINDER OF THEIR COASTDOWN. RIII MONITORED MODIFICATION AND POST-MAINTENANCE TEST.
- O WESTINGHOUSE WAS NOTIFIED BY THE LICENSEE. WESTINGHOUSE WILL INFORM THE AFFECTED PLANTS TO TAKE CORRECTIVE ACTION (MAY BE AS FEW AS 3 OR AS MANY AS 6 PLANTS).
- O THE PRAIRIE ISLAND LICENSEE HAS INDICATED THAT THEY WILL ISSUE A PART 21 NOTICE AND NOTIFY INPO.

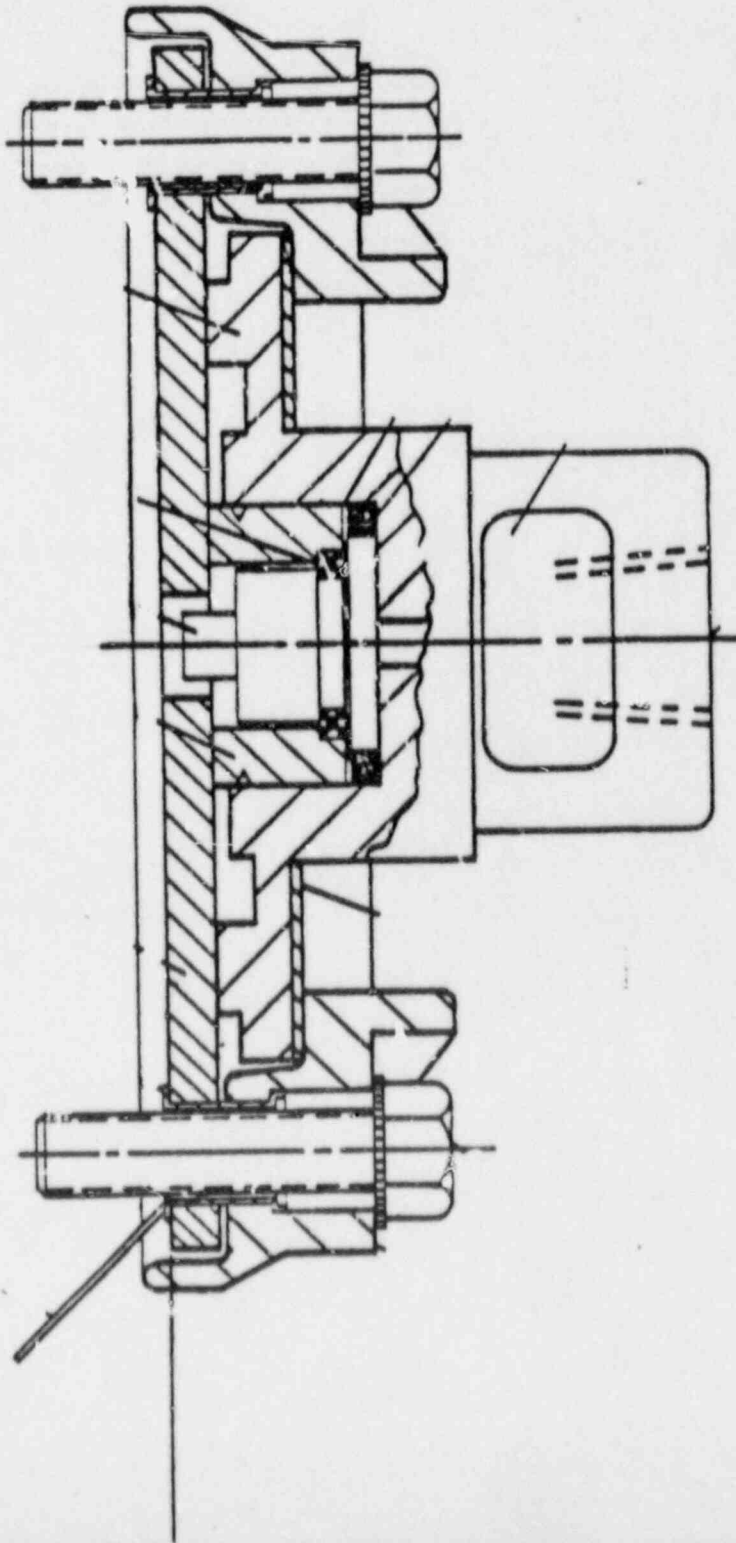
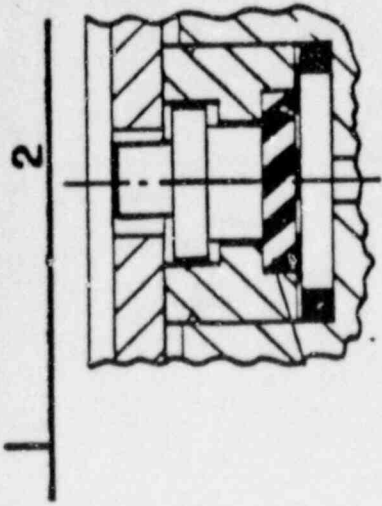
TYPICAL F5CO PRESSURE SWITCH AT YANKEE ROWIE

POTENTIAL GENERIC PROBLEM WITH ASCO PRESSURE SWITCHES MODEL TG13A42.

- o DISCOVERED WHEN RHR SHUTDOWN COOLING COULD NOT BE ESTABLISHED (INBOARD SUCTION VALVE WOULD NOT OPEN).
- o FOLLOWING CYCLING SWITCH FUNCTIONED PROPERLY.
- o ABOUT 44 SWITCHES PER UNIT INVOLVED OF WHICH 10 SWITCHES ARE SAFETY-RELATED.
- o LICENSEE REQUIRES BY TECH. SPEC. TO CHECK SAFETY SYSTEM ONCE PER MONTH.
- o LICENSEE PLANNING TO DISASSEMBLE SWITCHES TO DETERMINE FAILURE MODE.
- o UNKNOWN IF SIMILAR TO PROBLEM AT YANKEE-ROWE (DEC. '87) MODEL TL10A22 AND TM10A22.

- o REGION 11 AND RVIB (VENDOR BRANCH) CONTINUING TO FOLLOW.
- o EAB TO DETERMINE IF AN INFORMATION NOTICE IS WARRANTED.

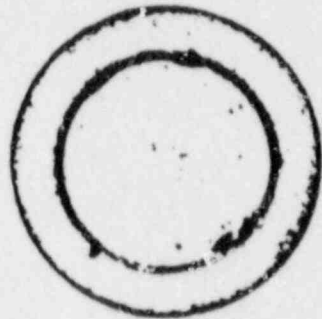
DISK DEFORMATION RESULTING FROM QUALIFICATION TEST

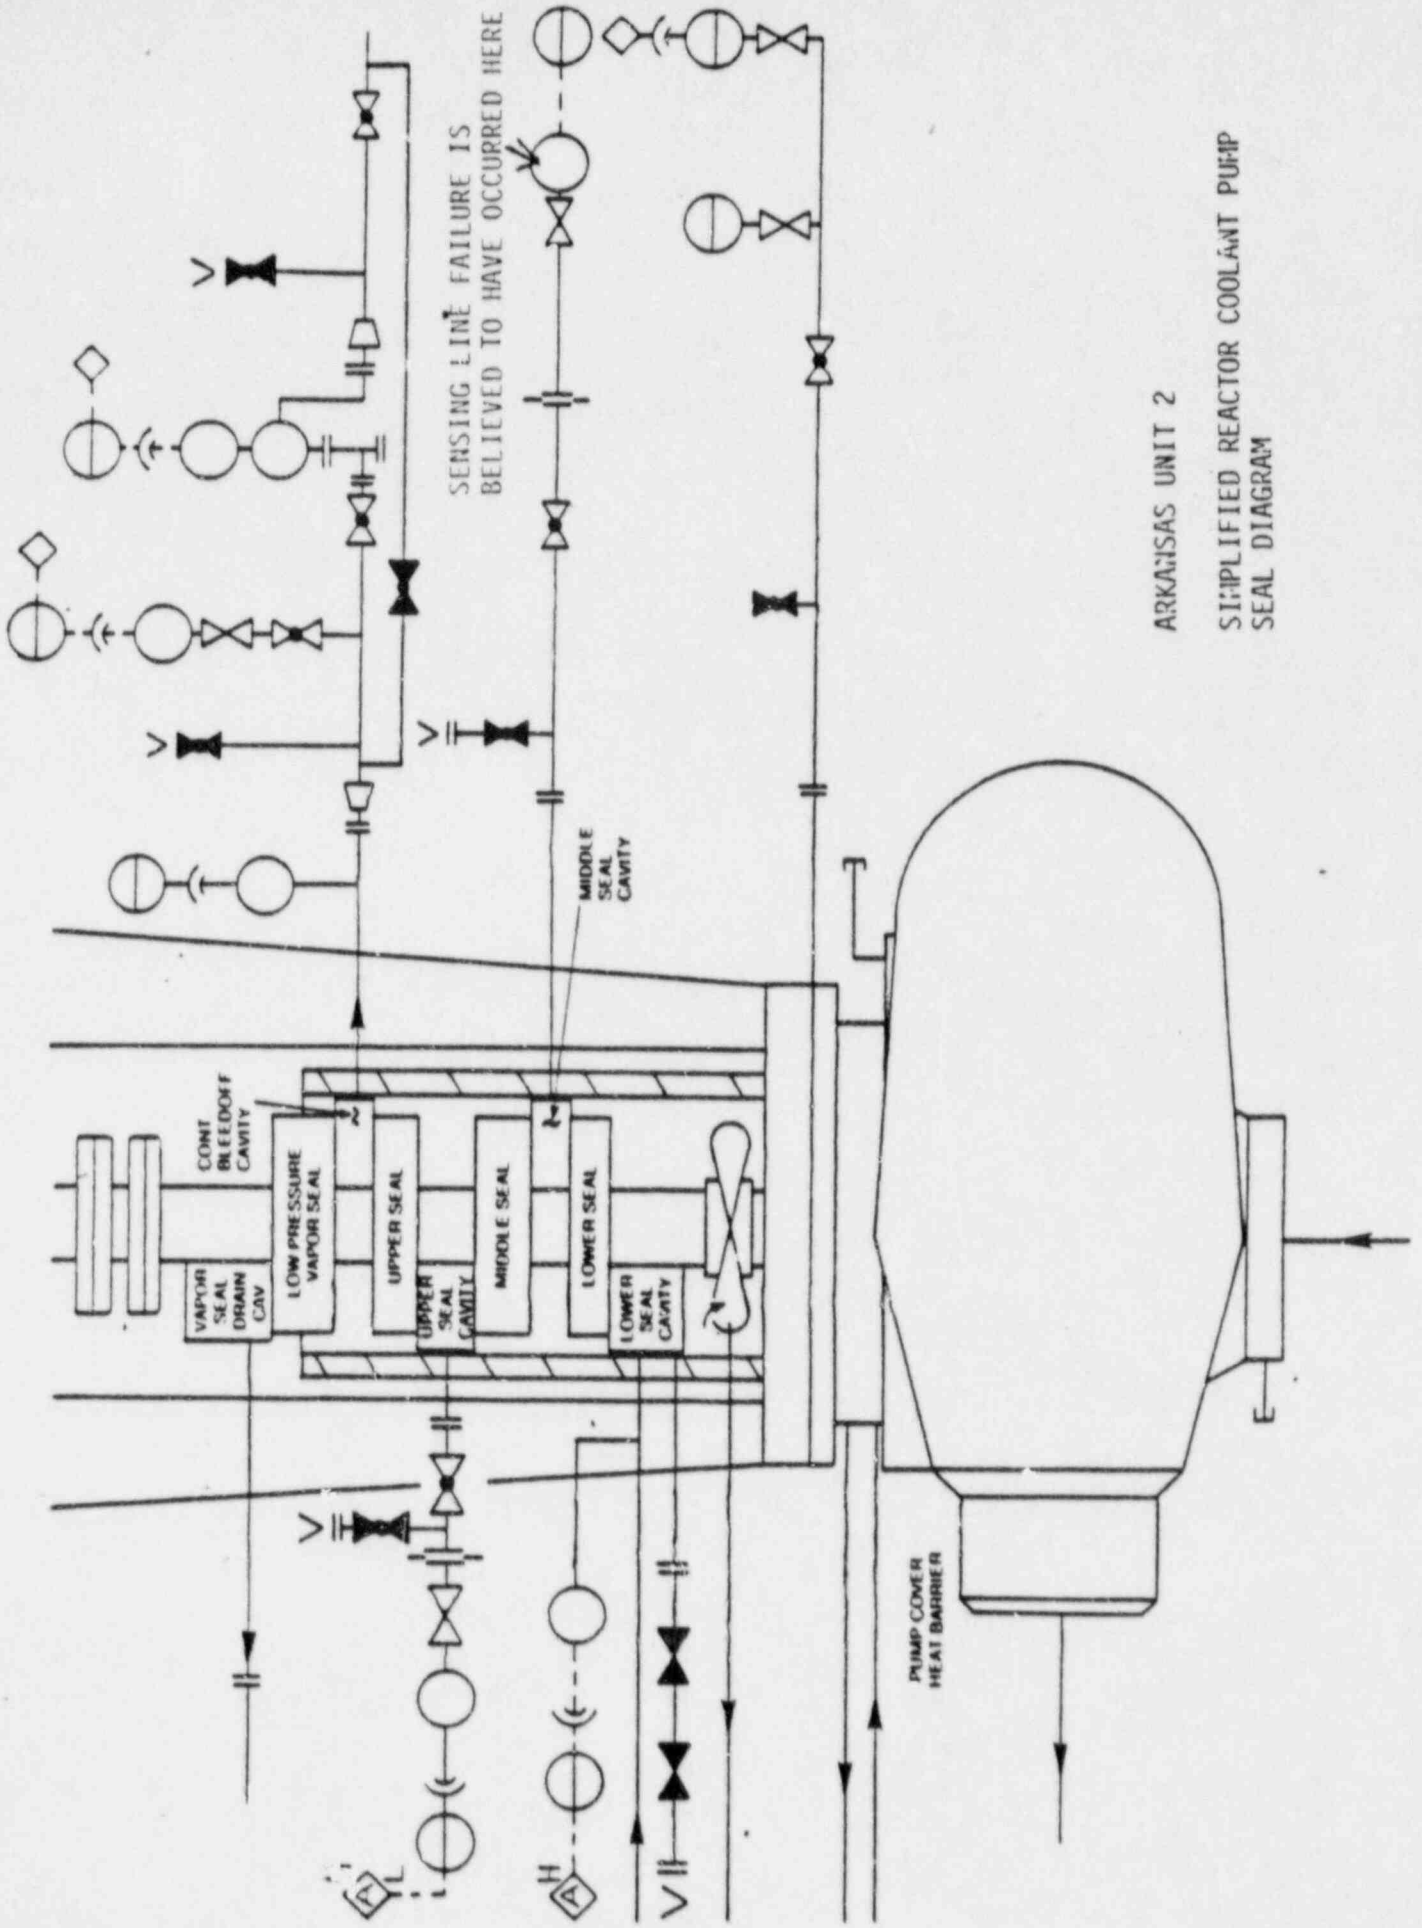
SIMPLIFIED REACTOR COOLANT PUMP SEAL DIAGRAM

LEAKAGE OF REACTOR COOLANT PUMP SEAL PACKAGE.

MIDDLE SEAL PRESSURE SENSING LINE SHEARED.

- O ON AUGUST 1, 1988 AT 16:50 CDT HIGH/LOW CONTROLLED BLEEDOFF ALARM ON "A" RCP.
- O DECREASING PRESSURIZER LEVEL, INCREASED SUMP LEVEL, INCREASED CHARGING FLOW, HIGH CONTAINMENT RADIATION.
- O REACTOR MANUAL TRIP AT 17:00 CDT.
- O LEAK RATE INCREASED FROM APPROXIMATELY 2 GPM TO 35 GPM BEFORE COOLDOWN.
- O UNUSUAL EVENT DECLARED BY LICENSEE AT 17:25 CDT BASED ON LEAK RATE GREATER THAN 10 GPM.
- O BY 19:28 CDT REACTOR COOLED TO 532<sup>0</sup>F, DEPRESSURIZED TO 1550 PSIG LEAK INCREASED TO 40 PSIG.
- O LEAK RATE DECREASED BY CONTINUED RCS COOLING AND DEPRESSURIZATION.
- O CONTAINMENT ENTRY BY 00:38 CDT AUGUST 2, 1988.
- O BROKEN SENSING LINE APPEARS TO HAVE CAUSED FAILURE OF MIDDLE, UPPER AND VAPOR SEALS FROM LACK OF FLOW.
- O LOWER SEAL APPEARS TO HAVE FAILED FROM HIGH  $\Delta P$ .
- O RC PUMPS MANUFACTURED BY BYRON JACKSON, CONTROLLED LEAKAGE DESIGN WITHOUT SEAL INJECTION.

LICENSEE AND NRR CONTINUING TO INVESTIGATE CAUSE OF PUMP SEAL FAILURE.
