SUBJECT: ISSUANCE OF NUREG-1306, SOUTH TEXAS PROJECT, UNITS 1 AND 2

The U. S. Nuclear Regulatory Commission has issued NUREG-1306 entitled "NRC Safety Significance Assessment Team Report on allegations related to the South Texas Project, Units 1 and 2."

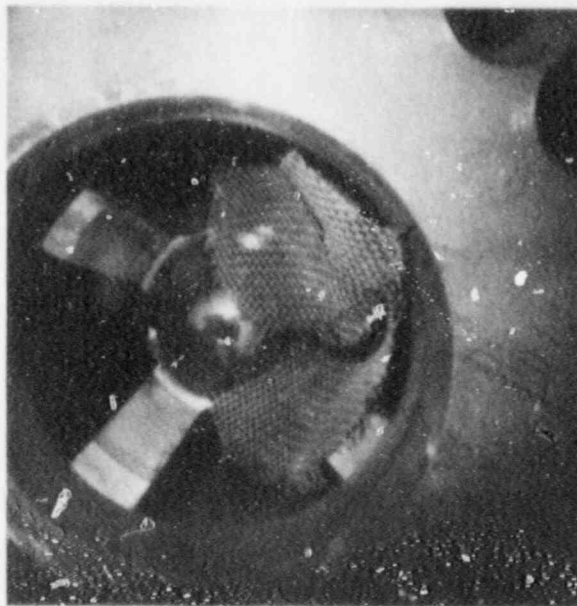
The SSAT reviewed a detailed Westinghouse report, WCAP-11506, dated June 1, 1987, entitled "Full Flow Filter Recovery and Equipment Assessment." The report stated that after completion of hot functional testing at South Texas Project Unit 1, which spanned 28 days under full-flow and operating temperatures, inspection of the full-flow filters installed on the lower core support plate in the reactor vessel revealed that 57 of the 192 filters had degraded. The filters were used during both cold and hot functional testing to help remove any debris from the primary coolant system. The Unit 1 filters had experienced certain degradations ranging from small tears or holes in the screen material to the complete loss of four filter screens (see Figure 5.1-1). As a result, the filter debris circulated throughout the primary coolant system and parts of the attached auxiliary systems after the failure of the filters.

Figure 5.1-1 Damaged Full-Flow Filter Screen
(View Looking Up Into Reactor Vessel)

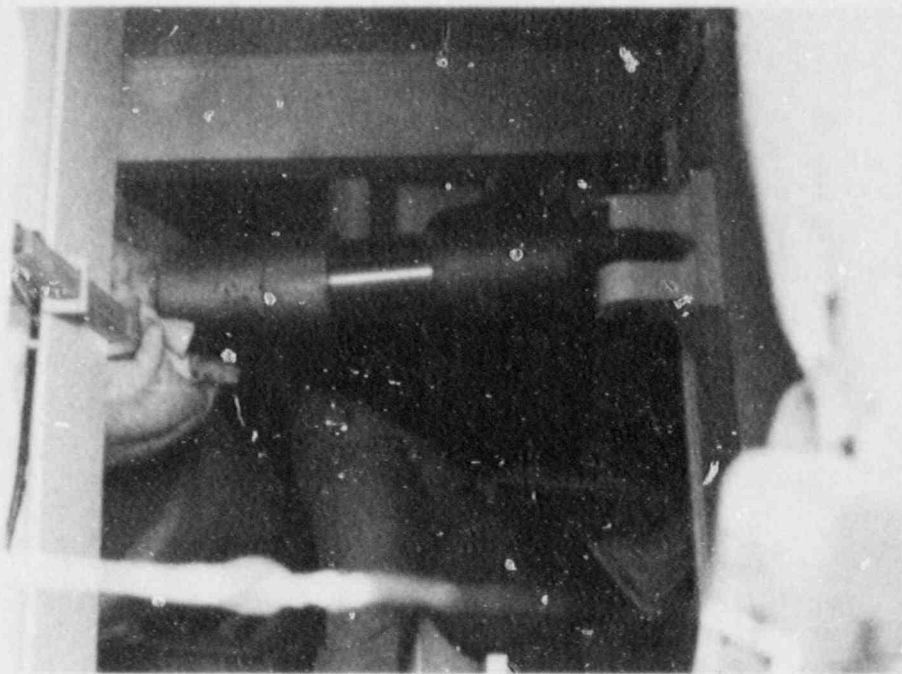
The SSAT reviewed calculation CC-5944, file C-37, Revision 7. Information on the calculation cover sheet indicated that the calculation for pipe whip restraint RC-1125-R1 had been deleted because the energy-absorbing-material (EAM) section of the pipe restraint was removed. However, there is a possibility for it to be reactivated in the future. It also stated that portions of the restraint that were installed are being used as pipe support structures. However, because the design pipe whip restraint loads are so large compared to the pipe support loads, no analysis needs to be performed. On this basis,

Figure 5.1-2 Feedwater Pipe Shock Suppressor (FW-9012-HL 5005)
Attached to Reactor Coolant Pipe Rupture Restraint
(RC1125R1)

this calculation was prepared as a reference only, and should the pipe whip restraint be reactivated, the reference drawings, specifications, and other applicable data must be checked for consistency at that time.

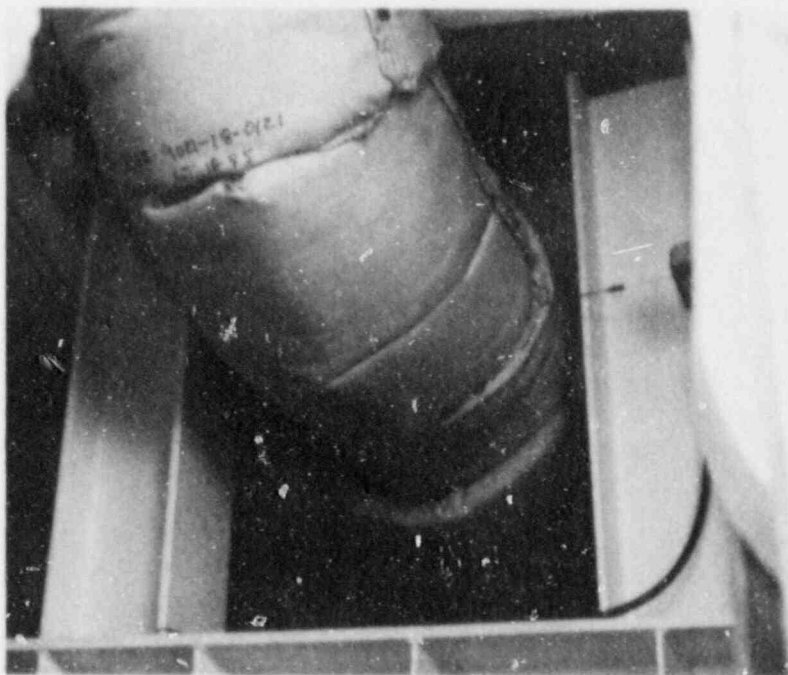
Figure 5.1-3 Feedwater Pipe and Rupture Restraint Structure
Attached to Reactor Coolant Pipe Rupture
Restraint (RC1125R1)

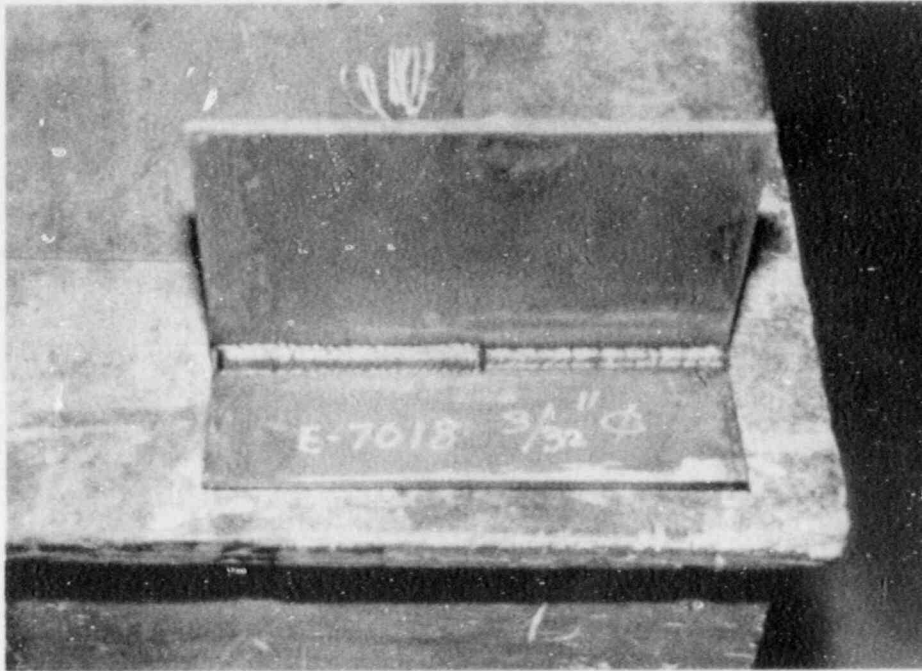
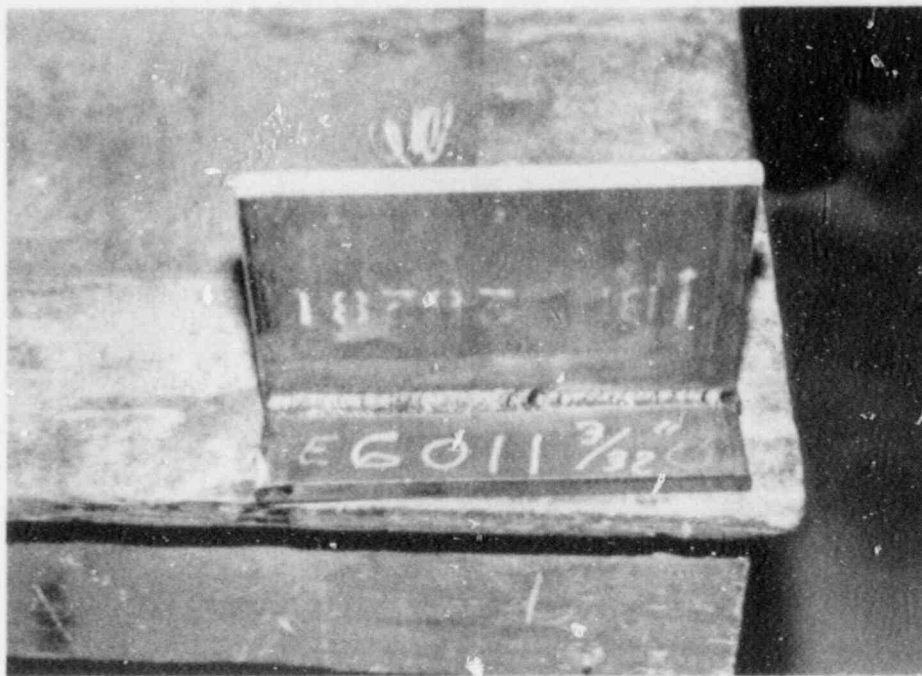
Figure 5.5-1 Weldments Showing Typical Bead Characteristics of E7018 and E6011 Weld Rods

In an effort to determine whether the E7018 electrodes in the unacceptable lot had been used in place of E6010 or E6011 electrodes for HVAC welding, the SSAT requested Ebasco to prepare weldments of the same material used in the HVAC system with two different type electrodes, E6011 and E7018. This was done to ascertain the typical bead characteristics of each electrode to aid in the HVAC weld inspections. The welds made with the E7018 electrode show a smoother surface profile than welds made with the E6011 rod (see Figure 5.5-1(a) and (b)).

(a) Fillet Weld Using E7018 Weld Rod

(b) Fillet Weld Using E6011 Weld Rod

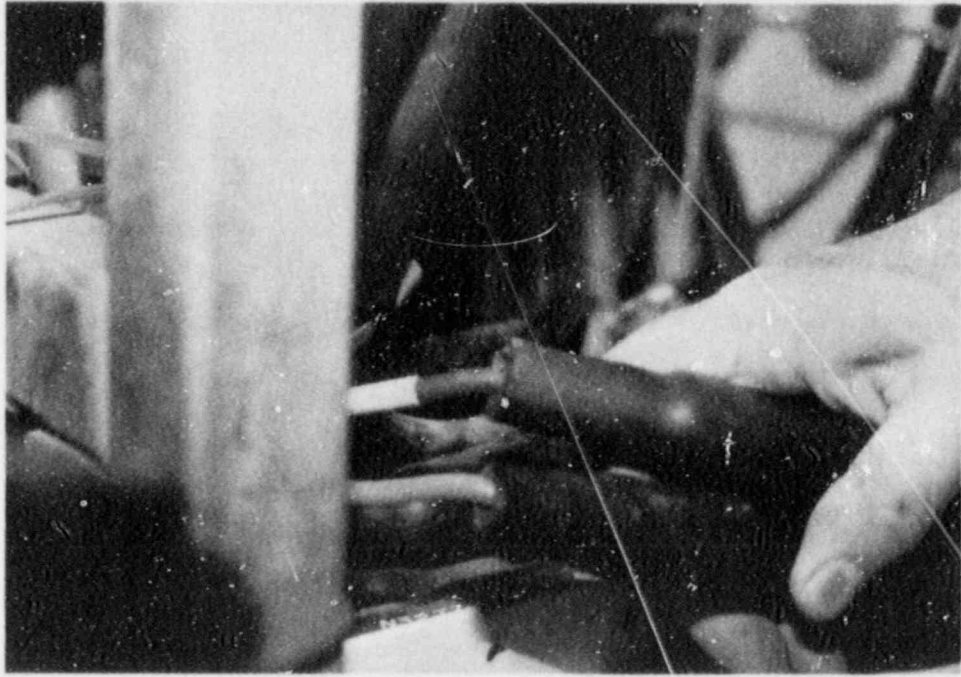
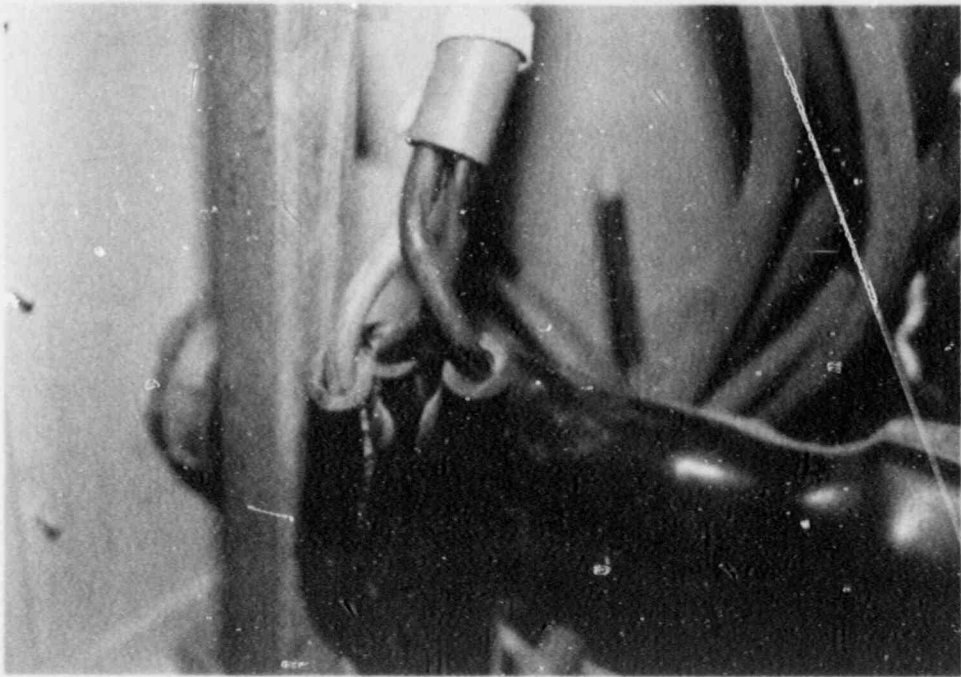
Figure 5.6-1 Raychem Splices

The SSAT determined that 91 (of approximately 2300) Raychem splices were identified as having been excluded from earlier reinspections performed by HL&P. As a result of a reinspection of the 91 splices, 3 were identified as needing rework and another 3 splices were identified as marginal. The SSAT determined that all 6 splices had been reworked by HL&P.

Before loading fuel into Unit 2, HL&P shall complete a reexamination of Raychem cable splices using the revised corrective action program implementing procedures and perform all corrective hardware and software actions found to be necessary.

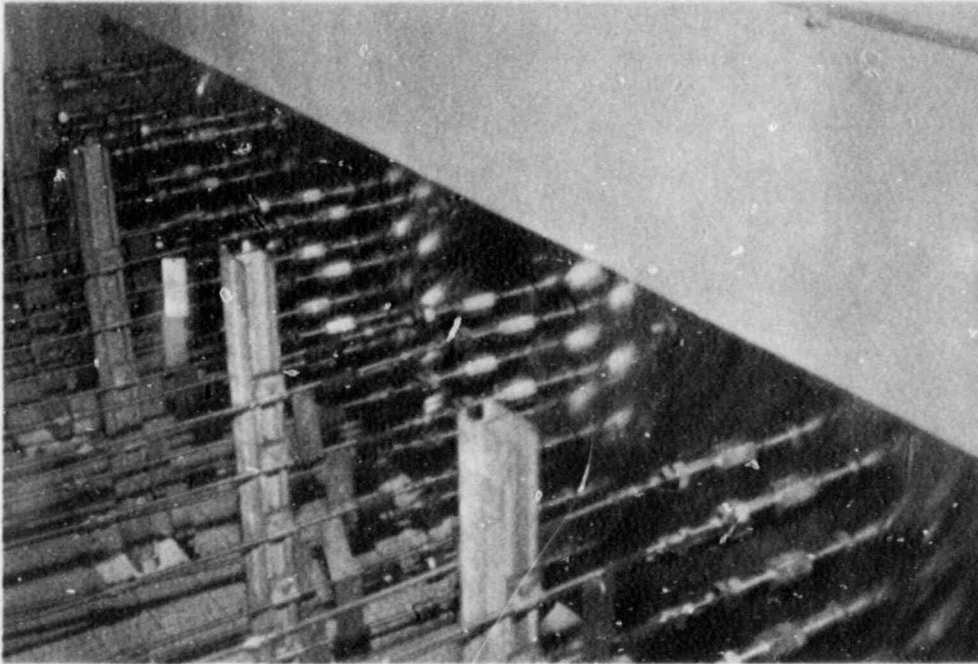
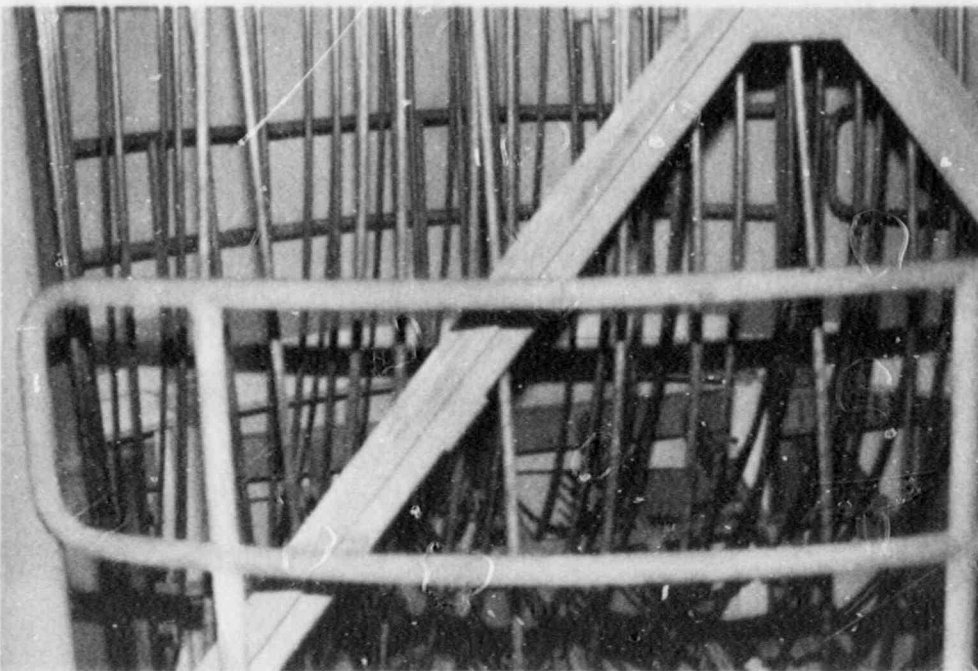
(a) Connections to the Seal Table

(b) Just Below Reactor Vessel

Figure 5.6-2 Incore Instrumentation Guide Tubes

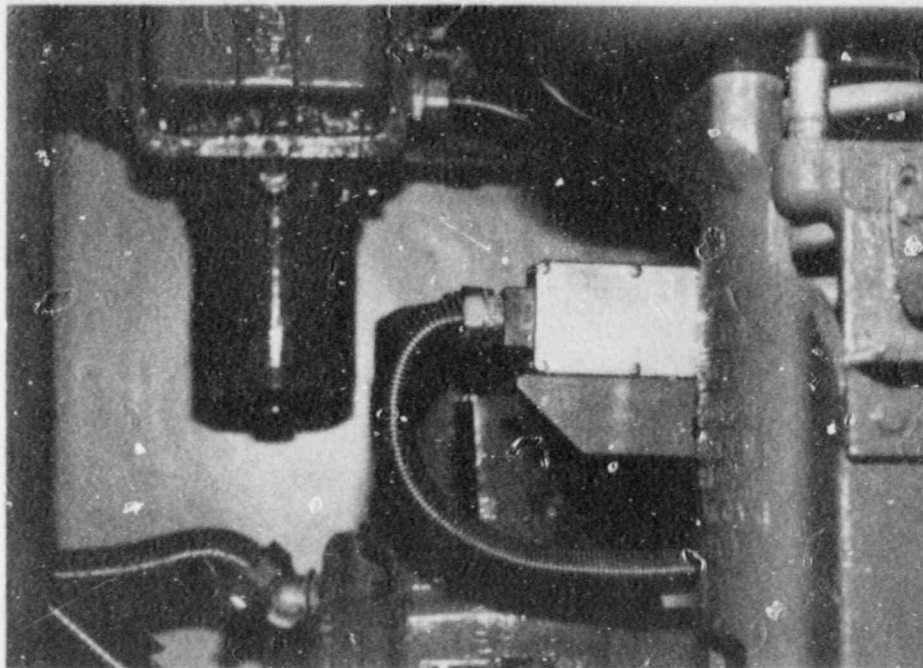
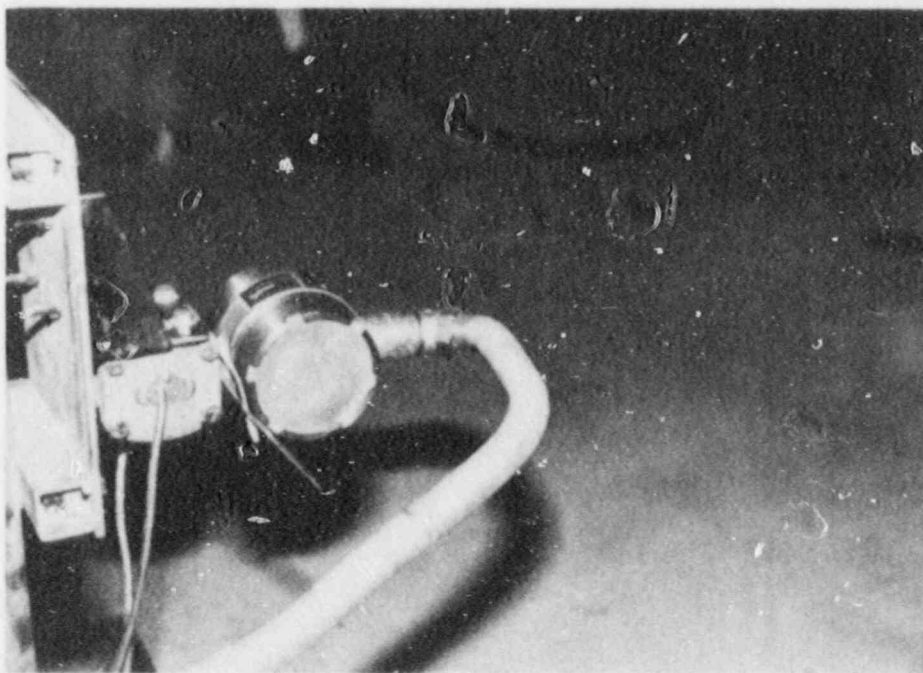
Figure 5.6-3 Flexible Conduit Installation Reviewed by SAFETEAAM-Dispositioned Use As Is

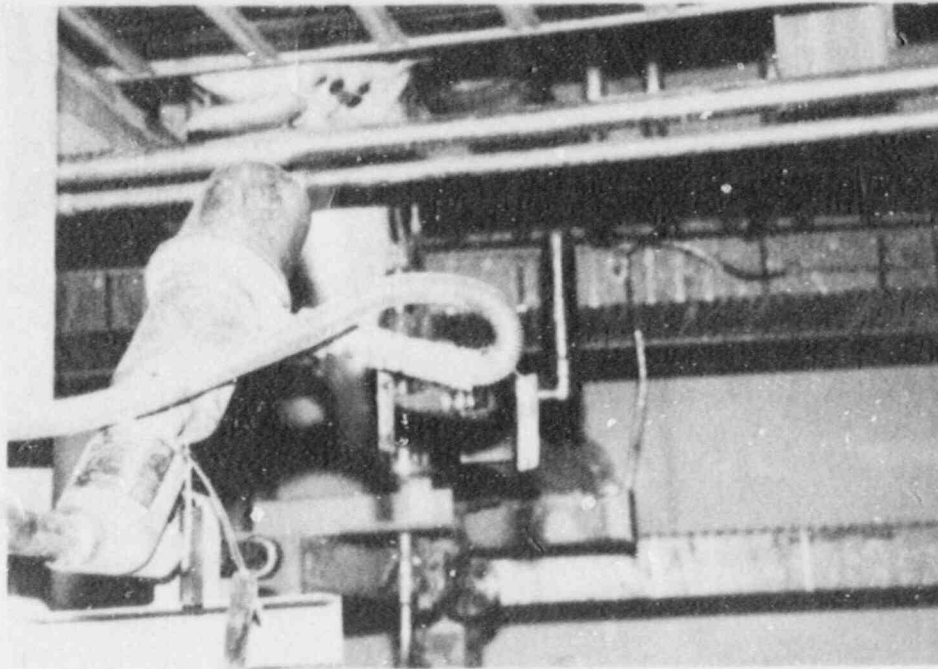
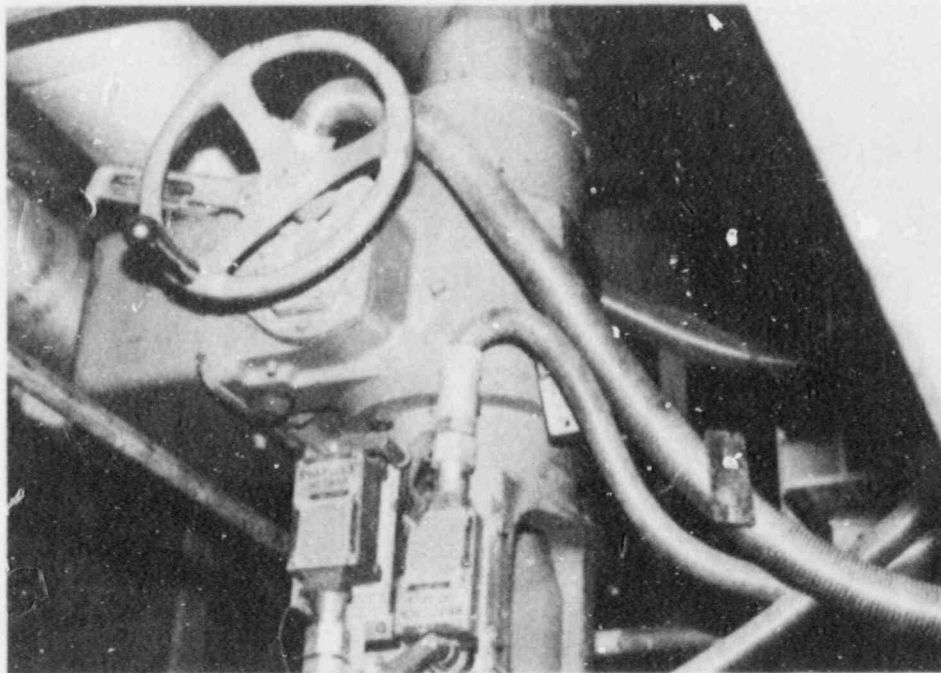
(a) Installation on Solenoid Valve - Cable Bend Radius Not Violated

(b) Installation to Limit Switch - Cable Bend Radius Not Violated

Figure 5.6-4 Flexible Conduit Installations With Apparent Bend Radius Violations

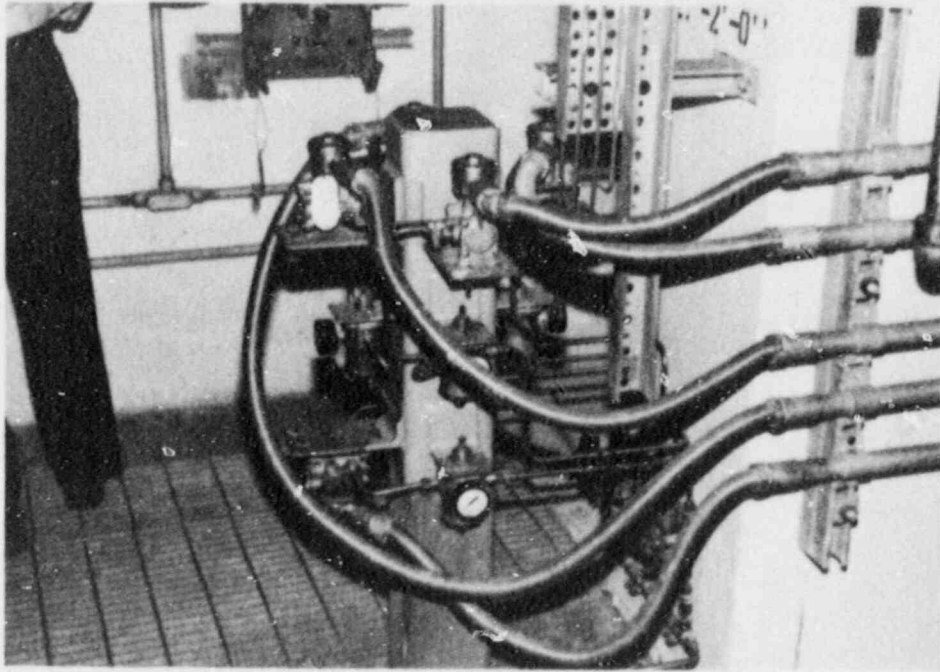
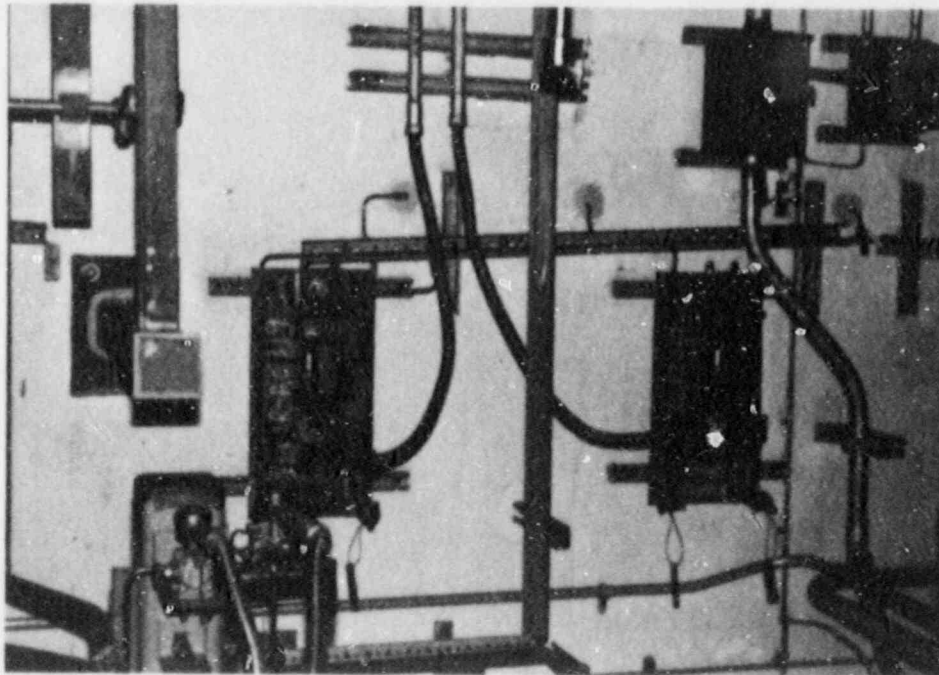
(a) Flexible Conduit to Solenoid Valves, Unit 1 Containment

(b) Flexible Conduit to Instrumentation, Unit 1 Containment

Figure 5.6-5 Typical Acceptable Flexible Conduit Installations

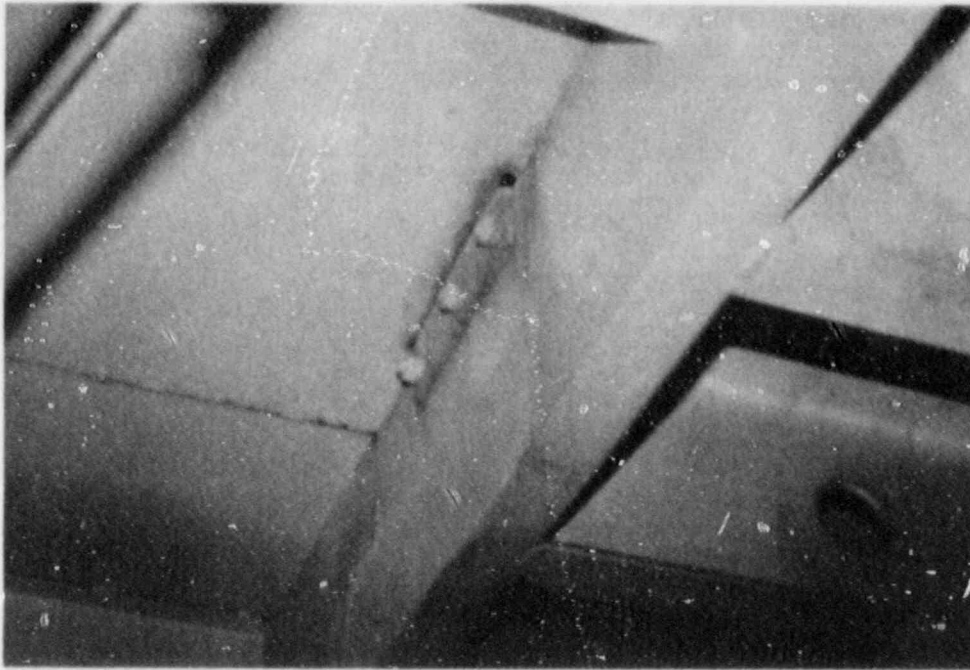
Figure 5.8-1 Discoloration of Polar Crane Coatings Due To Leaking Grease From Hoist Operating Mechanism

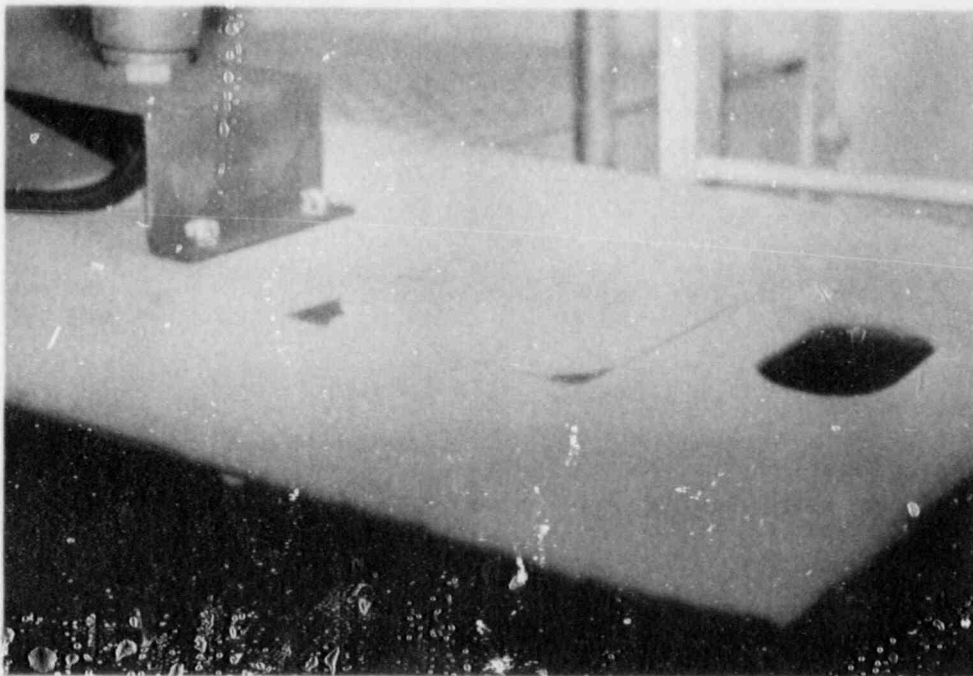
Figure 5.8-2 Area Under Lamp Maintenance Access on Polar Crane Catwalk With Taped Areas Not Coated

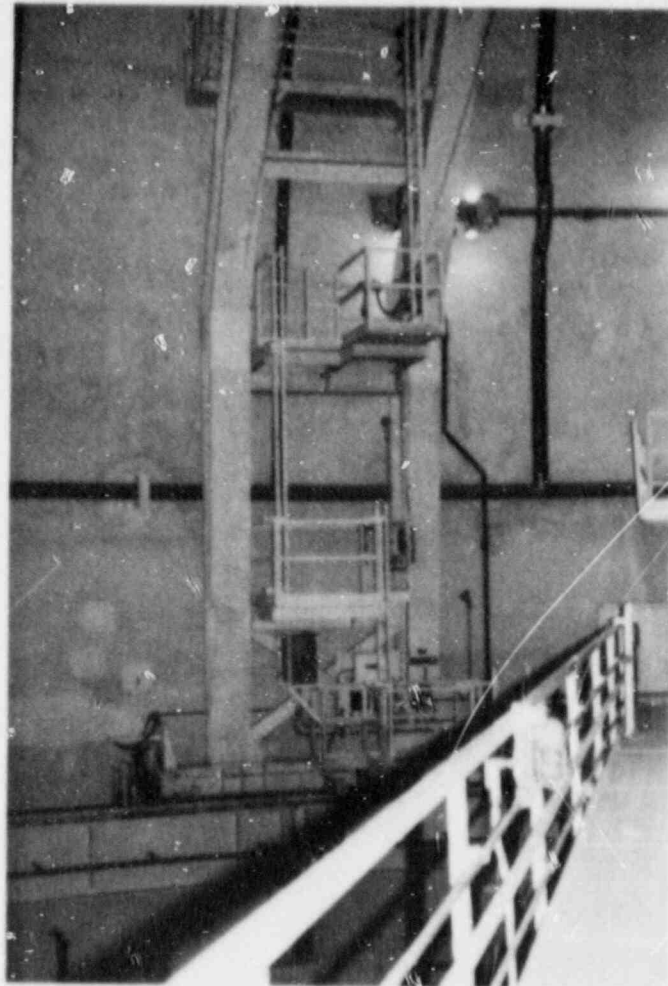
The orbital bridge is non-safety-related, seismically qualified, and self-propelled and is used as an inspection platform. Its base rides on the same track as the polar crane. The orbital bridge is used for inspecting and servicing the containment spray pipes that are attached to the containment dome (see Figure 5.10-1).

Figure 5.10-1 Lower Portion of Orbital Bridge
(As Seen From the Polar Crane Catwalk)

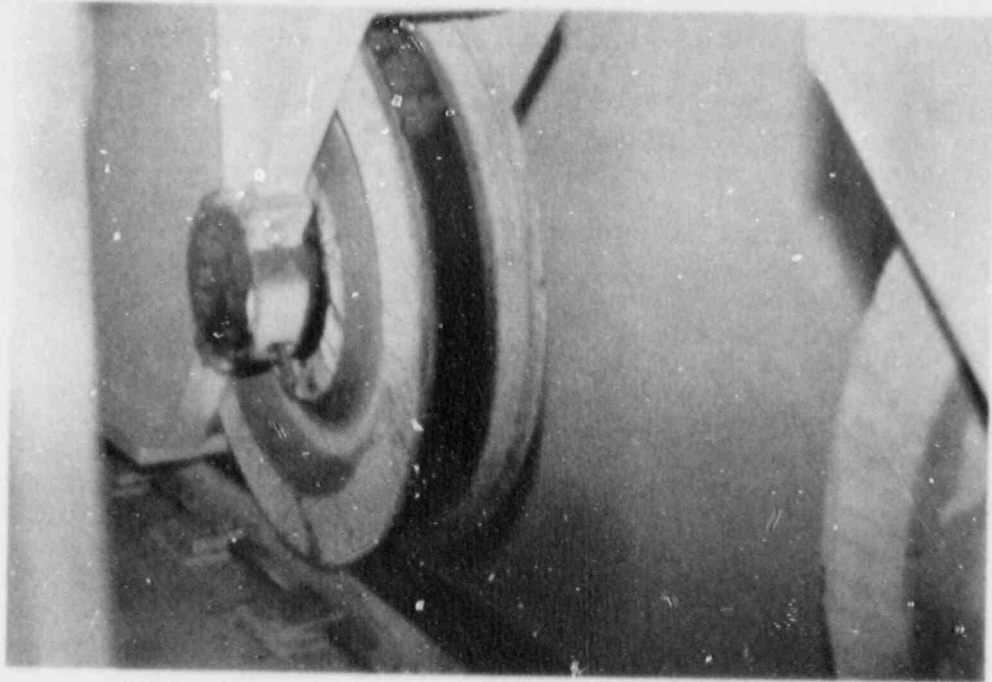
Figure 5.10-2 Polar Crane Wheel and Track

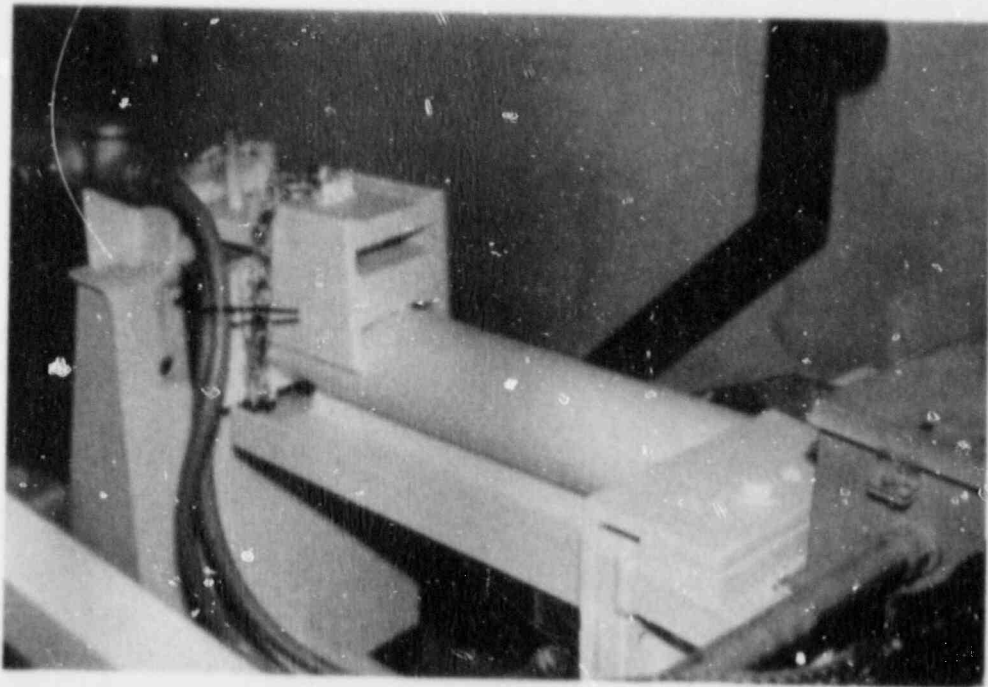
permanent linkage mechanism in place and instead were tied together with angle iron and a "come-a-long" device (see Section 5.6.5.2 of this report for an explanation of device).

Figure 5.10-3 Polar Crane/Orbital Bridge Linkage Mechanism

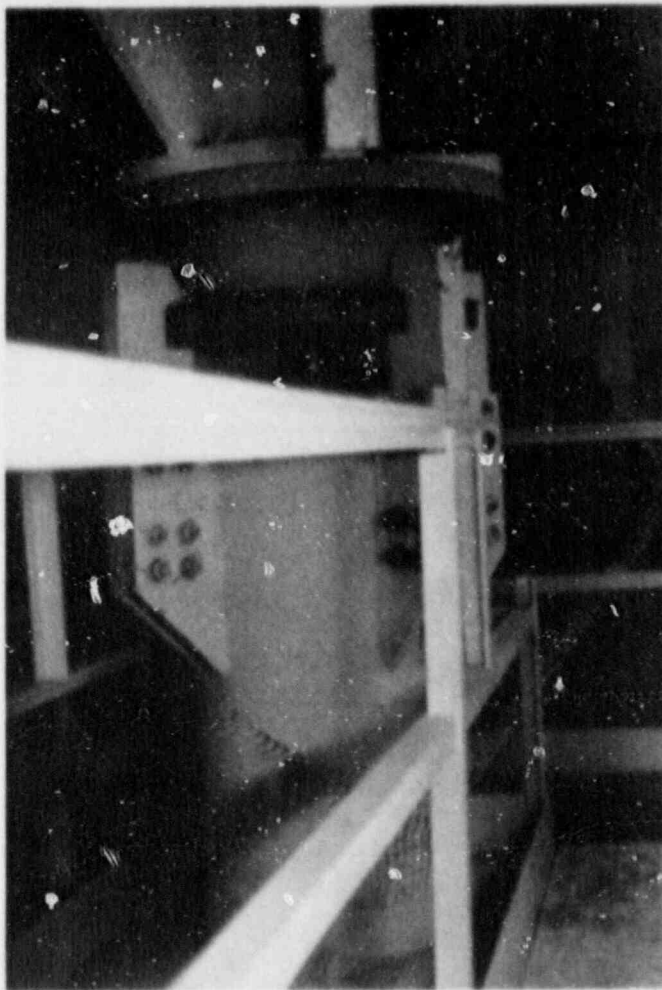
Figure 5.10-4 Orbital Bridge Pivot Assembly

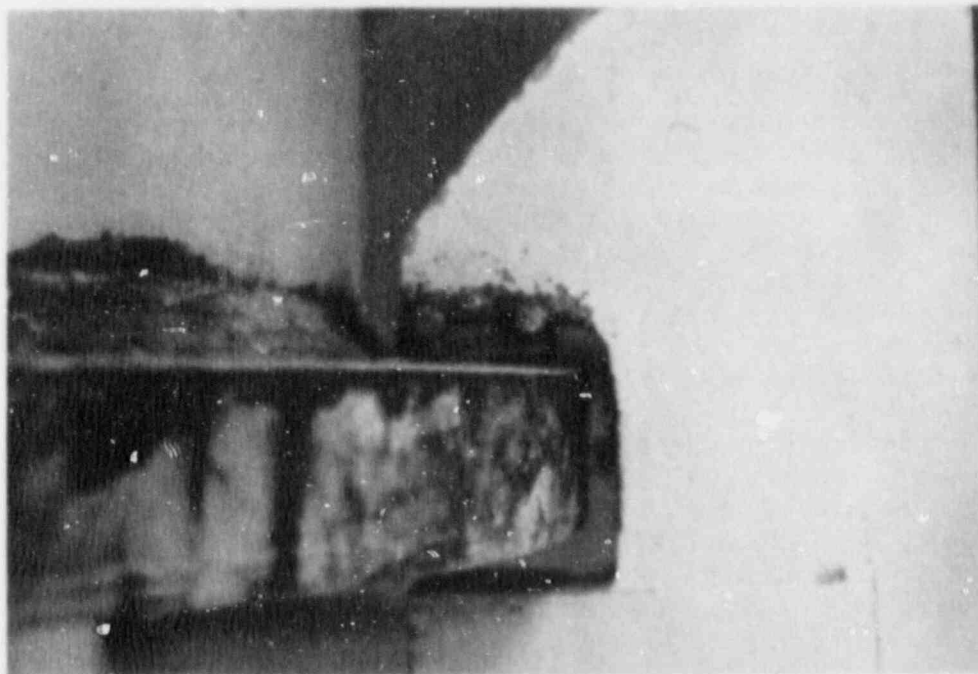
Figure 5.10-5 Modified Safety Lug on Orbital Bridge Pivot Assembly
