**GPU Nuclear****TECHNICAL DATA REPORT**TDR NO. 638REVISION NO. 1BUDGET  
ACTIVITY NO. 123125PAGE 1 OF 50

TMI-1 OTSG REPAIRS

Engineering & Design  
DEPARTMENT/SECTION Materials Engrg/Failure Anal.RELEASE DATE 10/21/85 REVISION DATE \_\_\_\_\_DOCUMENT TITLE: Evaluation of Eddy Current Indications Detected  
During the 1984 Tech. Spec. Inspection

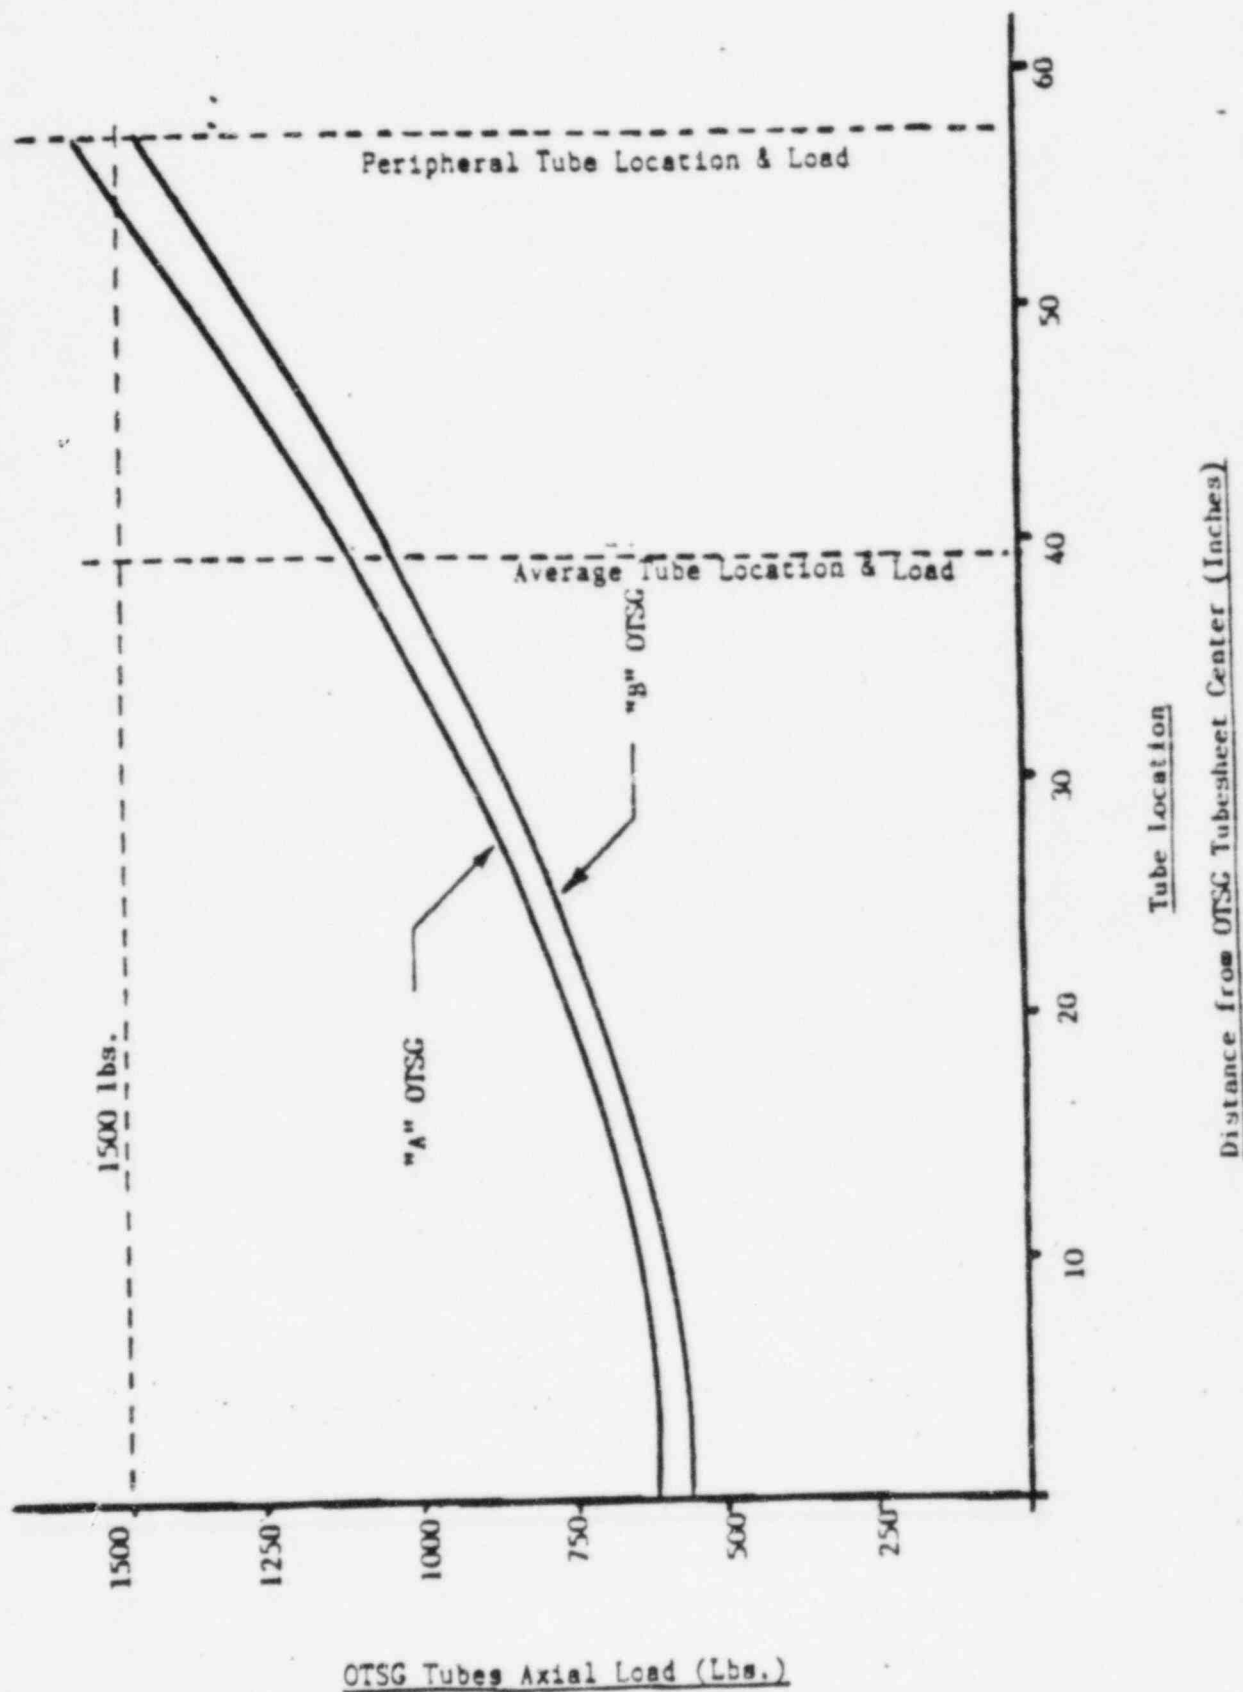
Figure 1 - TMI-1 OTSG Testing 3rd Cooldown (10-2-83)

Two additional pieces of data from Ref. 16 lend support to the mechanical scenario. First, peripheral tubes consistently see higher loads than core tubes. Therefore, in the periphery, the highest stresses would also act on this IGA/IGSAC. Second, the A-OTSG cooled down more quickly than the B unit. The peak load during the most rapid cooldown (Ref. 16) was 200 lb. in the A-OTSG, 17% higher than in B-OTSG. Figure 1 is a representation of how the A-OTSG would have had significantly more tubes carrying loads high enough to cause IGA/IGSAC to become more detectable.

Tube Load Distribution as a Function of Tube Location  
at the Peak Applied Load for "A" and "B" OTSGs

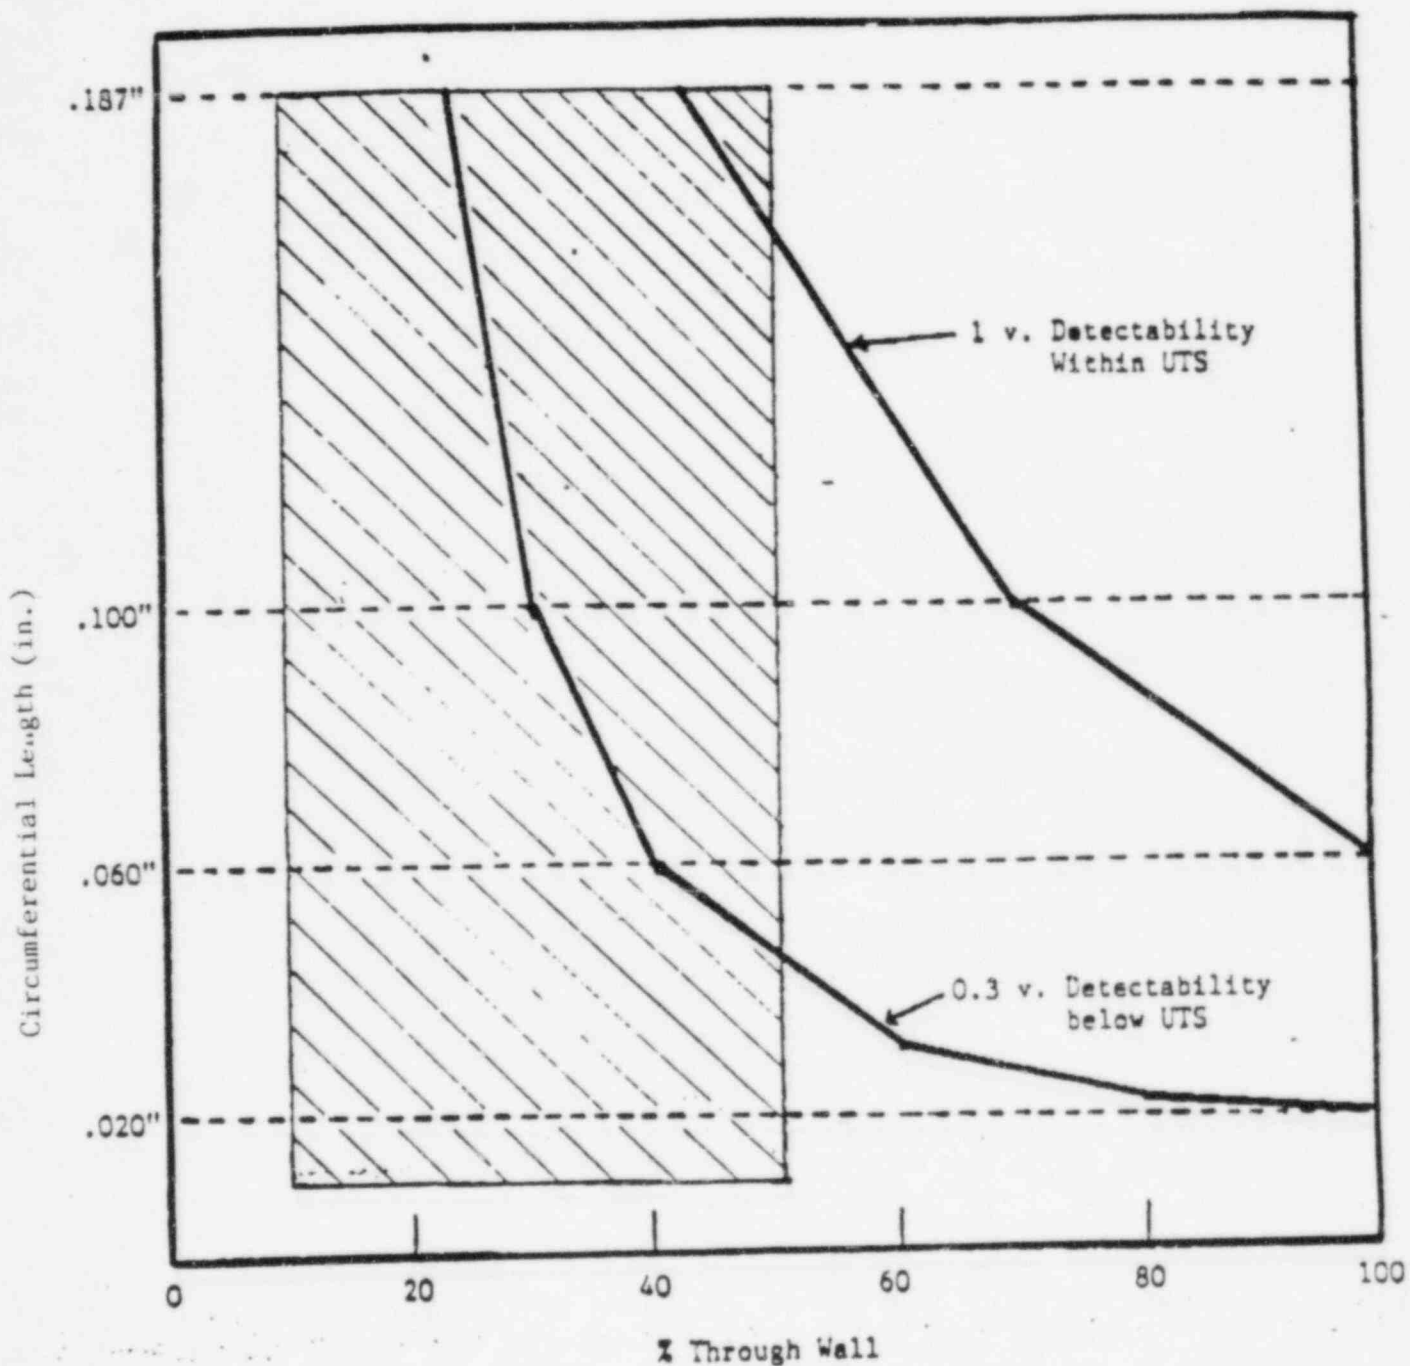
Figure 2 - 1984 Eddy Current Data

Figure 2 (Figure 2 from Reference 2) shows the measured sensitivity of the .540" S.D. technique in the range of short circumferentially oriented defects. The shaded region in Fig. 2 identifies the range based on eddy current indication sizing in which 90% of the 1984 indications fall. It can be seen that the eddy current calls span the 0.3 volt detectability limit. (NOTE: Circumferential length is based on the number of 8X1 coils giving a signal and not an actual defect measurement.) Thus only slight changes in indication geometry could cause a particular indication to become detectable assuming the defects lie close to the detectability line.

Compared to Detectability Limits

78% of 1984 Indications  
Lie Within This Range

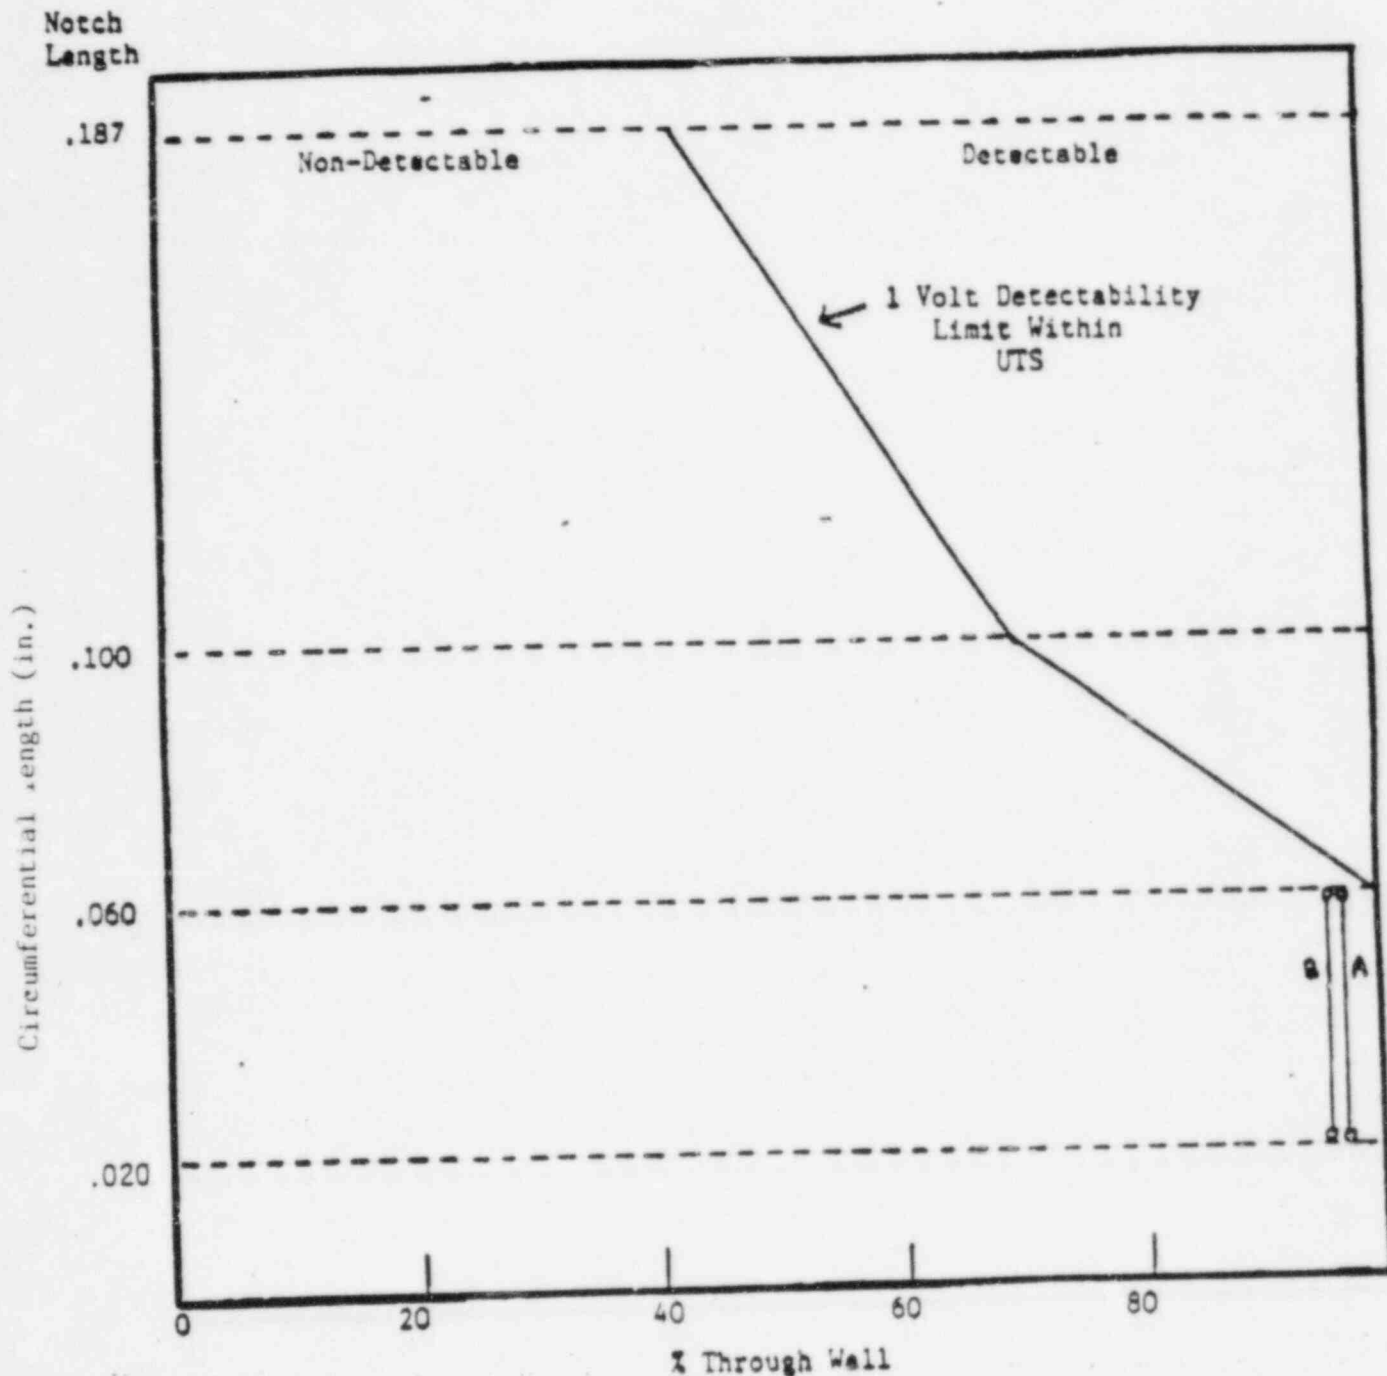
Figure 3a - Within - Tubesheet  
 Fiberscope Indications  
 Compared to Detectability Limit

In Figure 3a and 3b, we have taken the eddy current data and visual observations from the fibroscope inspection (shown in Table 6) and indicated where the indications would be in relationship to the calibration curves. The tubes for fibroscope inspection were chosen to be representative of the types of indications being found in 1984. All of the below-UTS indications (Figure 3b) are close to the 0.3 v detectability limits; the within-UTS indications (Figure 3a) do not fall into the detectable range. Therefore, it is reasonable that before mechanical loading these indications may not have been detectable. Mechanical loading, as discussed in the previous section, can alter IGA/IGSAC geometry.

A A-89-124  
 B A-76-119

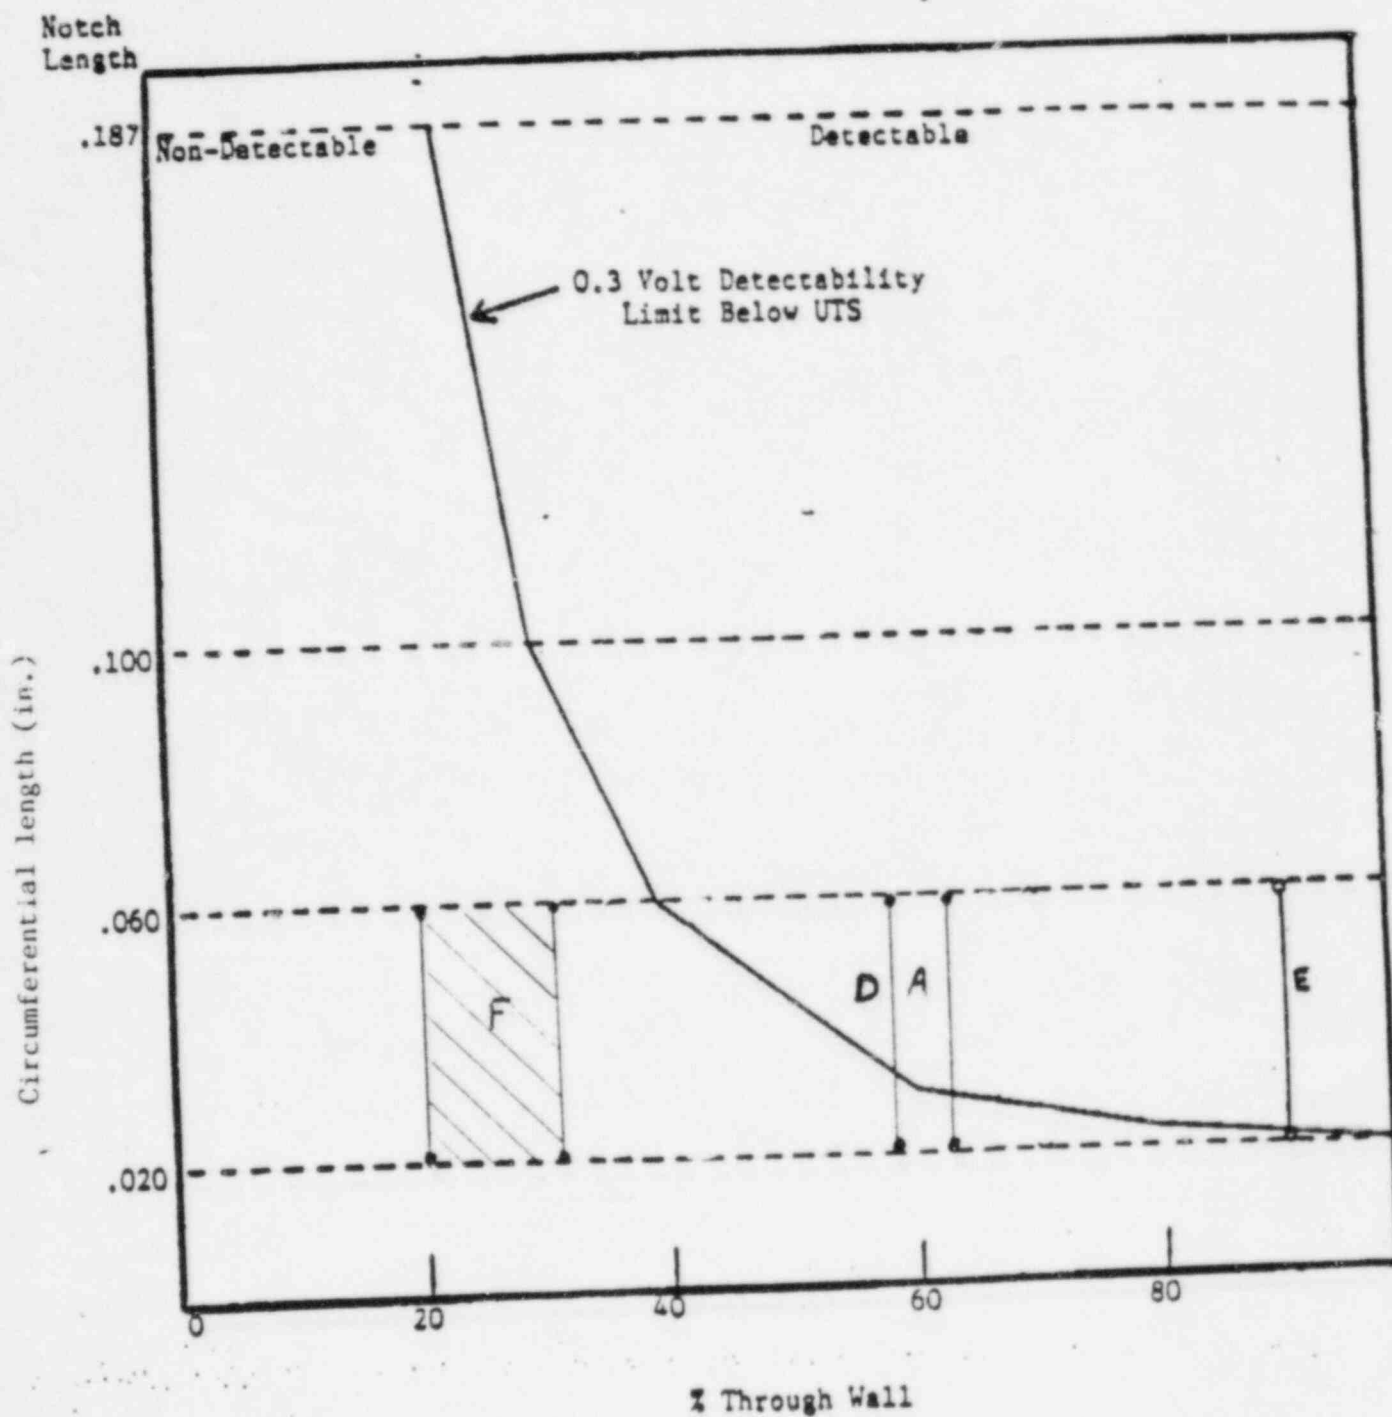
Figure 3b - Below - Tubesheet Fiberscope  
Indications Compared to  
Detectability Limit

C	A-66-129
D	A-61-123
E	A-57-128
F	A-60-126
