LICENSEE EVENT REPORT (LER)

FACILITY NAME (1) **Fort St. Vrain, Unit No. 1** DOCKET NUMBER (2) **05000021617** PAGE (3) **1 OF 12**

TITLE (4) **CORE SUPPORT FLOOR VENT SYSTEM PARTIALLY ISOLATED DURING REACTOR SHUTDOWN**

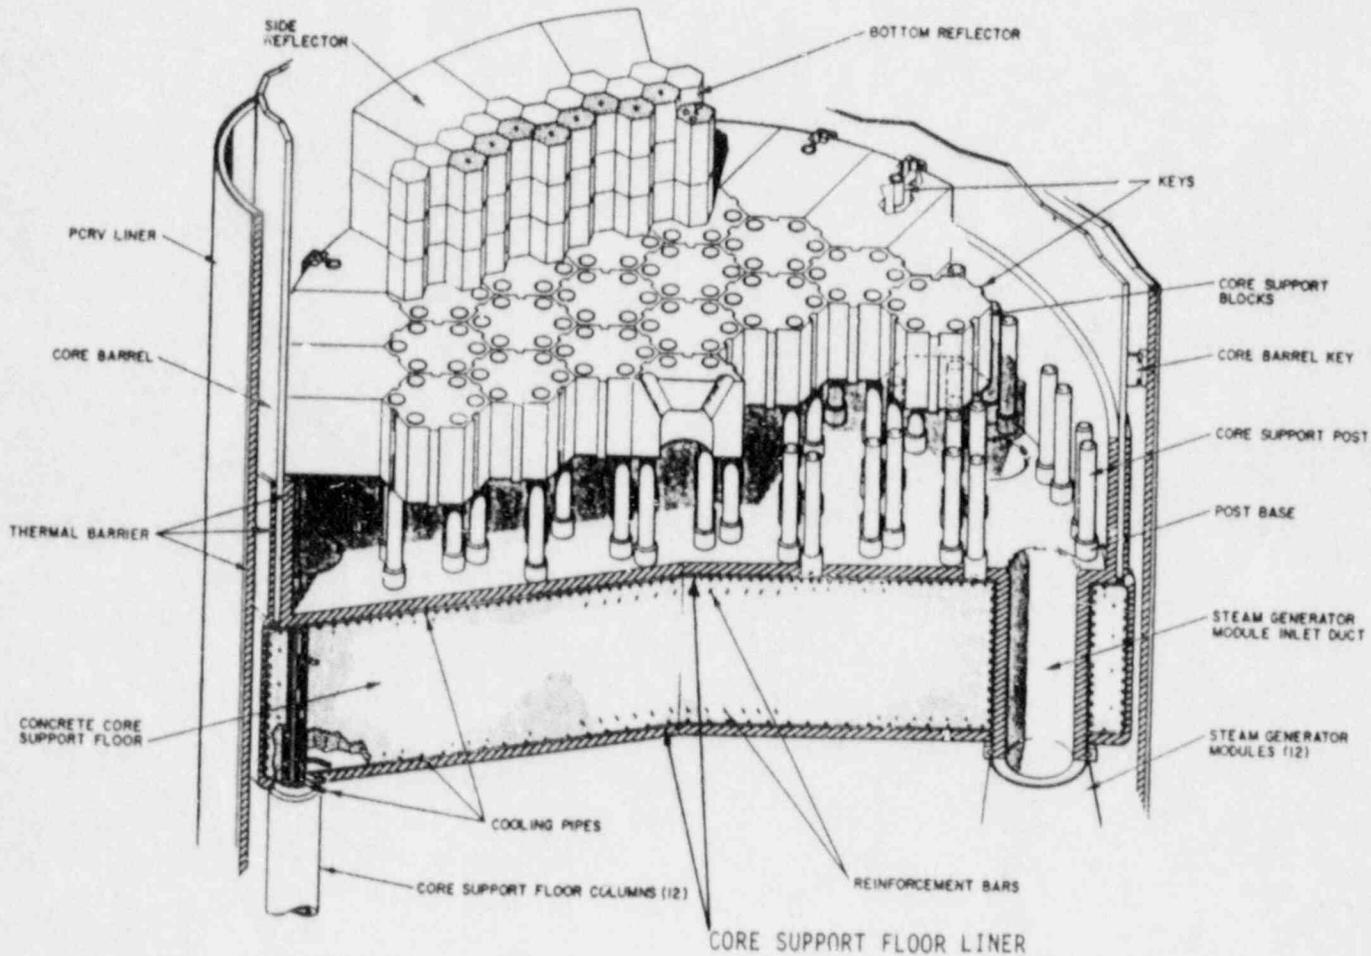
Figure 1.

The reactor core [AC]* is supported by the core support floor (CSF) [AC]*, an insulated and water cooled composite concrete and steel structure (see Figure 1). The space inside the CSF is vented and drained to maintain the pressure in the floor at 100 psig or less. The vent and drain cavities were formed during the concreting of the CSF and are interconnected by tubes permanently cast in the concrete and routed through the floor, down the core support columns and to the radioactive gas waste system [WE]* (see Figures 2 and 3). The CSF vent system provides protection against overpressurization of the floor in the event of a CSF liner leak, which could result in high differential pressure between the floor and the primary coolant system during a Design Basis Accident DBA-2 ("Rapid Depressurization/Blowdown").

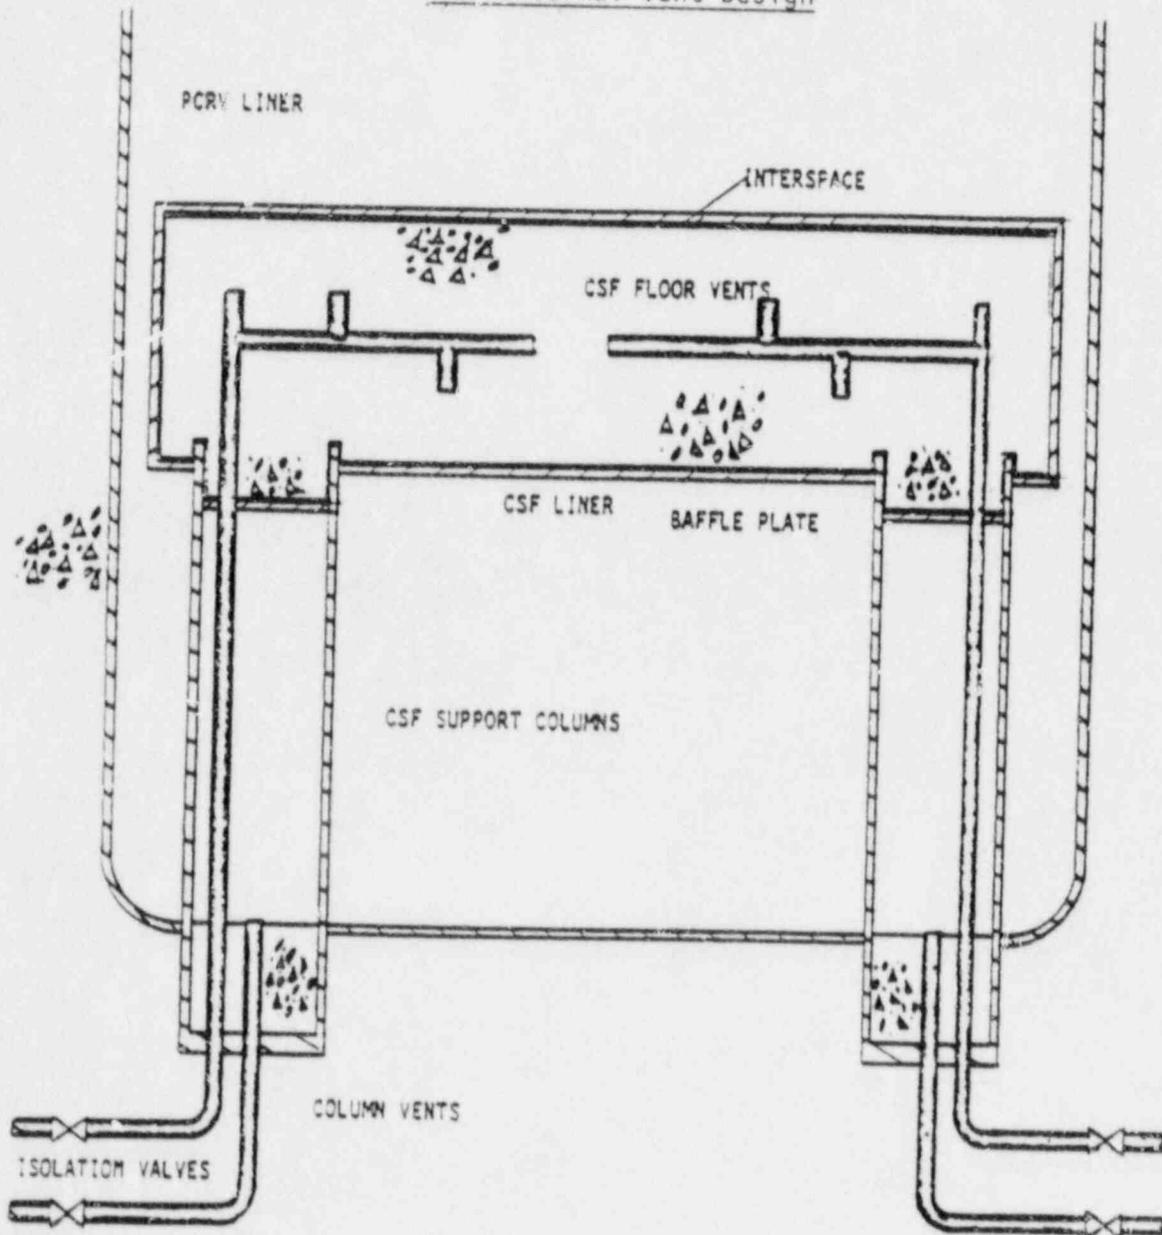
Figure 2.

CSF Internal Vent Design

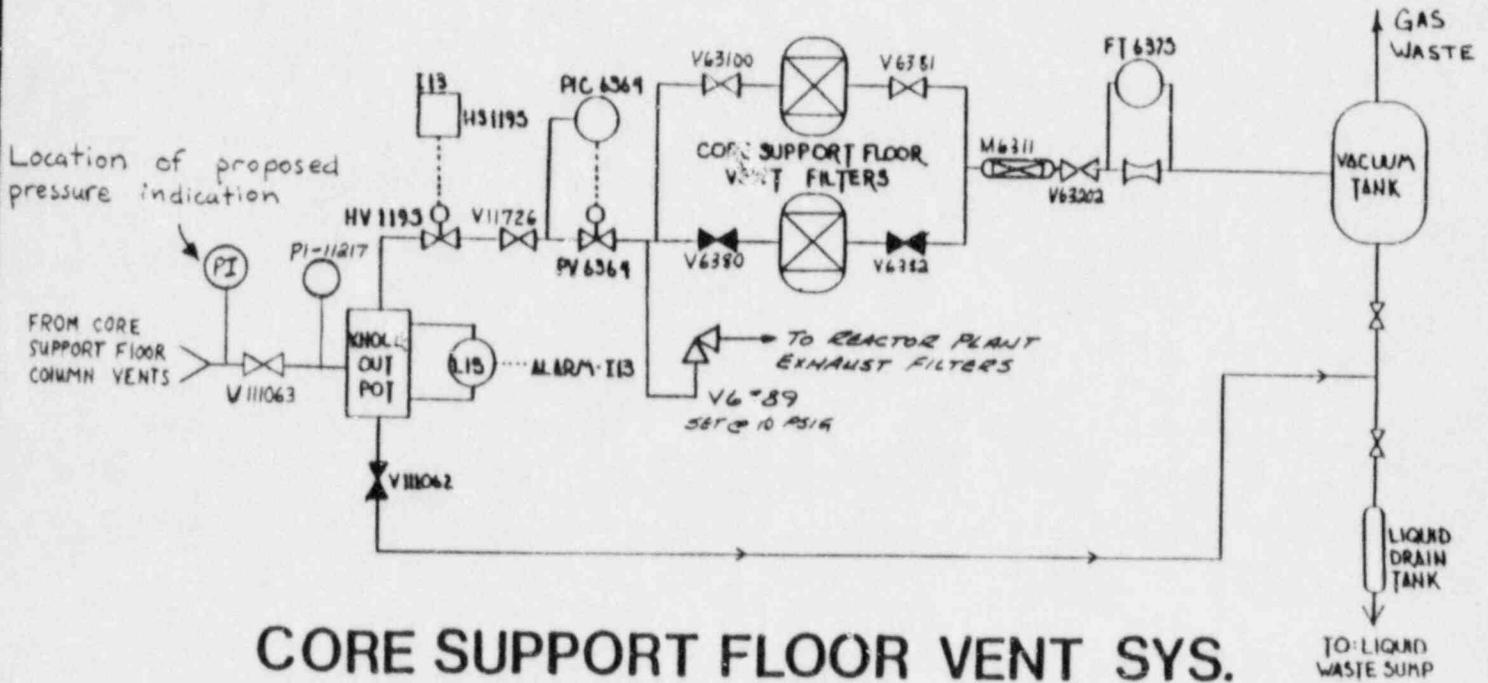
Figure 3.

V-111063 was operated most likely to isolate the CSF knockout pot for draining (see Figure 3). However, during a review of the Reactor Side Equipment Operator round sheets (which record CSF knockout pot water level on a shiftly basis) and narrative logs for the time period from May 27 through July 5, 1988, no entries were found that indicated the CSF knockout pot had been drained during that time period. The Reactor Side Equipment Operators could not specifically recall having operated V-111063 for any reason during that time, and therefore, exactly when V-111063 became nearly closed is unknown.

CORE SUPPORT FLOOR VENT SYS.

To provide a means of identifying inadvertent isolation of the CSF vent in a timely manner, pressure indicating instrumentation will be added upstream of V-111063 (see Figure 3). This location will indicate as nearly as possible the pressure in the CSF itself. This corrective action will be completed prior to startup.

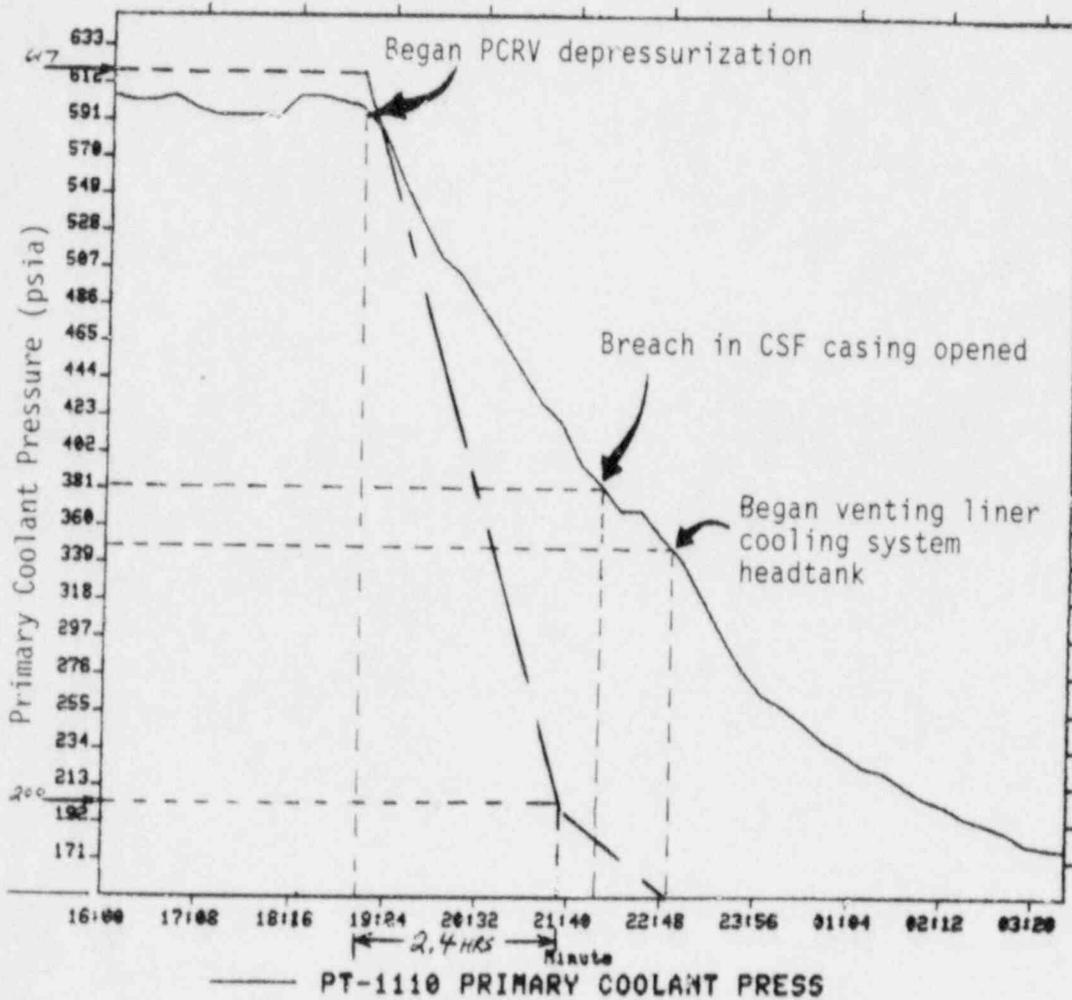
Figure 4.

At approximately 2200 hours on July 5, 1988, with the reactor at 20% power and decreasing, all four circulators operating at 3800 RPM on steam turbine drive, 382 psia PCRV pressure, and 1036°F average core outlet temperature, the CSF liner breach opened as indicated by flow recorded on FR-6375 through the CSF vent to the radioactive gas waste system. The flow rate through the vent, however, was significantly less than flow rates normally observed during reactor shutdown and depressurization operations. However, since the CSF pressure indicator controller, PIC-6364, was operating normally at the setpoint of 60 psig, this low flow rate through the CSF vent piping was not considered to be a problem. At 2255 hours on July 5, 1988, Operators began venting the Loop I PCRV liner cooling system surge tank (T-4601) to the gas waste vacuum tank (T-6301). Surge tank venting is normal procedure during reactor depressurization to release gas that enters the liner cooling water system through leaking CSF cooling water tubes. Upon venting the PCRV liner cooling system surge tank, CSF vent flow gradually decreased towards zero as indicated by flow recorder FR-6375, suggesting that the path of least resistance for CSF gas was into the PCRV liner cooling system via leaking CSF cooling water tubes in the CSF, to the Loop I PCRV liner cooling system surge tank, and finally to the gas waste vacuum tank. It is believed that this venting of the liner cooling system relieved any significant primary coolant pressure that may have developed in the CSF following the time the breach opened at approximately 2200 hours (see Figure 4).

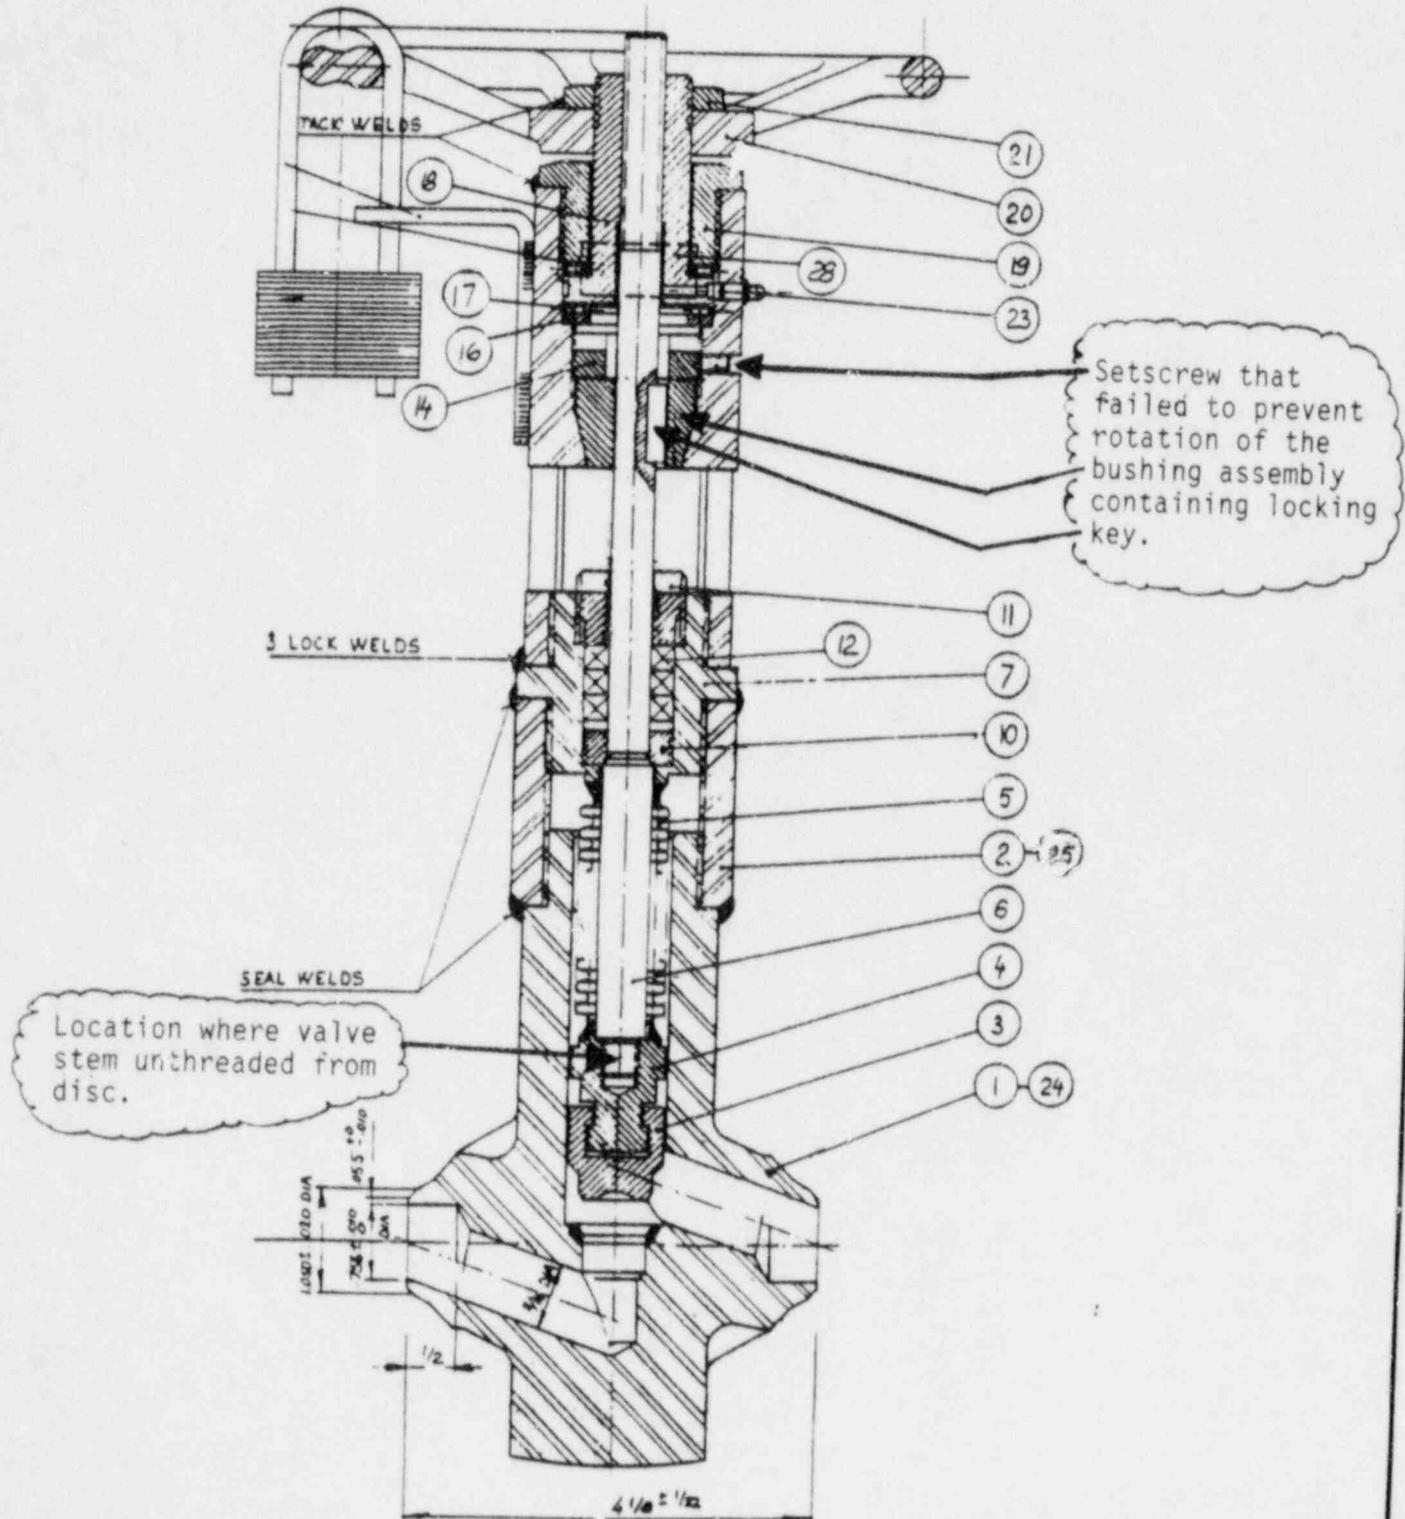
Figure 5

Failure of a set screw in V-111063, caused by overloading the valve handwheel due to a buildup of corrosion on the valve internals, allowed the valve stem to rotate within the valve body and eventually unthread itself from the valve disc.

V-111063 has a keyed collar and set screw assembly in the valve operator that is designed to prevent rotation of the valve stem as the valve is operated (see Figure 5). It is known that Operators have had to use a "cheater bar" to operate V-111063 in the recent past. Since the set screw is not actually recessed into the collar assembly, use of a cheater bar to operate the valve caused the set screw to fail and allow rotation of the entire collar assembly and valve stem, which in turn caused the stem to unthread from the valve disc. Upon valve disassembly, a significant amount of corrosion products were found in the area of the bellows and the valve disc/seat. It is postulated that corrosion caused the internals of the valve operator to seize up and led to the use of a cheater bar.

Diagram of V-111063

Valve V-111063 will be repaired or replaced with a different valve type prior to startup. The possibility of using a diaphragm-seal valve as opposed to the existing bellows-seal valve is still being investigated. This type of valve would be less susceptible to the type of failure involved in this event, which is believed to be due to the buildup of corrosion products on the valve internals. If the option of using a diaphragm-seal valve is eliminated, Velan (the manufacturer of the existing V-111063) has recommended a repair that would prevent rotation of the keyed collar assembly should the set screw again fail.
