NRC Safety Significance Assessment Team Report on allegations related to the South Texas Project, Units 1 and 2

Docket Nos. 50-498 and 50-499

Houston Lighting and Power Company

March 1988

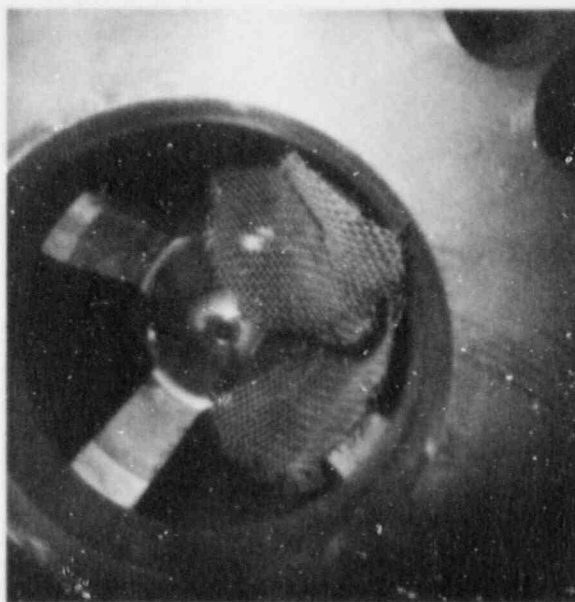
The SSAT reviewed a detailed Westinghouse report, WCAP-11506, dated June 1, 1987, entitled "Full Flow Filter Recovery and Equipment Assessment." The report stated that after completion of hot functional testing at South Texas Project Unit 1, which spanned 28 days under full-flow and operating temperatures, inspection of the full-flow filters installed on the lower core support plate in the reactor vessel revealed that 57 of the 192 filters had degraded. The filters were used during both cold and hot functional testing to help remove any debris from the primary coolant system. The Unit 1 filters had experienced certain degradations ranging from small tears or holes in the screen material to the complete loss of four filter screens (see Figure 5.1-1). As a result, the filter debris circulated throughout the primary coolant system and parts of the attached auxiliary systems after the failure of the filters.

The Westinghouse report discussed the design of the full-flow filters, the results of inspections performed on equipment in the primary coolant and certain auxiliary systems, results of metallurgical examinations performed on the filters, and the evaluations of the effects of the unrecovered filter debris on equipment. Additionally, the report contained a safety evaluation justifying operation of the plant with unrecovered filter debris.

Figure 5.1-1 Damaged Full-Flow Filter Screen
(View Looking Up Into Reactor Vessel)

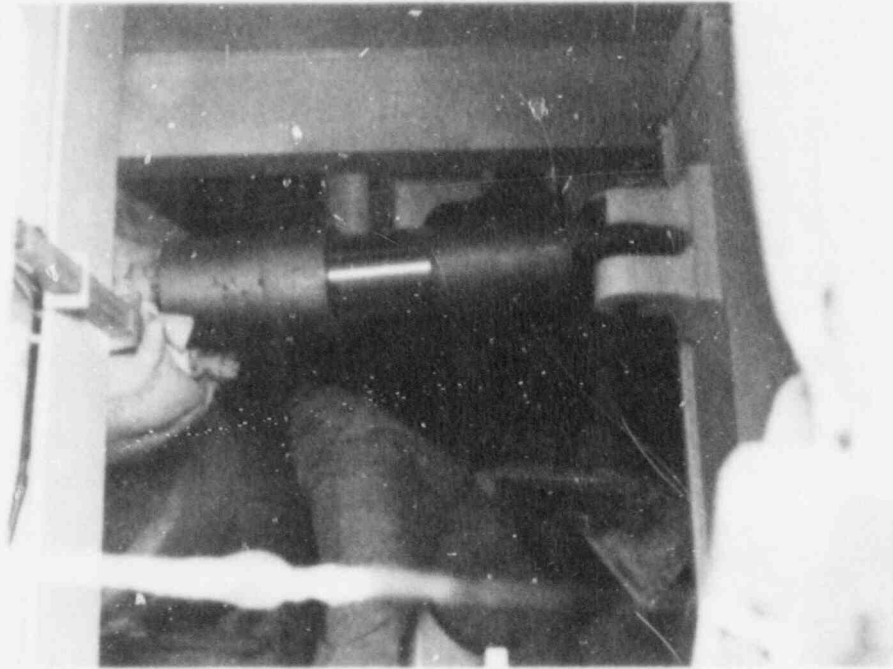
The SSAT reviewed calculation CC-5944, file C-37, Revision 7. Information on the calculation cover sheet indicated that the calculation for pipe whip restraint RC-1125-R1 had been deleted because the energy-absorbing-material (EAM) section of the pipe restraint was removed. However, there is a possibility for it to be reactivated in the future. It also stated that portions of the restraint that were installed are being used as pipe support structures. However, because the design pipe whip restraint loads are so large compared to the pipe support loads, no analysis needs to be performed. On this basis,

Figure 5.1-2 Feedwater Pipe Shock Suppressor (FW-9012-HL 5005)
Attached to Reactor Coolant Pipe Rupture Restraint
(RC1125R1)

this calculation was prepared as a reference only, and should the pipe whip restraint be reactivated, the reference drawings, specifications, and other applicable data must be checked for consistency at that time.

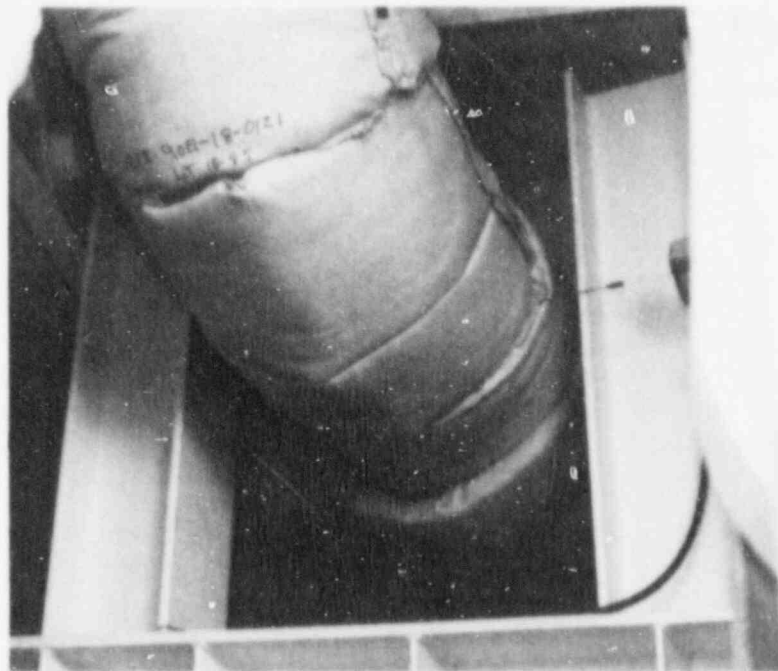
Figure 5.1-3 Feedwater Pipe and Rupture Restraint Structure
Attached to Reactor Coolant Pipe Rupture
Restraint (RC1125R1)

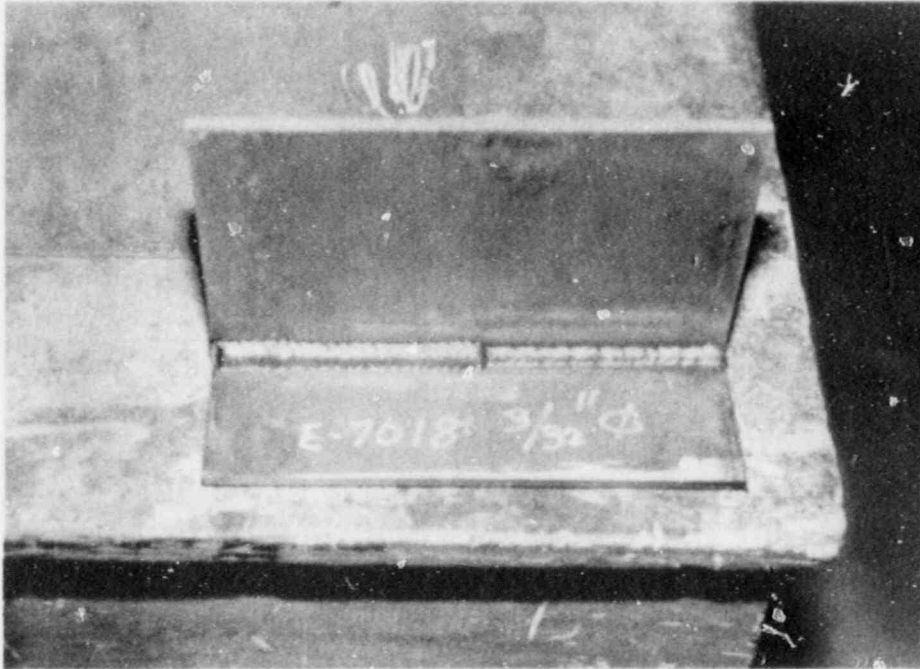
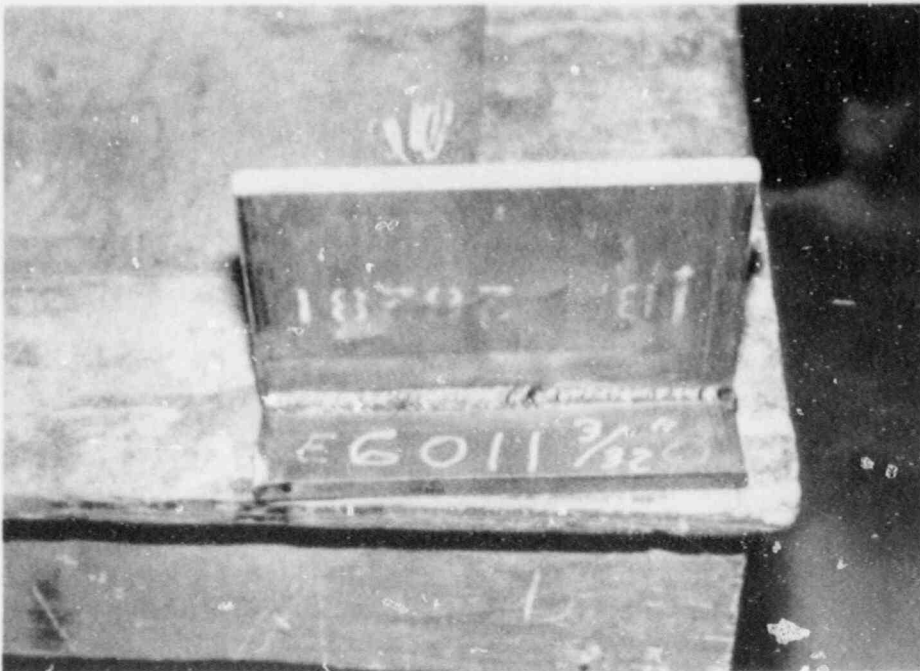
In an effort to determine whether the E7018 electrodes in the unacceptable lot had been used in place of E6010 or E6011 electrodes for HVAC welding, the SSAT requested Ebasco to prepare weldments of the same material used in the HVAC system with two different type electrodes, E6011 and E7018. This was done to ascertain the typical bead characteristics of each electrode to aid in the HVAC weld inspections. The welds made with the E7018 electrode show a smoother surface profile than welds made with the E6011 rod (see Figure 5.5-1(a) and (b)).

(a) Fillet Weld Using E7018 Weld Rod

(b) Fillet Weld Using E6011 Weld Rod

Figure 5.5-1 Weldments Showing Typical Bead Characteristics of E7018 and E6011 Weld Rods

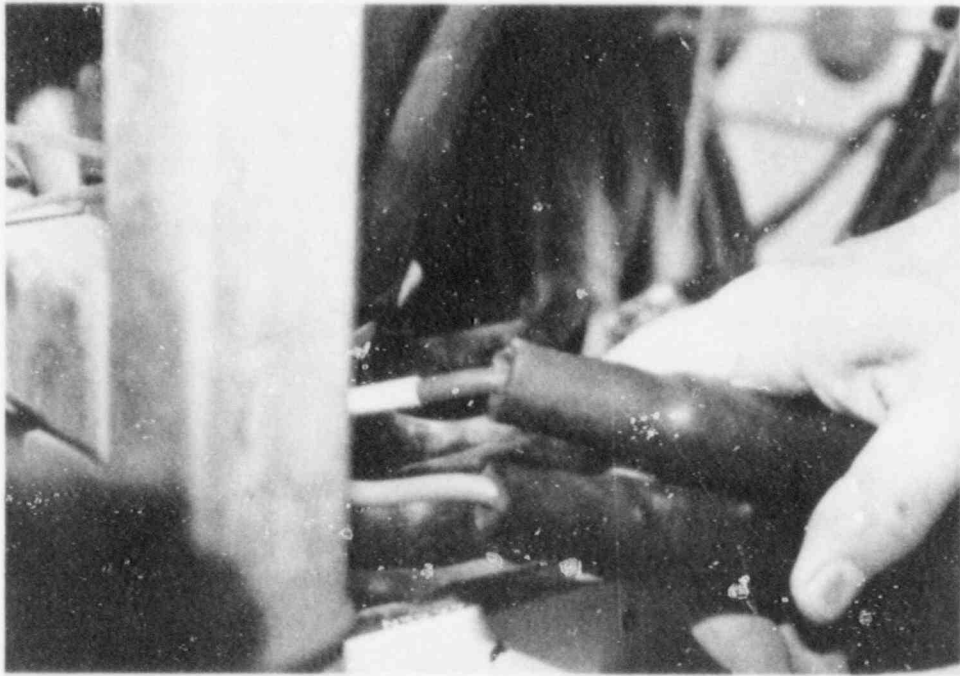
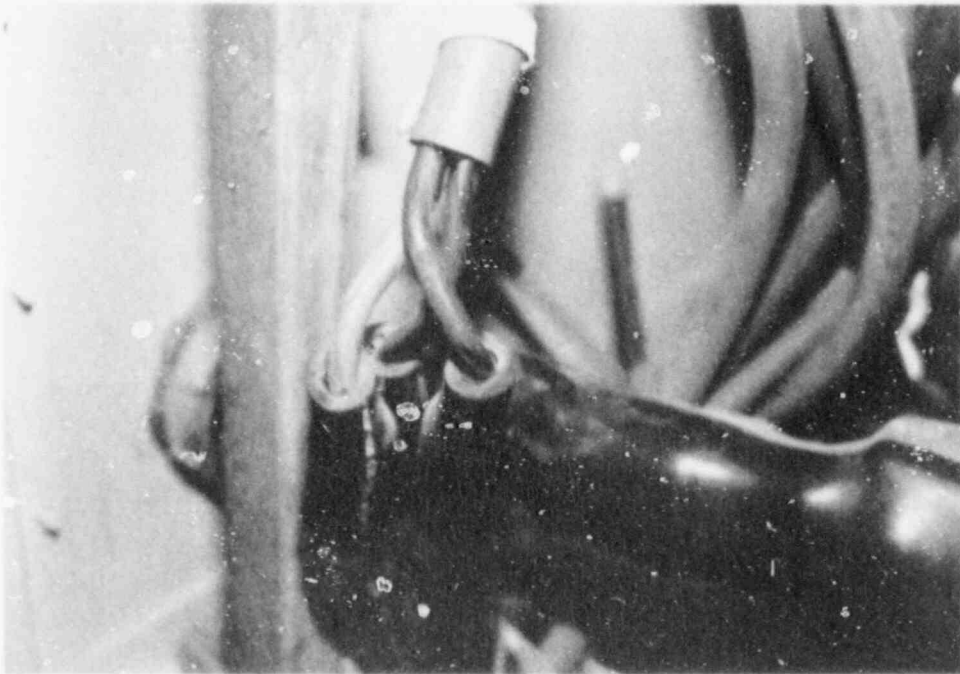
Figure 5.6-1 Raychem Splices

The SSAT determined that 91 (of approximately 2300) Raychem splices were identified as having been excluded from earlier reinspections performed by HL&P. As a result of a reinspection of the 91 splices, 3 were identified as needing rework and another 3 splices were identified as marginal. The SSAT determined that all 6 splices had been reworked by HL&P.

Before loading fuel into Unit 2, HL&P shall complete a reexamination of Raychem cable splices using the revised corrective action program implementing procedures and perform all corrective hardware and software actions found to be necessary.

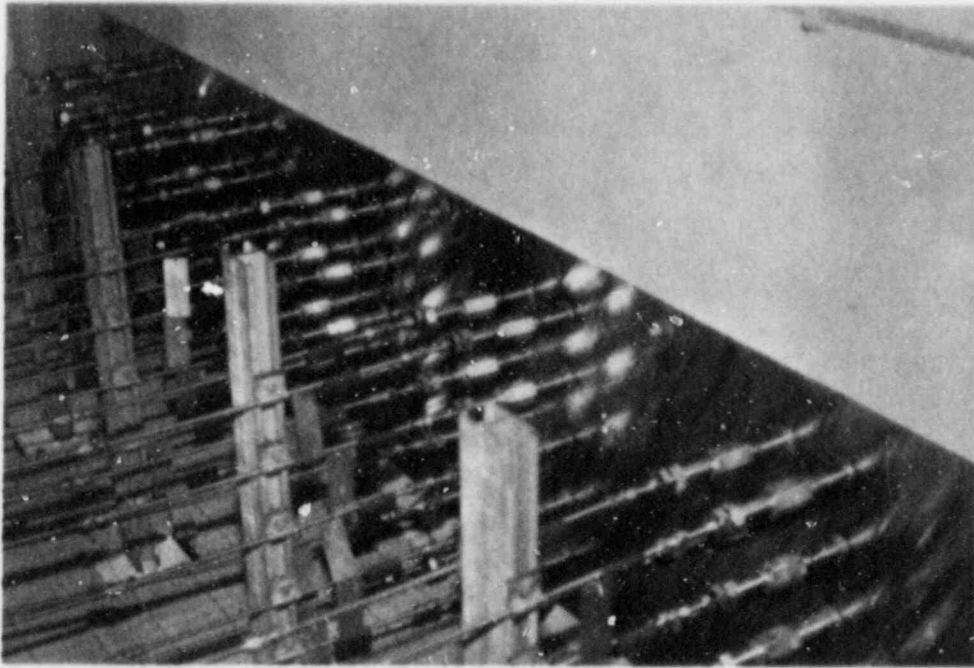
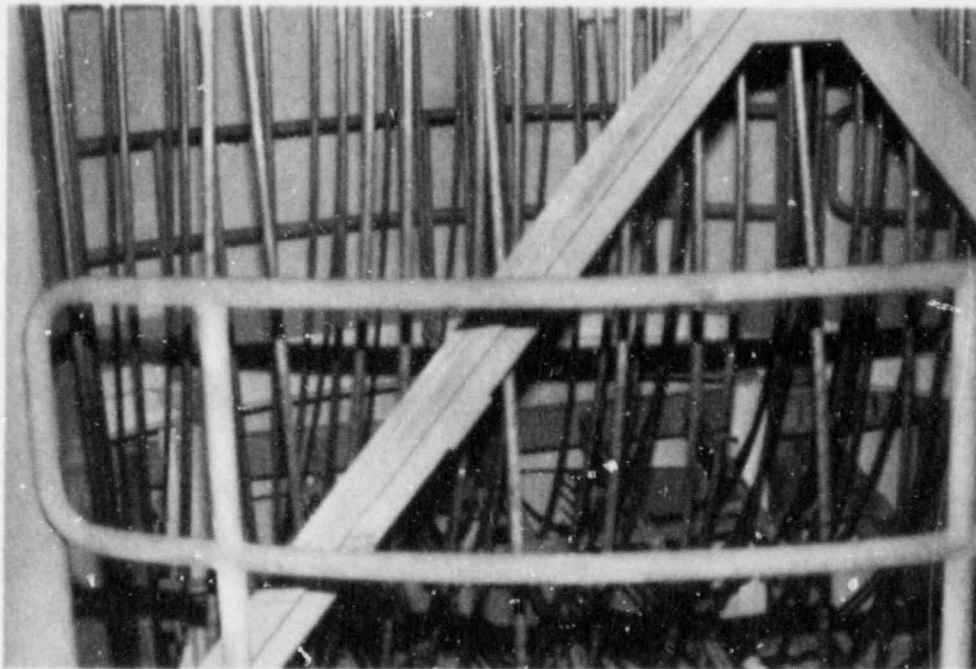
(a) Connections to the Seal Table

(b) Just Below Reactor Vessel

Figure 5.6-2 Incore Instrumentation Guide Tubes

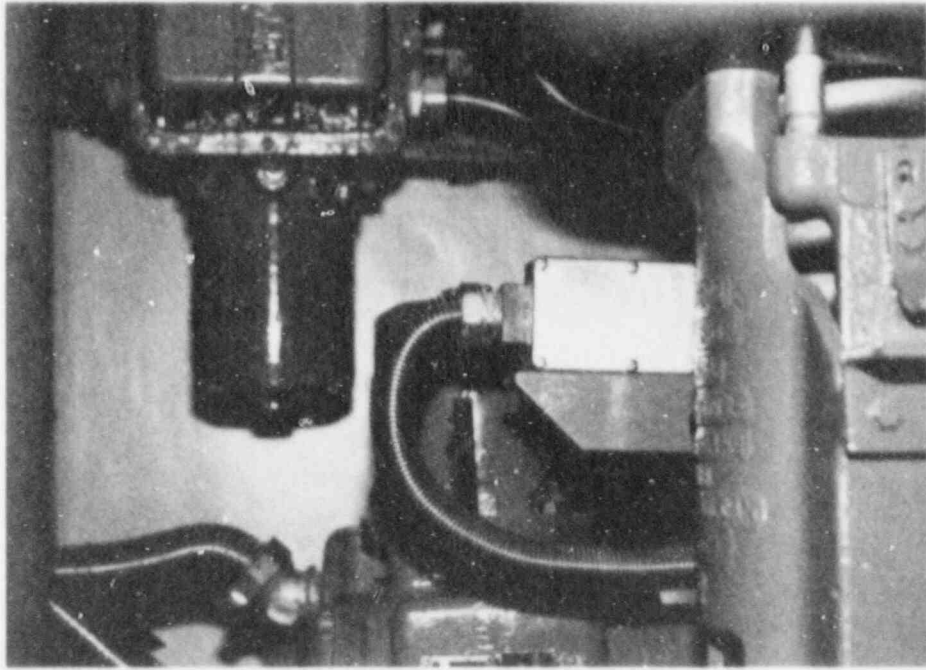
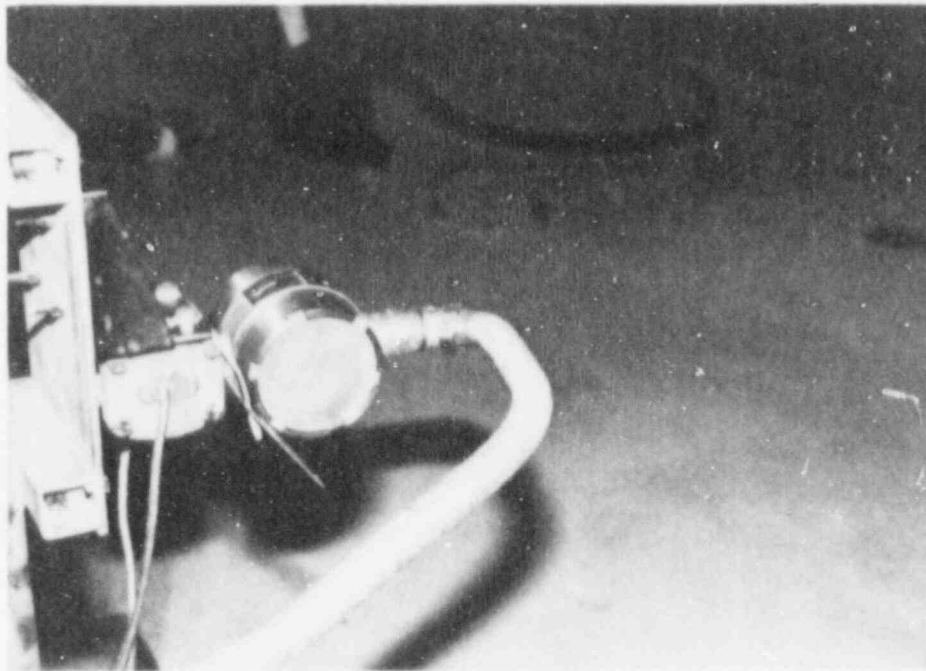
Figure 5.6-3 Flexible Conduit Installation Reviewed by SAFETEAM-Dispositioned Use As Is

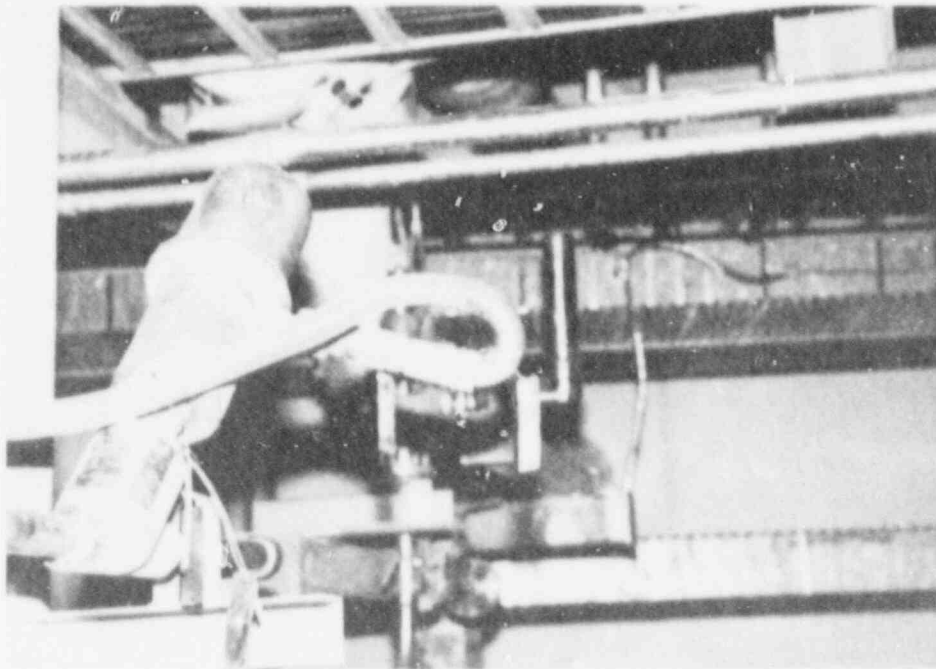
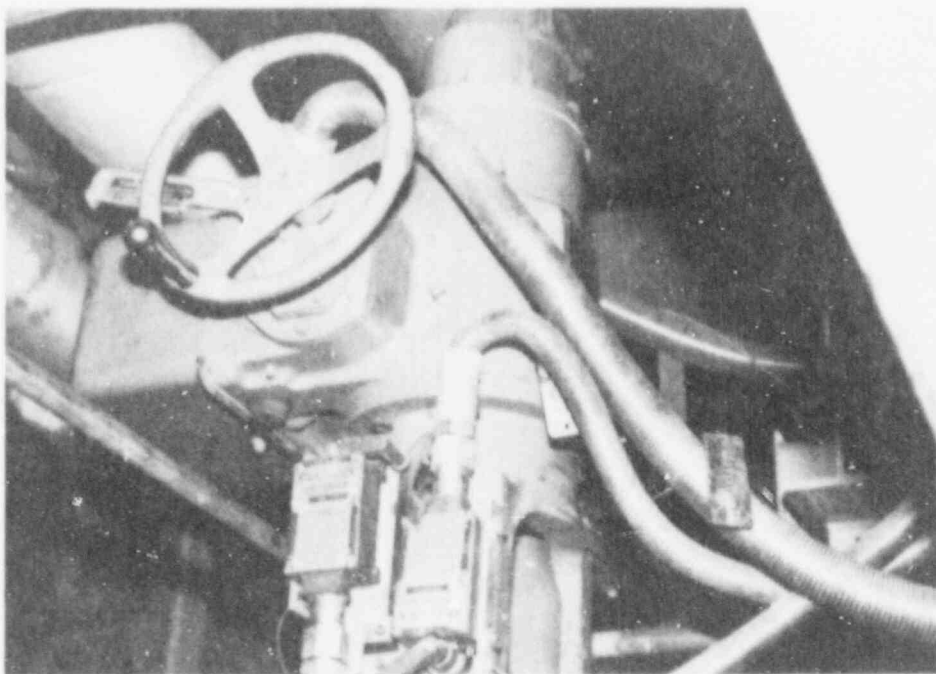
(a) Installation on Solenoid Valve - Cable Bend Radius Not Violated

(b) Installation to Limit Switch - Cable Bend Radius Not Violated

Figure 5.6-4 Flexible Conduit Installations With Apparent Bend Radius Violations

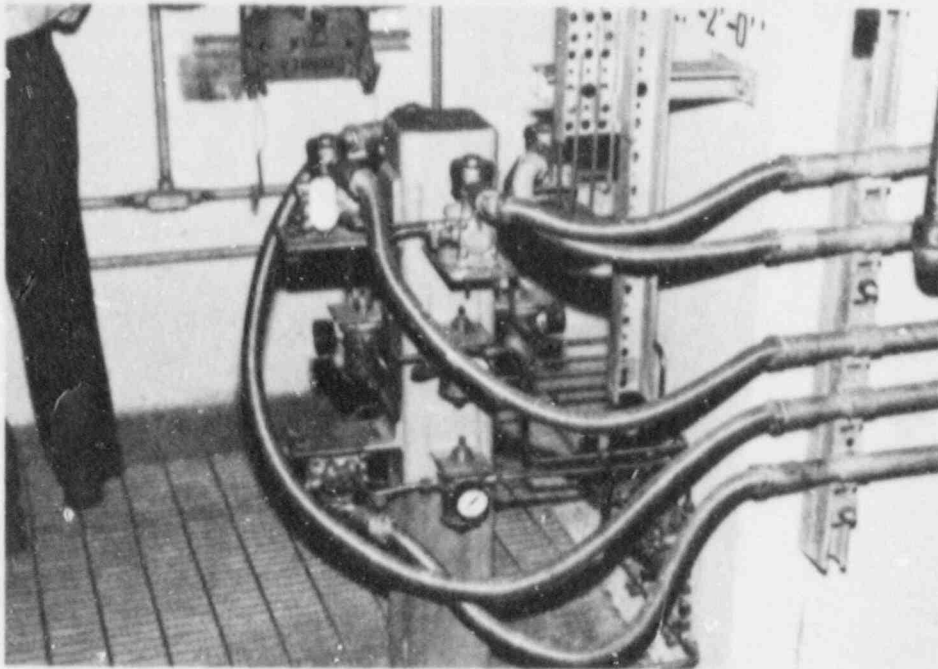
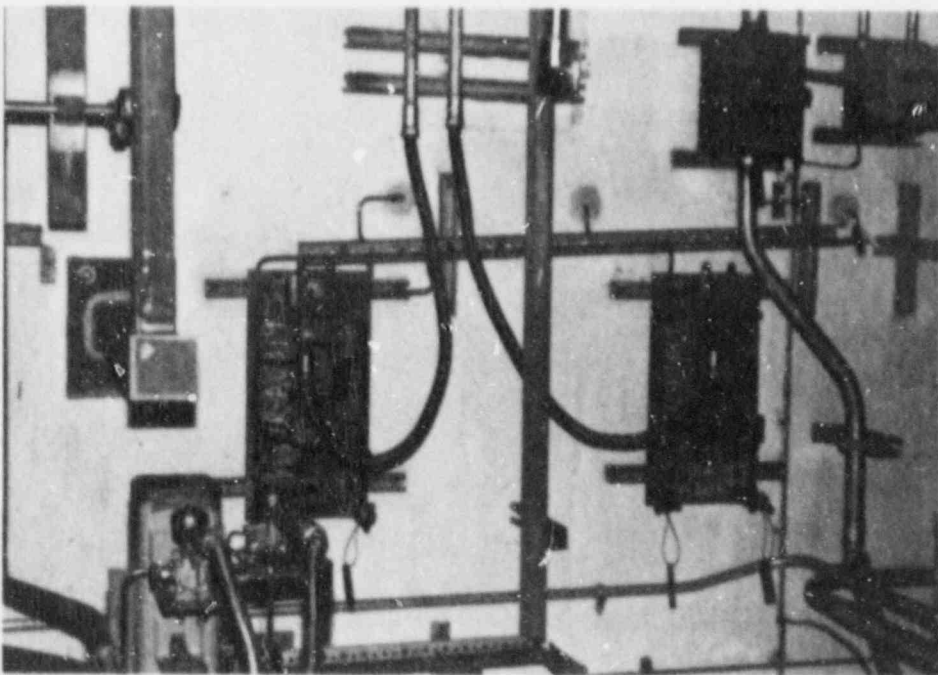
(a) Flexible Conduit to Solenoid Valves, Unit 1 Containment

(b) Flexible Conduit to Instrumentation, Unit 1 Containment

Figure 5.6-5 Typical Acceptable Flexible Conduit Installations

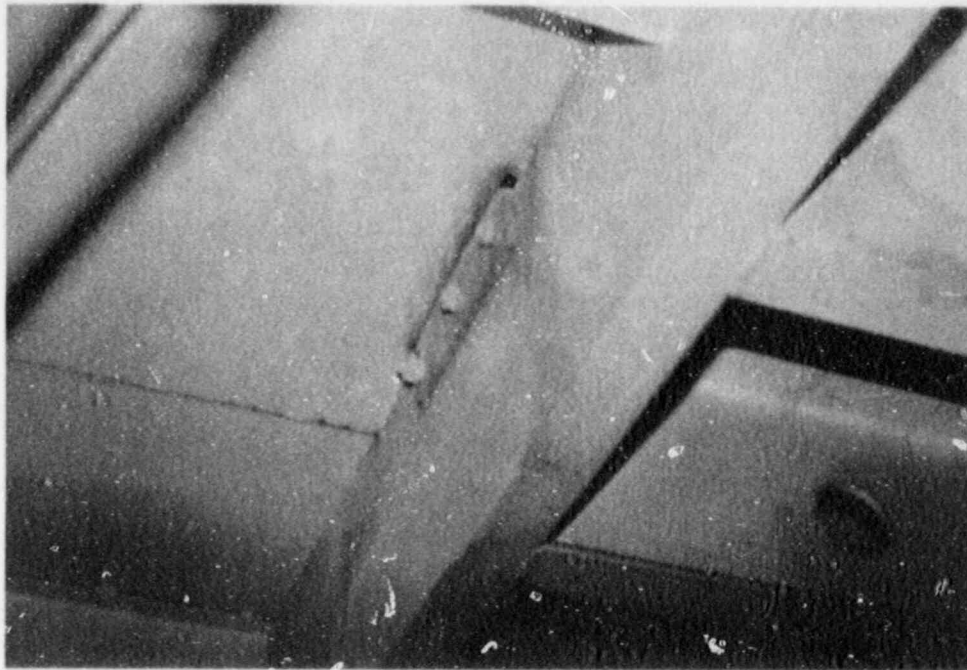
Figure 5.8-1 Discoloration of Polar Crane Coatings Due To Leaking Grease From Hoist Operating Mechanism

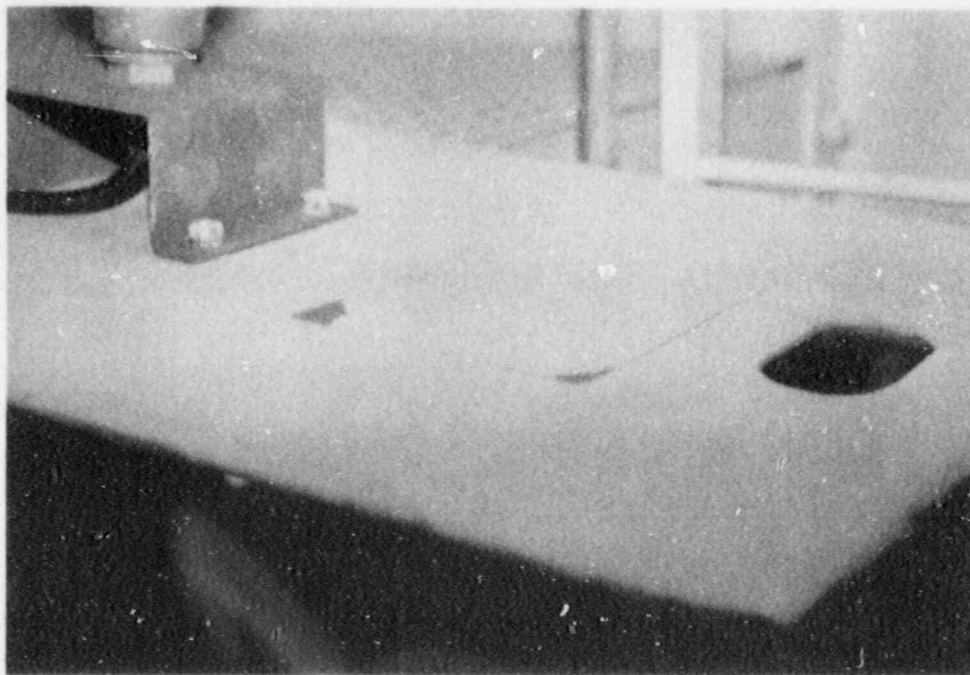
Figure 5.8-2 Area Under Lamp Maintenance Access on Polar Crane Catwalk With Taped Areas Not Coated

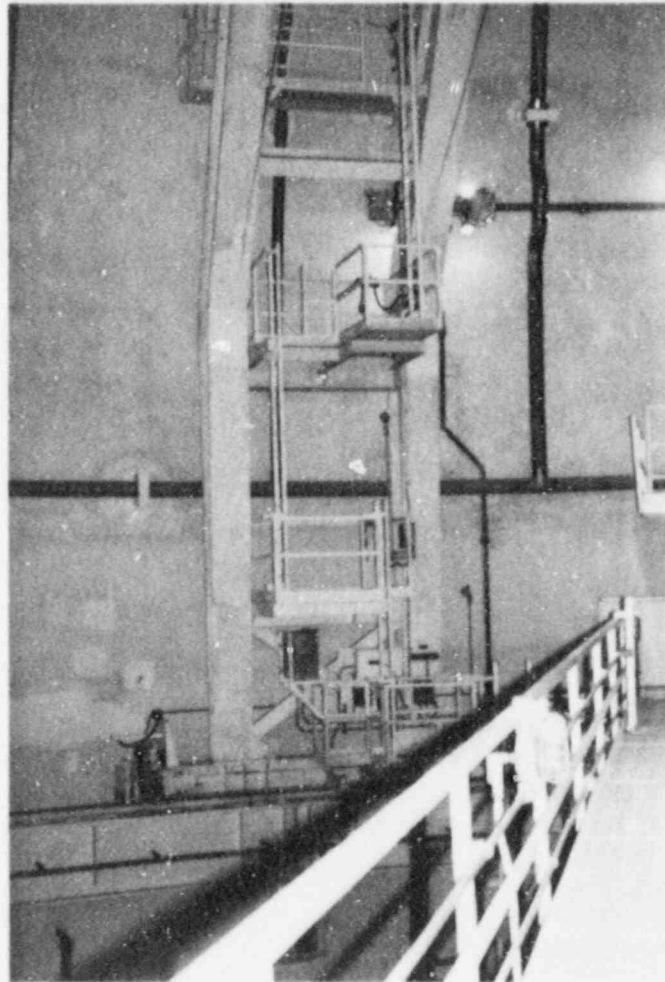
The orbital bridge is non-safety-related, seismically qualified, and self-propelled and is used as an inspection platform. Its base rides on the same track as the polar crane. The orbital bridge is used for inspecting and servicing the containment spray pipes that are attached to the containment dome (see Figure 5.10-1).

Figure 5.10-1 Lower Portion of Orbital Bridge
(As Seen From the Polar Crane Catwalk)

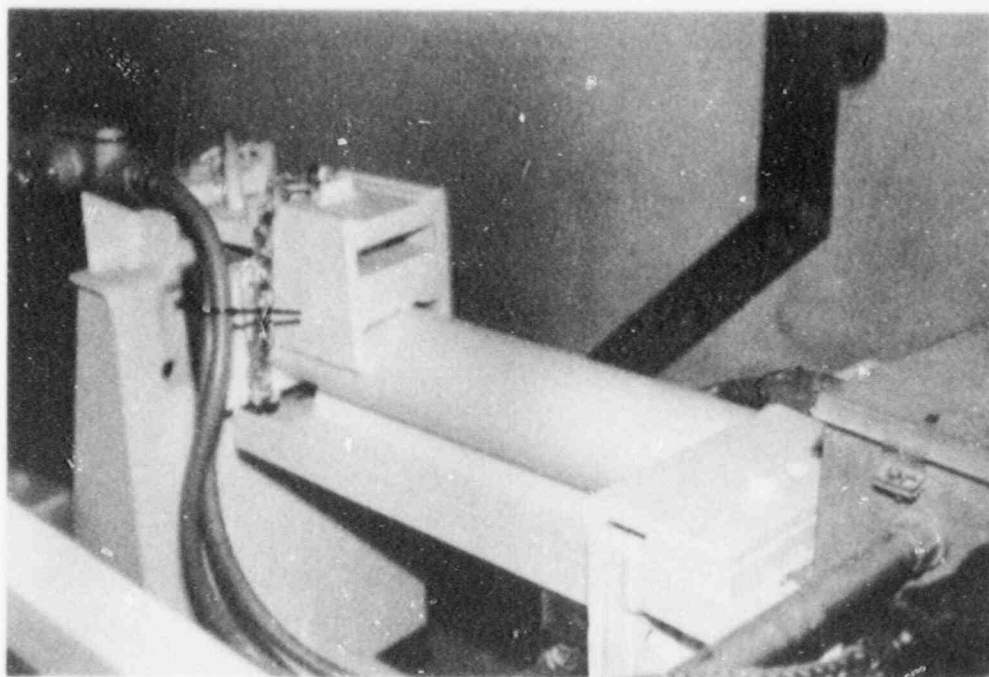
permanent linkage mechanism in place and instead were tied together with angle iron and a "come-a-long" device (see Section 5.6.5.2 of this report for an explanation of device).

Figure 5.10-3 Polar Crane/Orbital Bridge Linkage Mechanism

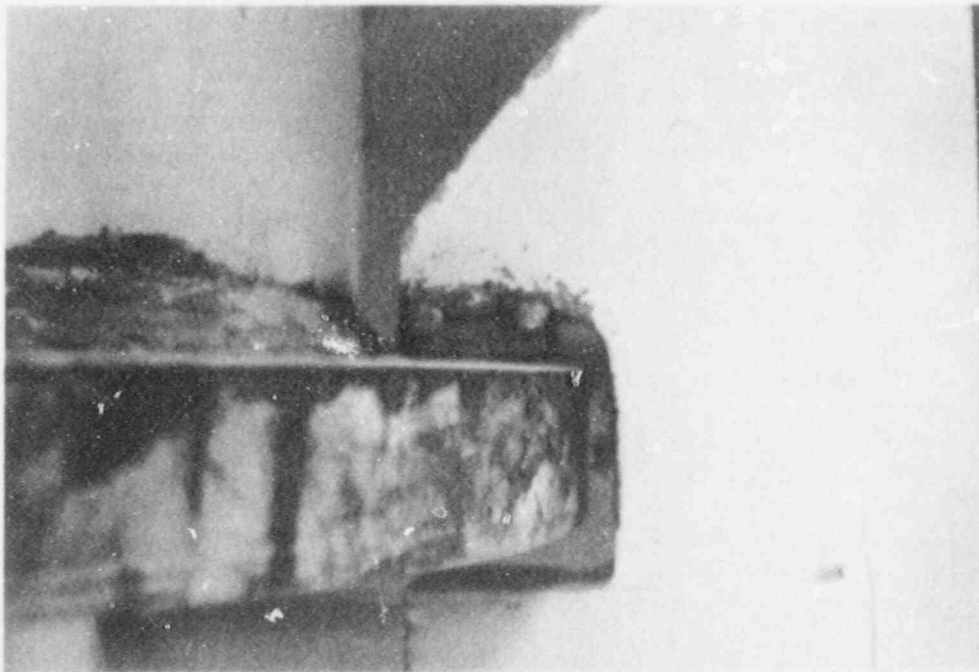
Figure 5.10-5 Modified Safety Lug on Orbital Bridge Pivot Assembly
