LICENSEE EVENT REPORT (LER)

FACILITY NAME (1) <b>Sequoyah, Unit 2</b>	DOCKET NUMBER (2) <b>0 5 0 0 0 3 2 7 8</b>	PAGE (3) <b>1 OF 0 8</b>
--	---	-----------------------------

TITLE (4)  
**Performance Of An Inadequate Maintenance Instruction For The Inspection Of The Reactor Trip Breakers Resulted In A Main Feedwater Isolation**

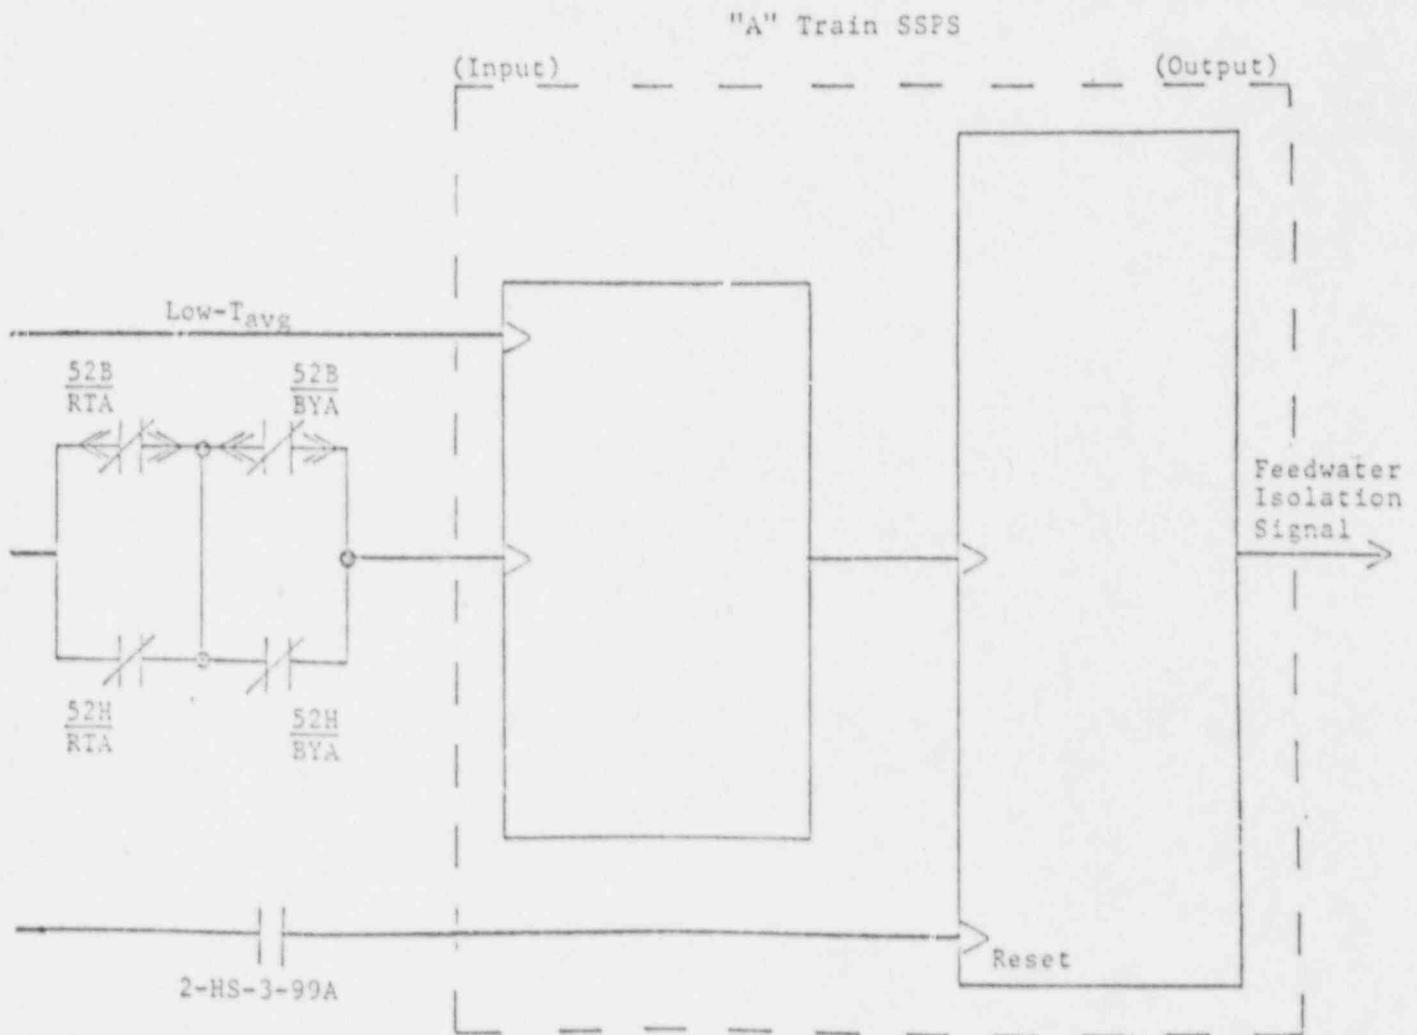
FIGURE 1

A MFW isolation signal is generated when the reactor trip breaker opens and a low RCS Tav<sub>g</sub> (i.e., less than 554 degrees F) signal is present. As shown in Figure 1, the logic requires the reactor trip breaker or bypass breaker to be open (or racked out) and Tav<sub>g</sub> to be less than 554 degrees F to initiate a MFW isolation signal. During operation in mode 3, the RCS Tav<sub>g</sub> is typically maintained at the no-load Tav<sub>g</sub> of approximately 547 degrees F. As a result, the low Tav<sub>g</sub> portion of the MFW isolation signal was present during the performance of the subject MI. Opening the trip breakers or removal of the trip breakers from their compartments would then complete the logic necessary for a MFW isolation signal. However, a MFW isolation did not occur when the breakers were initially opened and removed because a sustained reset signal was being applied by the operator in the MCR. The Solid State Protection System (SSPS) (EIS Code JC) logic is designed such that a sustained reset signal from MCR handswitch 2-HS-3-99A will prevent the generation of a MFW isolation signal during a change of state of the

input signal. However, if either the low Tavg or trip breaker "open" signal is interrupted and then reestablished without a reset signal present, a MFW isolation signal will be generated. In this case, with the low RCS Tavg signal already present and no reset signal being applied, operation of the cell switch on the left side of the breaker compartment interrupted then reestablished the trip breaker "open" signal, thereby causing the train "A" MFW isolation.

52H (cell switch) - Shown with the breaker in the "racked out" position.

52B (breaker auxiliary contact) - Shown with the breaker in the "open" position.
