LICENSEE EVENT REPORT (LER)

FACILITY NAME (1) Joseph M. Farley - Unit 1	DOCKET NUMBER (2) 0 5 0 0 0 3 4 8	PAGE (3) 1 OF 1
---	---	---------------------------

TITLE (4)
Potential Inoperability Of The A Train Charging Pump Due To Gas Accumulation

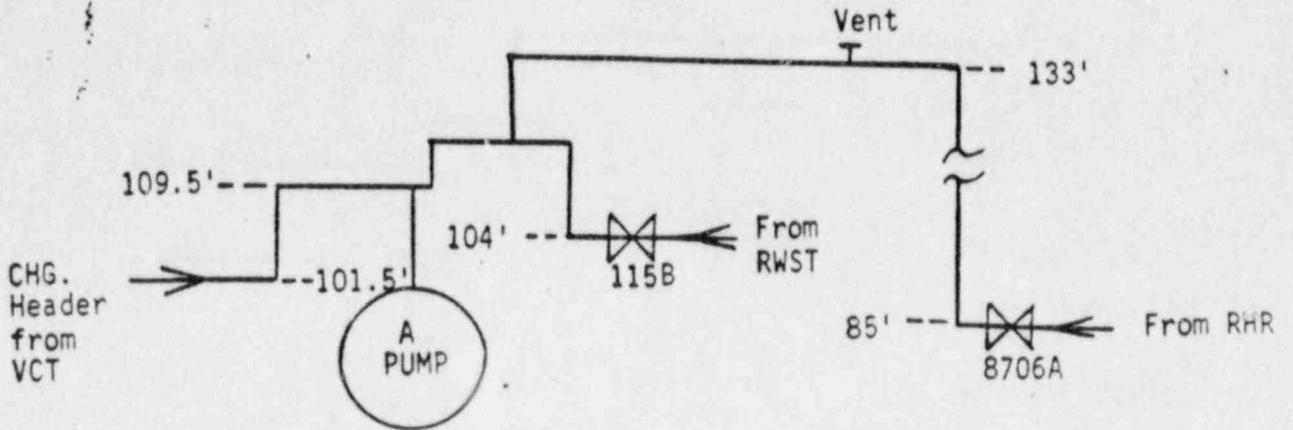
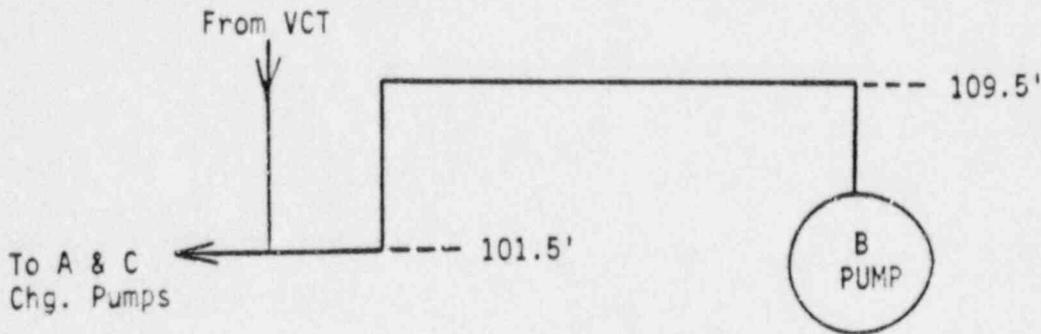
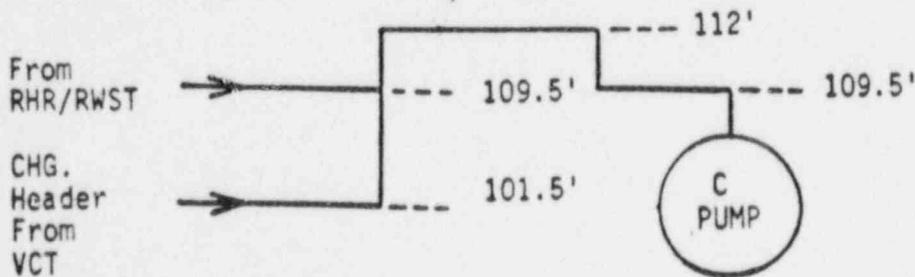
For the Unit 1 A charging pump suction piping, the top of the inverted loop is at 109.5 ft. elevation. The RHR to charging pump suction header is connected to the top of the inverted loop and rises to elevation 133 ft. The vent used to vent the gas is located at this elevation. The Unit 2 A pump suction piping is similar to Unit 1 except the top of the loop is located at 114 ft. elevation. The highpoint and location of the vent in the RHR to charging pump suction header is at elevation 132.5 ft. Both of these geometries provide the conditions for trapping large amounts of hydrogen gas in the respective RHR to charging pump suction headers.

If hydrogen comes out of solution, it would accumulate in these A charging pump inverted loops. Review of the piping layouts identifies that the section of pipe containing the void is connected via a vertical pipe run to the charging pump suction piping at the top of the inverted loop. It is believed that hydrogen gas was evolving from the fluid and accumulating in the RHR to charging pump suction supply header, since this provided the high point in the system.

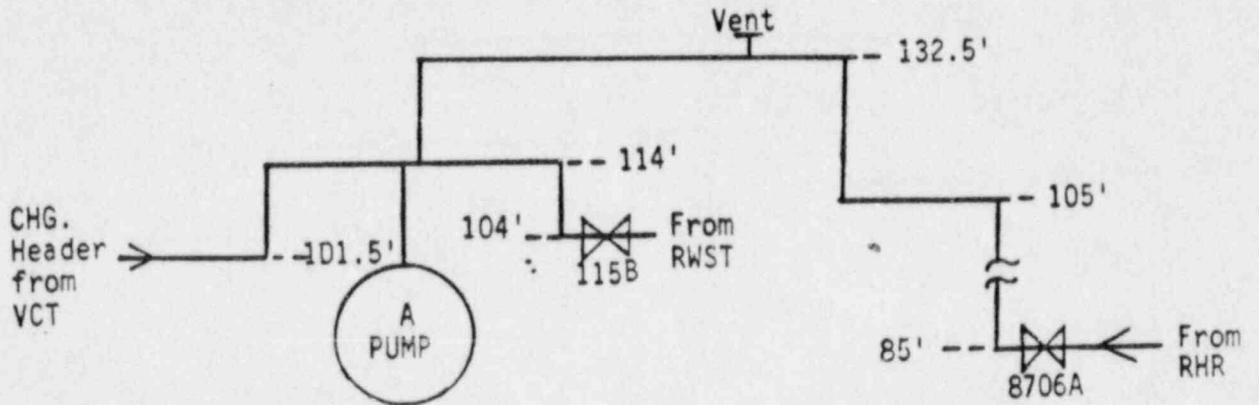
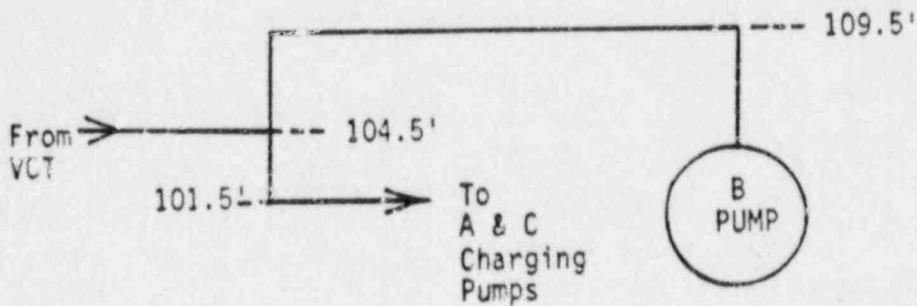
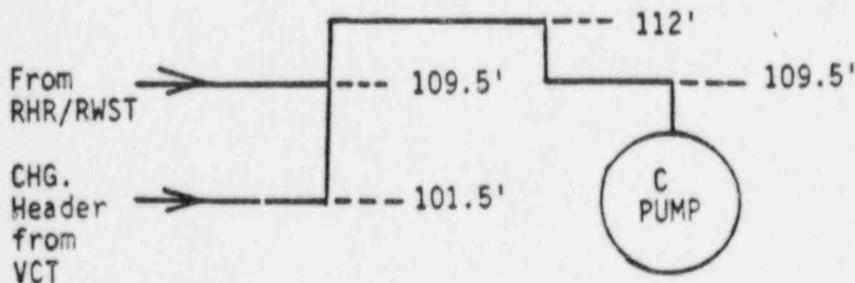
Unit 2

The B train (both Units 1 and 2) has a suction piping geometry which does not permit the voiding of large sections of piping, regardless of pump status. The geometry in these piping sections is such that any hydrogen evolving cannot be trapped and is therefore swept through the pump. This is due to the fact that there are no auxiliary lines (potential traps) connected to the suction piping at the top of the inverted loop. This is supported by the fact that the plant found no indication of hydrogen accumulation when venting the B train RHR to charging pump suction piping on both Units 1 and 2.
