AUGMENTED INSPECTION TEAM

REPORT NOS. 50-413/88-14 AND 50-414/88-14

Facility Name: Catawba Units 1 and 2

Inspection Conducted: March 10-18, 1988

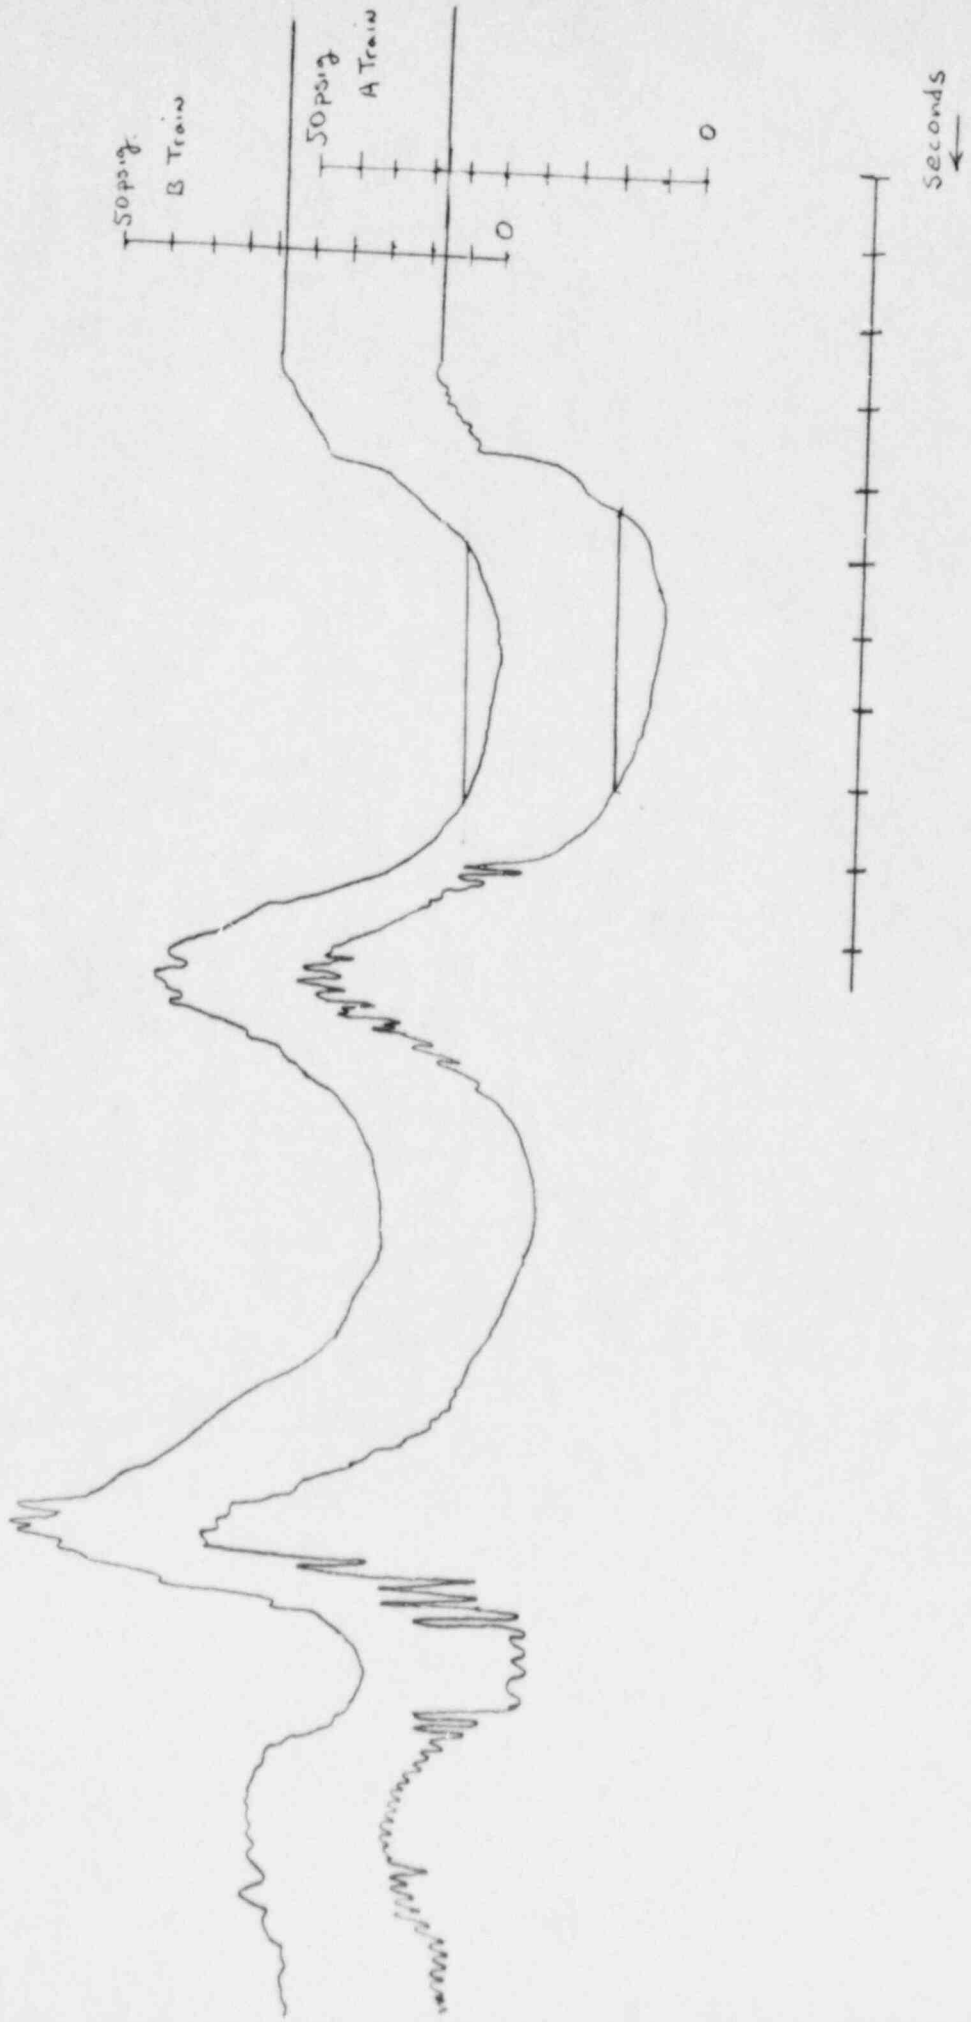
ATTACHMENT 1  
GRAPH 1

The transients exhibited a characteristic suction pressure dip of 25-30 psig just after pump start as expected, lasting 3-4 seconds. (Refer to graph 1.) In each case where 2CA6 was open, the CA suction pressure never dipped below the low suction pressure setpoints. When 2CA6 was shut, available NPSH was less and pressure was observed to drop below the low pressure setpoints. This caused control room annunciators to momentarily alarm, but not longer than the 3-5 second time delay and the CA pump trip did not occur. In all cases steady state suction pressure was acceptable.

3 CA PUMPS - 2CA6 SHUT - NO PUMP TRIP

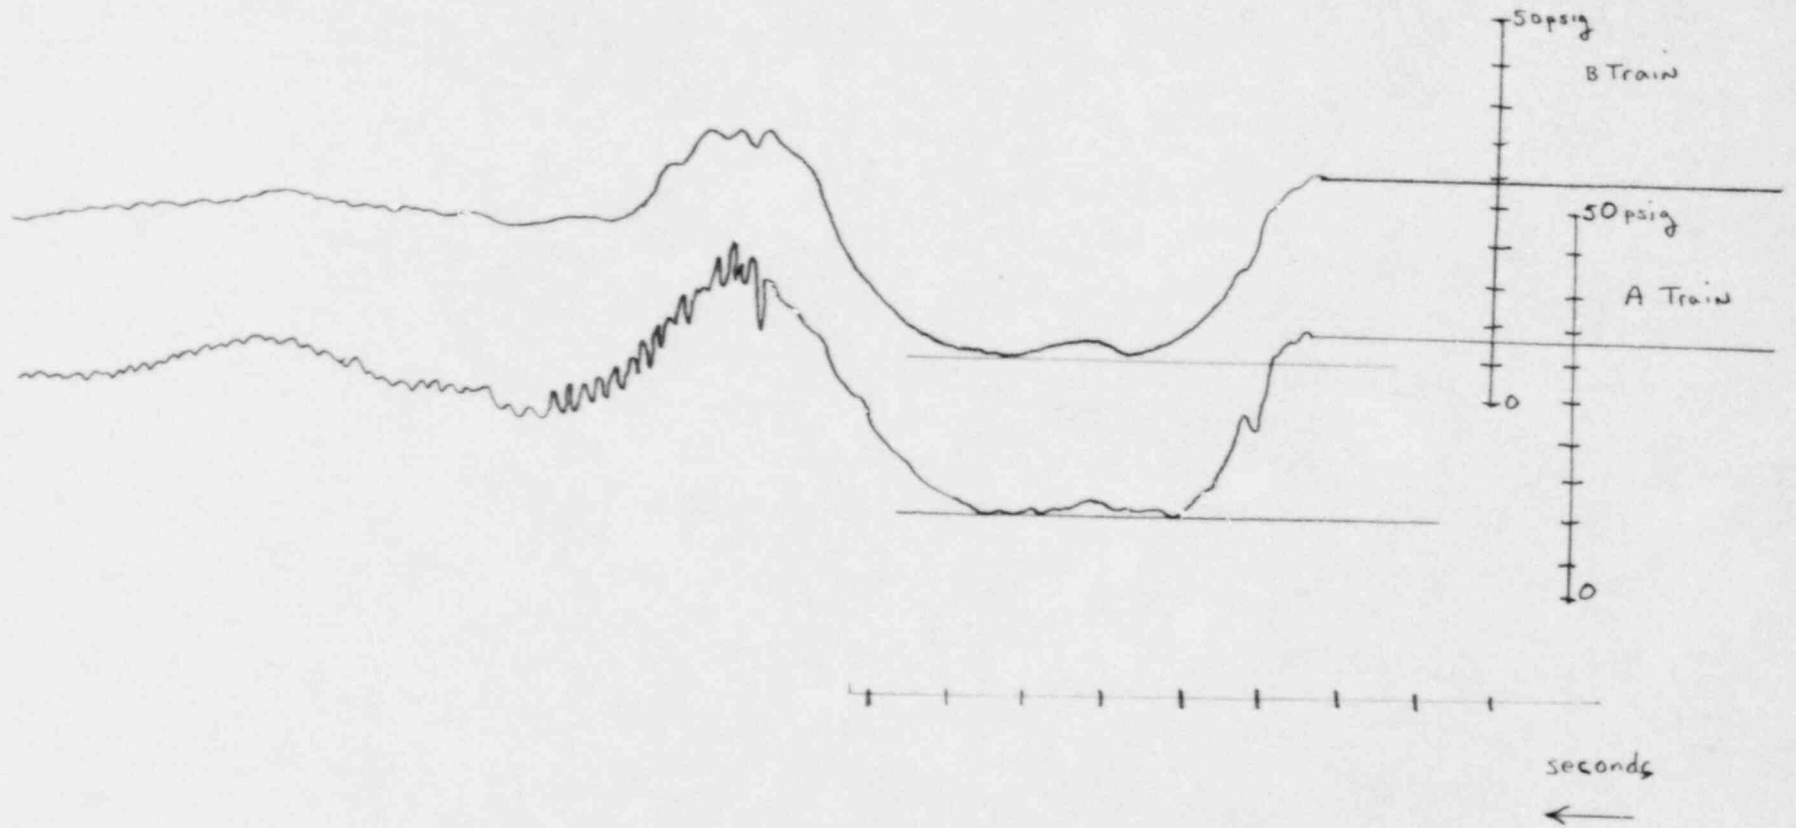
Three (3) starts of the MDCA pumps, staggered by 2 seconds, were then conducted with 2CA6 shut. UST level varied from 65-90%. No CA pump trips were observed. On graph 2 one notes that the transient is indeed extended to about 6 seconds; however, the pressure did not dip below the setpoints. The licensee suspected this stagger time to be too long to cause swapover and did 3 more starts with pump starts staggered at 1/2 - 1 second. In each of these last 3 starts the train A MDCA pump tripped, indicative of an extended low pressure sensed on train A. The transient is shown on graph 3. The sequence of starting pump A or B first did not matter.

GRAPH 2  
2 SECOND STAGGERED START OF MDCA PUMPS - 2CA6 SHUT-UST 60%  
NO PUMP TRIP

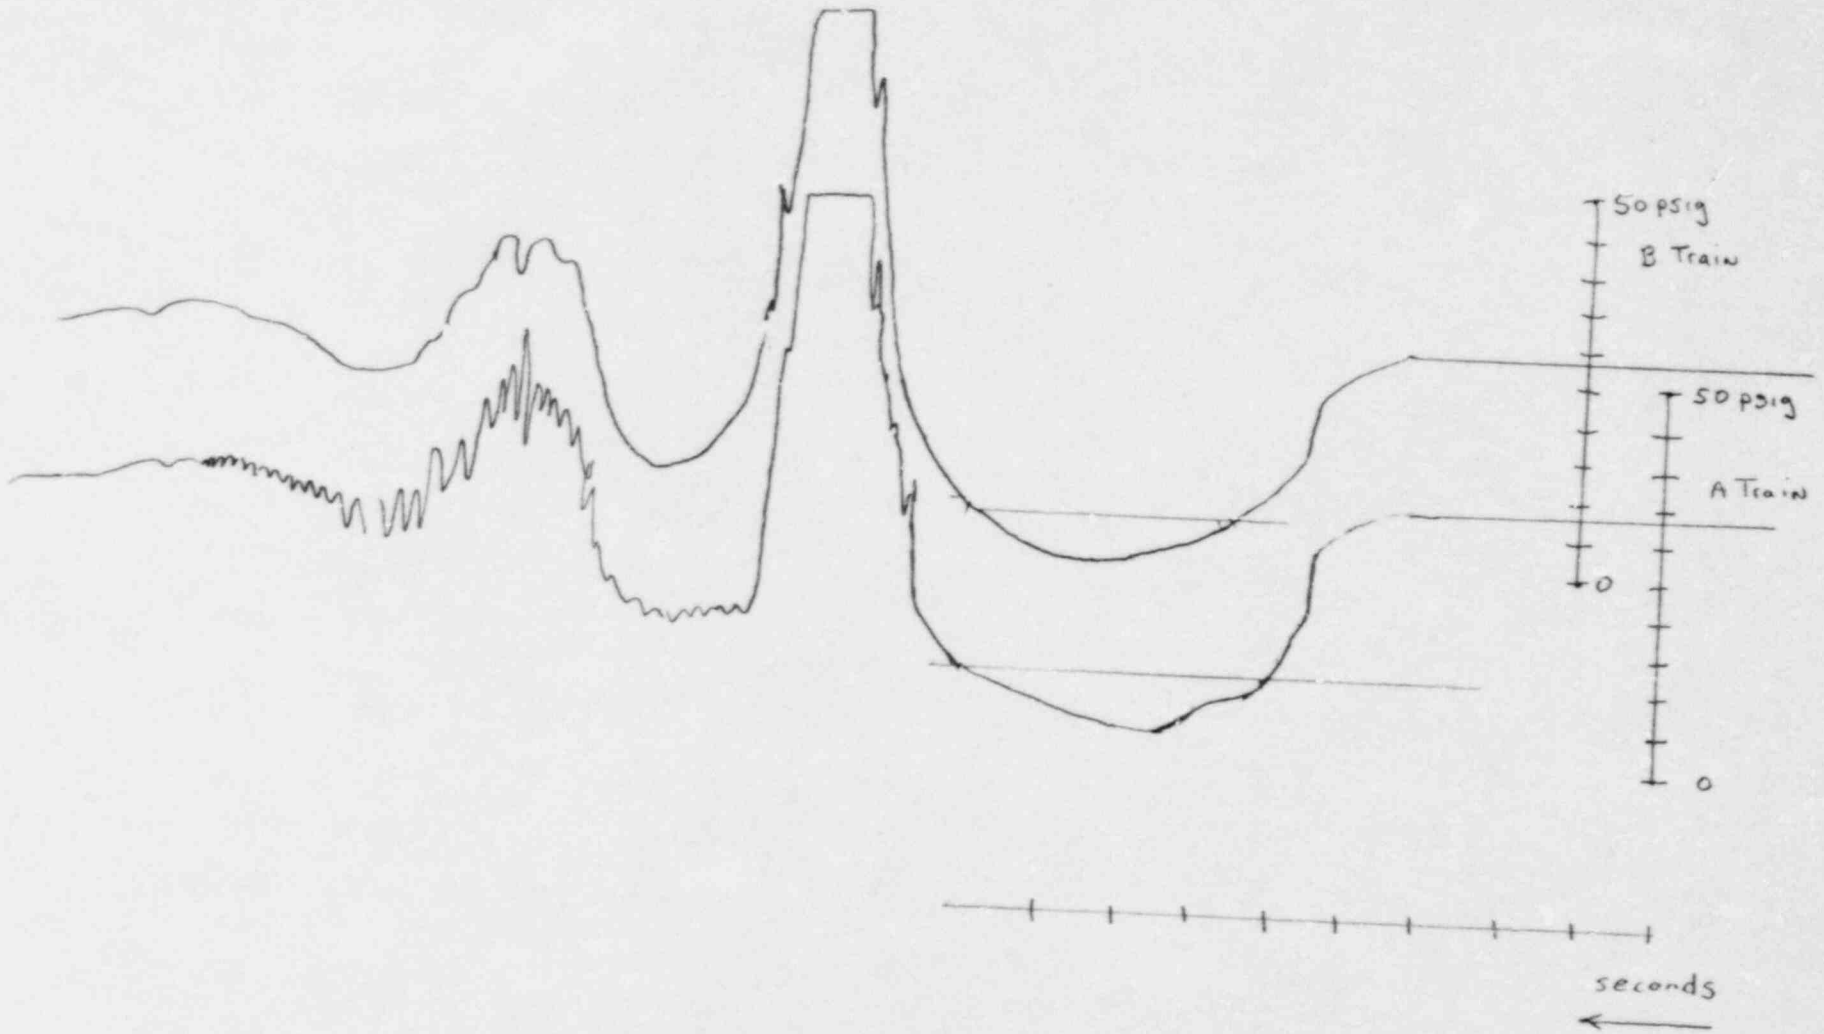
- a. With 2CA6 shut and UST level between 55-60%, starting the MDCA pumps simultaneously or slightly staggered would cause a swapover to RN on "A" train only because of 3 reasons.
  - (1) The suction pressure transient dipped lower and lasted longer than expected.
  - (2) The pressure transient as sensed by "A" train instruments typically lasted 0.3 to 0.4 seconds longer than "B" train due to the location of the instruments and the length of impulse lines.
  - (3) The time delay relay on "A" train (4.15 seconds) was shorter than "B" train (4.70 seconds).
- b. With UST above 90% and 2CA6 shut or with 2CA6 open, enough NPSH was available during the transient to prevent swapover.

1 SECOND STAGGERED START OF MDCA PUMPS-2CA6 SHUT-DST 60%-A-MDCA PUMP TRIP
