# Aging and Qualification Research on Solenoid Operated Valves

Prepared by V. P. Bacanskas, G. J. Toman, S. P. Carfagno

Franklin Research Center

Prepared for  
U.S. Nuclear Regulatory  
Commission

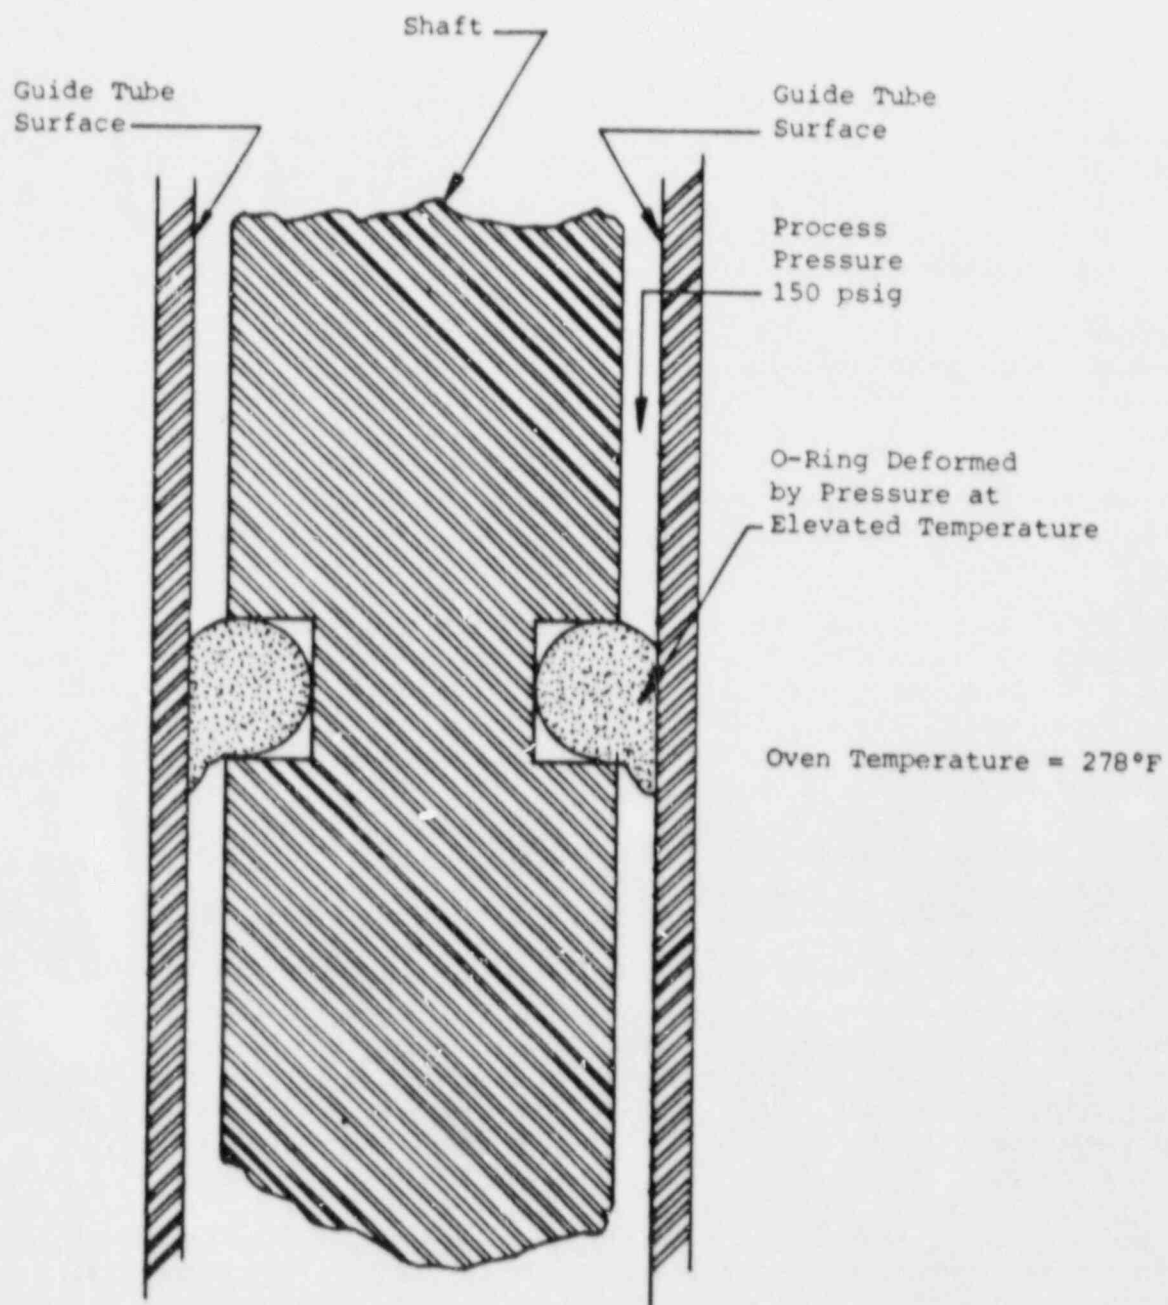
Figure 7. Hypothesized Deformation of Valcor Shaft Seal O-Ring During Accelerated Thermal Aging

Two of the three Valcor SOVs (6096-22 and -23) failed to return to their deenergized position upon deenergization of their coils. A failure analysis showed that the failure to transfer was caused by sticking of the shaft seal O-ring to its guide tube. Using a spare Valcor\* SOV, the temperature of the shaft seal O-ring was measured as 278°F (137°C) at the thermal aging temperature of 230°F (110°C). The temperature measurement confirmed that the temperature at the shaft seal O-ring had not exceeded the manufacturer's suggested limit of 300°F (149°C).

Further evaluation of the failure indicated that the observed failure could have been the result of peculiarities of the accelerated thermal aging procedure which would not occur in a plant environment. Two possible causes were hypothesized.\*\* The first hypothesis was that the physical and chemical changes of the EPDM O-ring that occurred at the elevated aging temperature and caused it to adhere to the guide tube, rather than slide in it, are different from the changes that occur under service conditions. The second hypothesis was that creep of the O-ring at the aging temperature under the stress of the process pressure far exceeded the creep that could occur under the same pressure at service temperatures. At the aging temperature (278°C [137°C]), the O-ring tends to soften; therefore, the 150-psig process pressure would tend to compress the O-ring between the shaft it rides on and the shaft guide tube (see Figure 7). When the oven temperature was reduced to room temperature with the SOV energized, the O-ring returned to a less pliable state and prevented movement of the shaft.

Because the shaft seal O-ring provides a dynamic seal during normal operation, it has several mechanical stresses acting on it. The shaft seal O-ring is under compression where it contacts the guide tube on its outer diameter and the shaft on its inside diameter. Another mechanical stress acting on the O-ring is caused by the pressure from the process medium acting downward on the upper surface of the O-ring when the solenoid coil is energized (Figure 7).

The pressure normally assists in unseating the SOV seats and starts the shaft in its downward direction when the SOV is deenergized. The second stress acting on the O-ring is related to a combination of mechanical and thermal stresses acting on it and is a possible explanation of the observed failure. At elevated temperatures, such as those used during the thermal aging simulation, the EDPM O-ring material has a tendency to soften and become more pliable, as with most rubber products. The differential pressure across the O-ring (150 psig) causes the O-ring to deform by wedging between the shaft and guide tube, such that a larger portion of the O-ring is in contact with the guide tube. If the SOV is cooled while remaining in the energized state, the deformed O-ring becomes harder and binds the shaft in its energized position.

To allow completion of the thermal aging simulation and continuation of the research program, the accelerated thermal aging analysis was revised in an attempt to preclude further Valcor SOV failures that appeared to be nonrepresentative of normal aging. The objective was to reduce the accelerated aging temperature and correspondingly increase the aging time. As a result of the observed failure mode, the shaft seal O-ring was chosen to be the critical component, since its failure could prevent the seats from transferring from the energized position to the deenergized position. Previously, failure of the lower seal assembly O-ring with subsequent high leakage had been considered the critical failure mode.
