NUCLEAR ENGINEERING SCIENCES DEPARTMENT  
Nuclear Reactor Facility  
University of Florida

April 25, 1988  
Report 2  
Safety Channel 1 Circuit Failure

Re: University of Florida Training Reactor  
Facility License: R-56, Docket No. 50-83

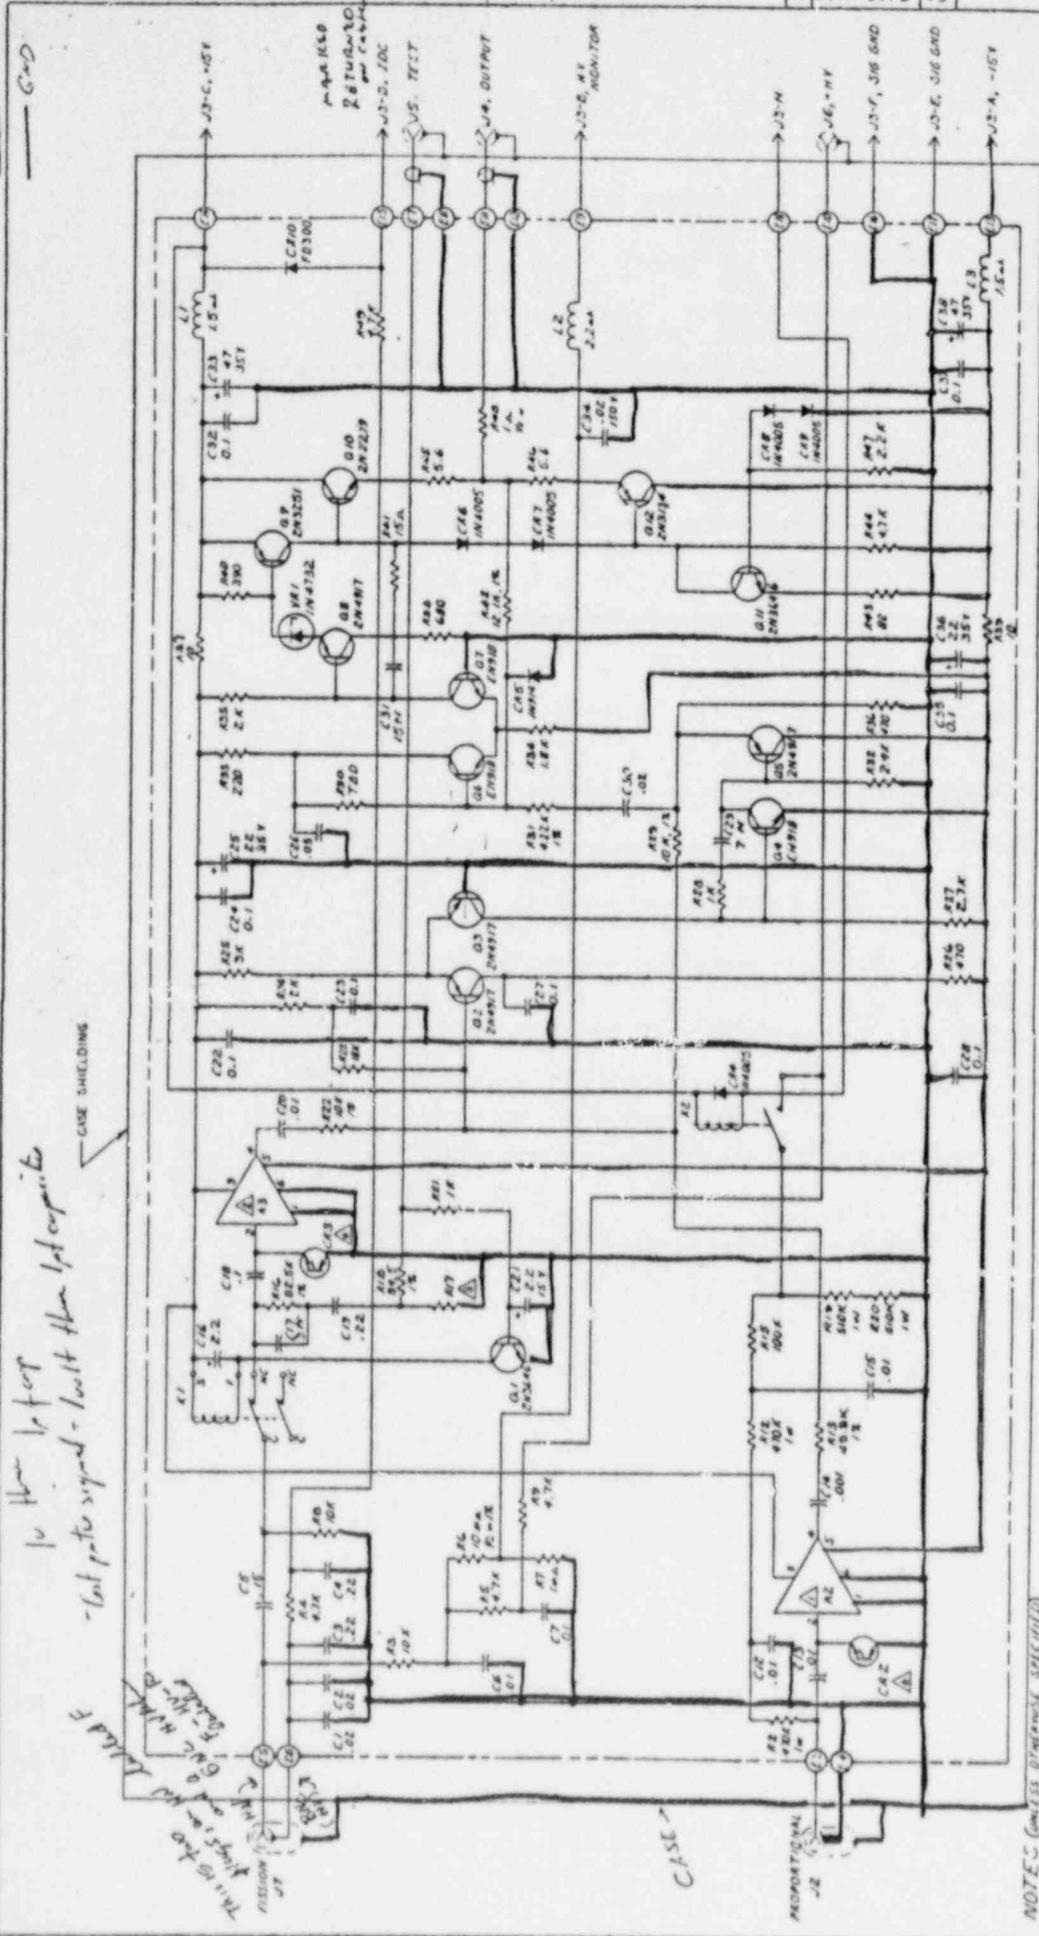
# NI CHANNEL 1

If the current flow drops while the monitored voltages in the low voltage electrode circuit also drop, the indication is that the high voltage supply (probably the filter network, resistor R5 or resistor R3 increased in resistance) is not operating properly, and not allowing enough current to operate the Safety Channel 1 circuit. If the high voltage monitor at the control console is stable while these conditions are occurring, the problem is isolated to the preamplifier.
