LICENSEE EVENT REPORT (LER)

FACILITY NAME (1) <b>Sequoyah, Unit 2</b>	DOCKET NUMBER (2) 0   5   0   0   0   3   2   8	PAGE (3) 1 OF 0   8
----------------------------------------------	----------------------------------------------------	------------------------

TITLE (4)  
**Inadequate Configuration Control Caused Two Auxiliary Feedwater Flow Paths To Be Inoperable Resulting In Noncompliance With Technical Specification 3.7.1.2**

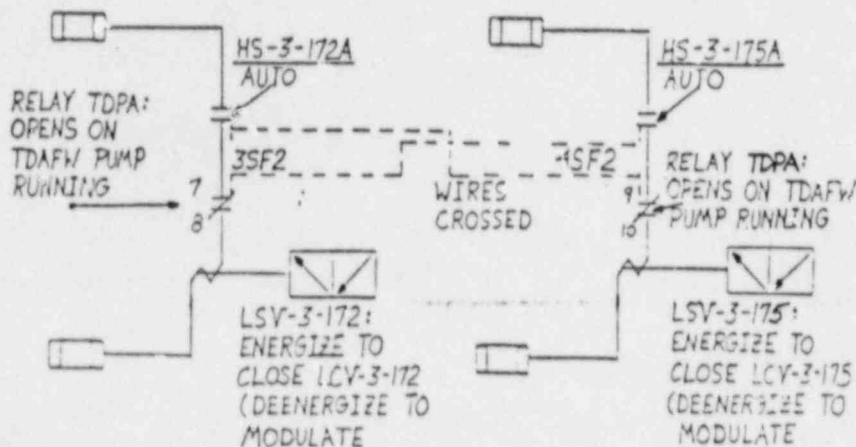
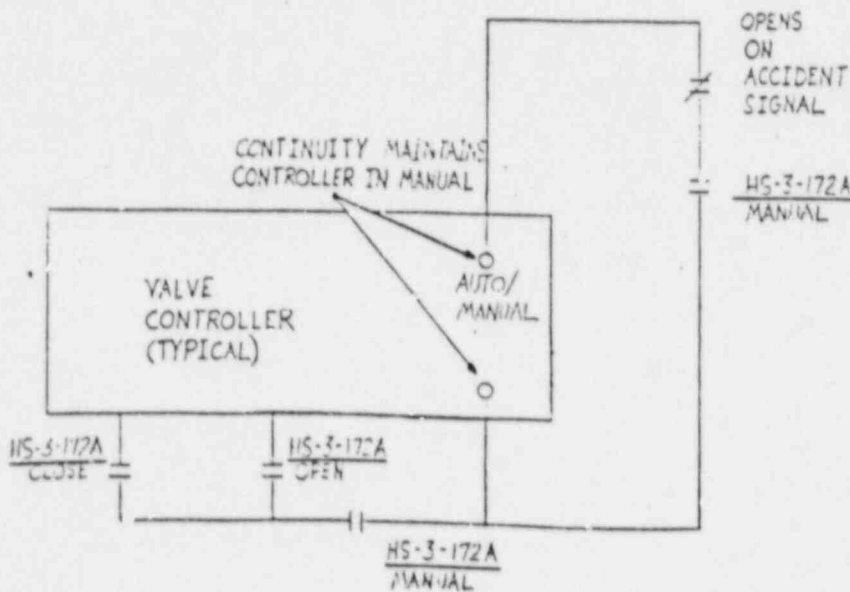
FIGURE 1

The immediate cause of the interaction between 2-LCV-3-172 and -175 was an incorrect wiring configuration. The crossing of wires 3FS2 and 4SF2 completed the circuit from handswitch 2-HS-3-172A to solenoid valve 2-LSV-3-175, and from handswitch 2-HS-3-175A to solenoid valve 2-LSV-3-172 (see Figure 1). Thus, with both valves in the automatic mode, the associated solenoid valves remained energized and both valves remained closed. However, when 2-HS-3-172A was placed in MANUAL, the circuit to solenoid valve 2-LSV-3-175 was opened and the subject valve lost power. Deenergizing 2-LSV-3-175 then allowed 2-LCV-3-175 to modulate; however, since the circuit through 2-HS-3-175A to solenoid valve 2-LSV-3-172 remained energized, 2-LCV-3-172 remained closed. The incorrect wiring configuration would also have allowed 2-LCV-3-172 to modulate if handswitch 2-HS-3-175A was switched to MANUAL while 2-LCV-3-172 remained in the automatic mode. The root cause of this event was the failure to comply with established configuration control requirements. Although the specific work activity that caused this event could not be determined, TVA believes that the failure to uniquely identify the wires that were lifted during a performance of IMI-99 RT611A/B (before November 5, 1987) resulted in wires 3FS2 and 4SF2 being improperly reterminated. IMI-134, "Configuration Control of Instrument Maintenance Activities," requires wire lifts to be recorded in sufficient detail to uniquely identify each wire. In addition, when the configuration is returned to normal (i.e., when the wires are reconnected) a second person verification is required to ensure it is properly performed. If these configuration control requirements were satisfied during all previous performances of IMI-99 RT611A/B, TVA does not believe this event would have occurred.

Operations personnel declared the turbine-driven AFW pump inoperable and entered LCO 3.7.1.2 when 2-LCV-3-172 could not be stroked from the main control room. During the interval in which the turbine-driven AFW pump was considered to be inoperable, both motor-driven AFW pumps were operable. Since each motor-driven pump can deliver 100 percent of the AFW necessary to mitigate the consequences of an accident, adequate AFW was available at all times during this event. In addition to the motor-driven AFW pumps, TVA has determined that the crossing of wires 3FS2 and 4SF2 did not have an adverse impact on the ability of the turbine-driven AFW pump to perform its intended function. Following an AFW actuation signal and subsequent start of the turbine-driven AFW pump, contacts associated with the improperly terminated wires on relay TDPA would open (see Figure 1) and solenoid valves 2-LSV-3-172 and -175 would deenergize.

As immediate corrective action, wires 3FS2 and 4SF2 were reterminated at their proper terminals in accordance with WR B290386. Following verification that 2-LCV-3-172 and -175 were capable of performing their intended function, LCO 3.7.1.2 was exited.
