# Loss of Power and Water Hammer Event at San Onofre, Unit 1, on November 21, 1985

U.S. Nuclear Regulatory  
Commission

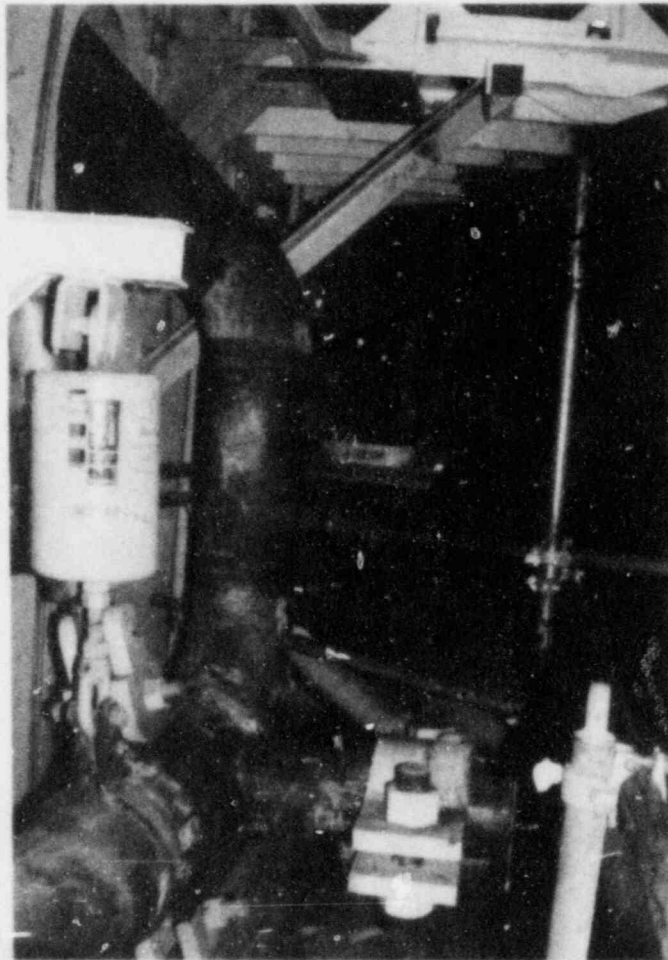
VERTICAL/SEMIVERTICAL  
RUN OF FW LINE "B"  
TO SG "B"  
LOOKING WESTWARD.\*

SUPPORTS HOOA, HOOB,  
& HOOC PROVIDE A RIGID  
SUPPORT. NO DAMAGE WAS  
OBSERVED AT THIS  
SUPPORT STATION.

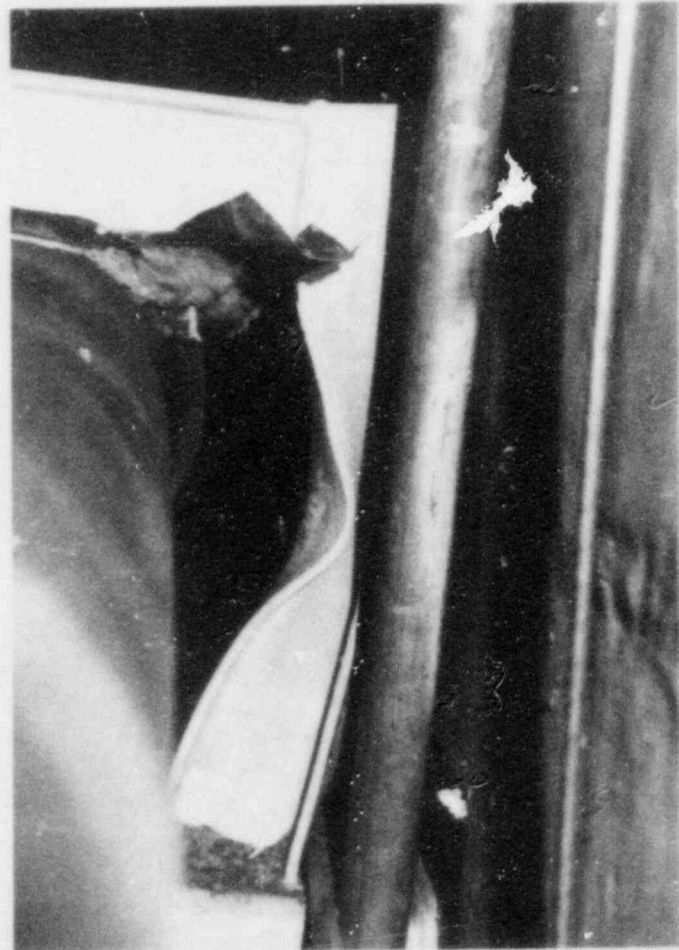
Figure 6.21 Local Damage at Support  
HOOK

VIEW LOOKING SOUTH ALONG  
PIPE, DAMAGE DUE TO  
PIPE LATERAL (WESTWARD)  
MOTION INDUCED BY  
WATER HAMMER

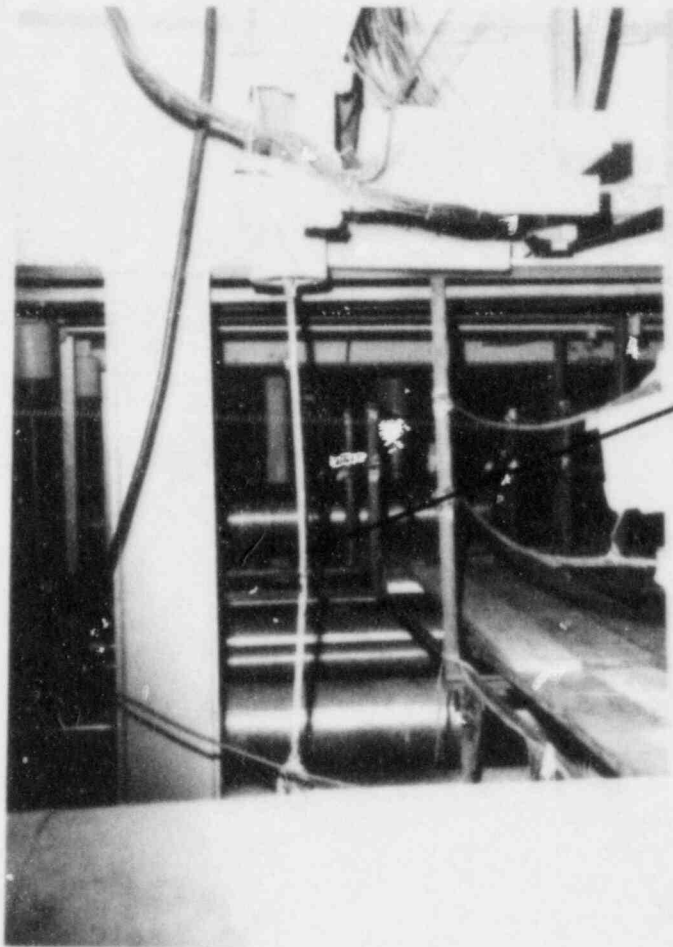
Figure 6.29 Pipe Hanger Damage at Support  
Station H015

NOTE BENT VERTICAL  
ROD DUE TO UPWARD  
MOTION OF PIPE

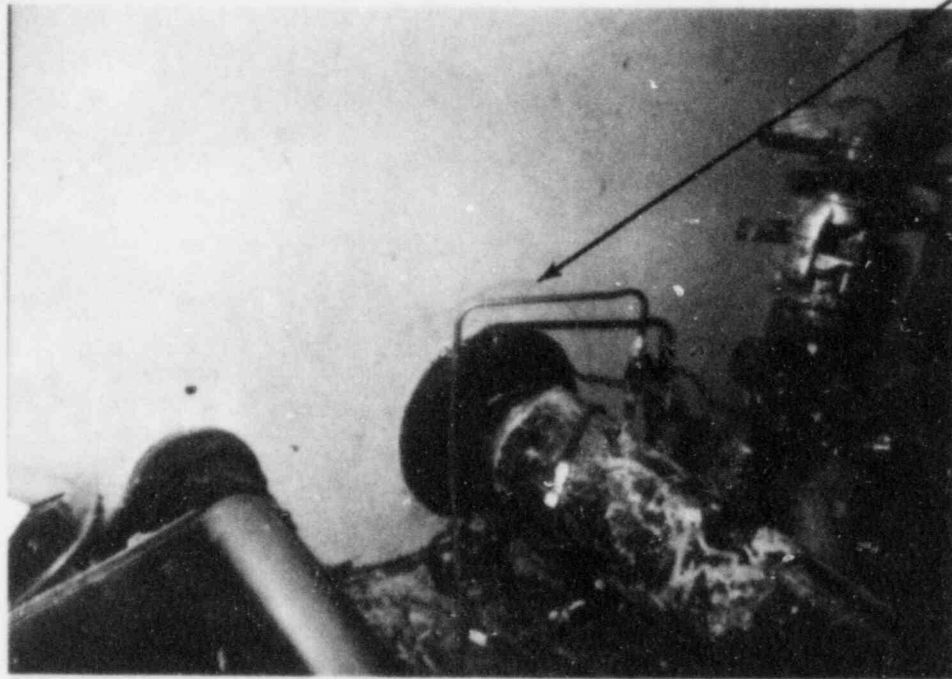
Figure 6.31 FW Loop "B" Penetration at Turbine Building Wall

NOTICE CIRCUMFERENTIAL  
CRACK IN CONCRETE  
TURBINE BUILDING WALL

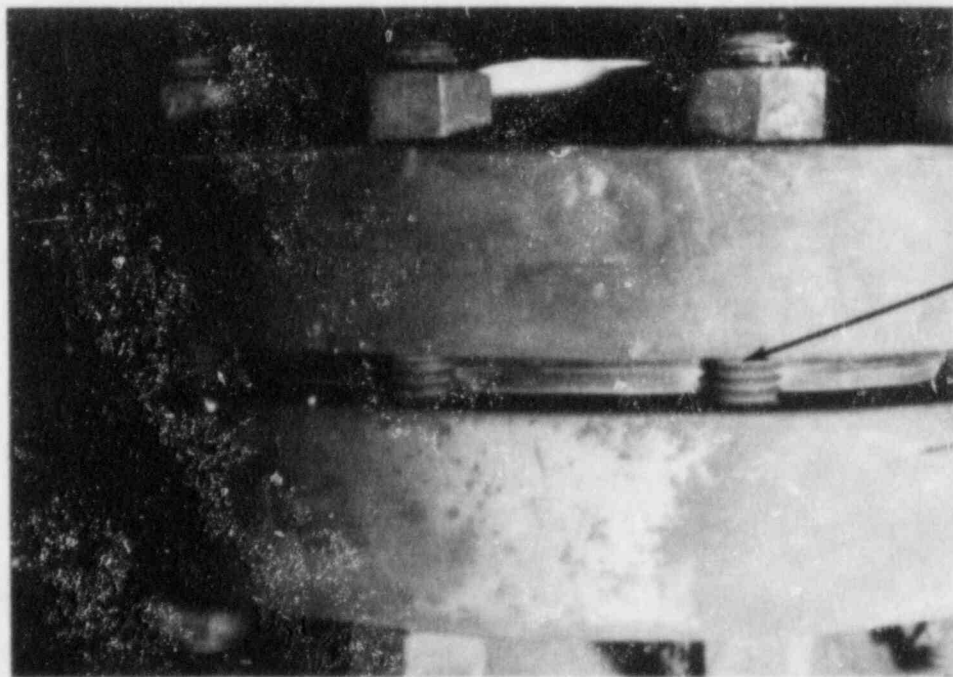
Figure 6.37 Closeup of FWS-378 Bonnet

NOTE EXTENDED  
BOLTS AND  
GASKET EXTRUDED  
AGAINST BOLTS  
BY WATER HAMMER  
LOADING

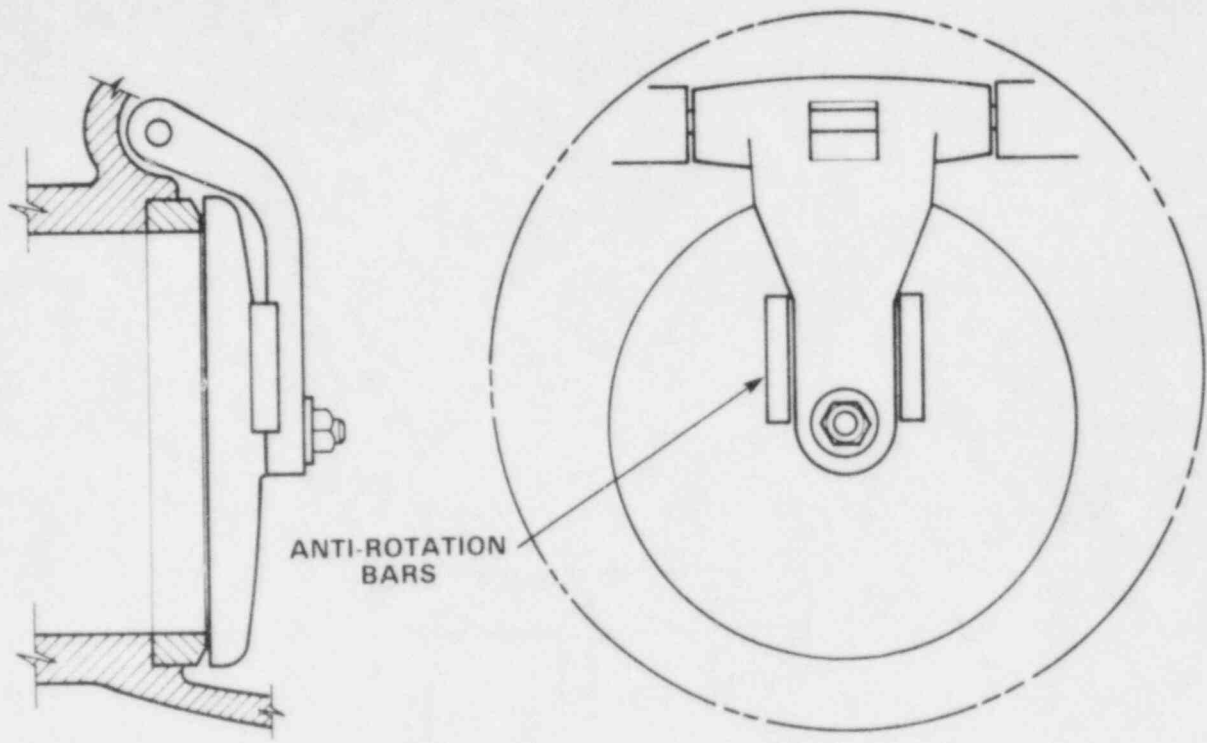
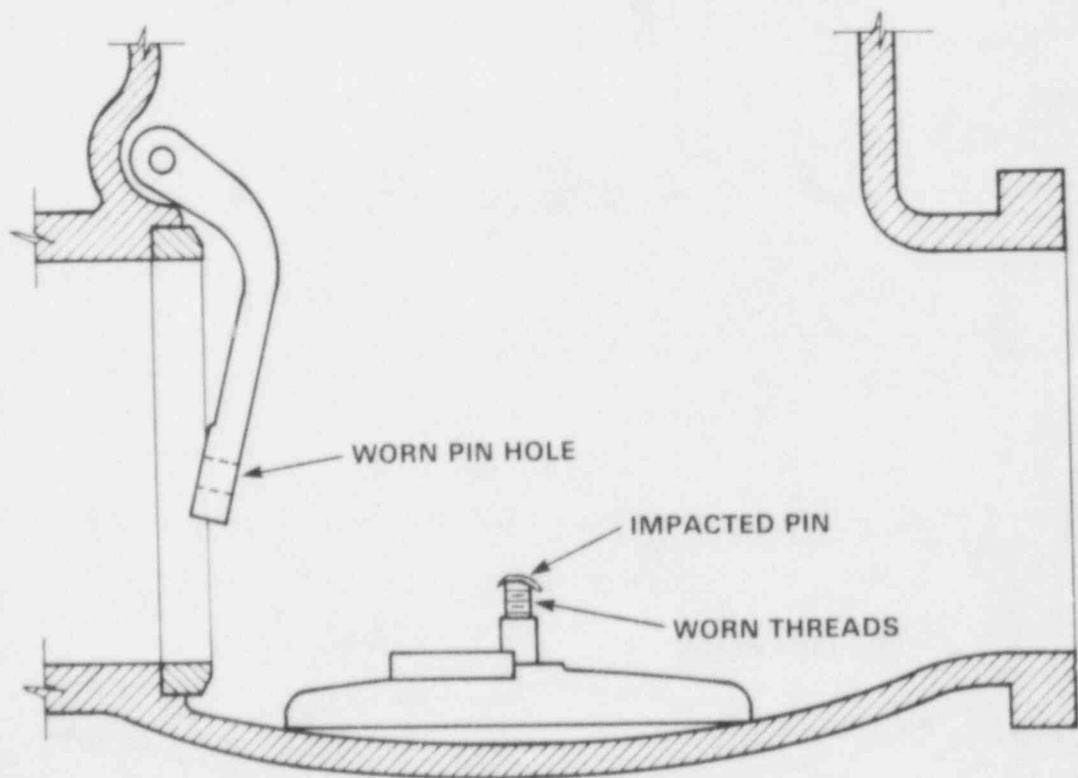
Figure 6.47 Check Valve FWS-346

VALVE FWS-346 AS FOUND

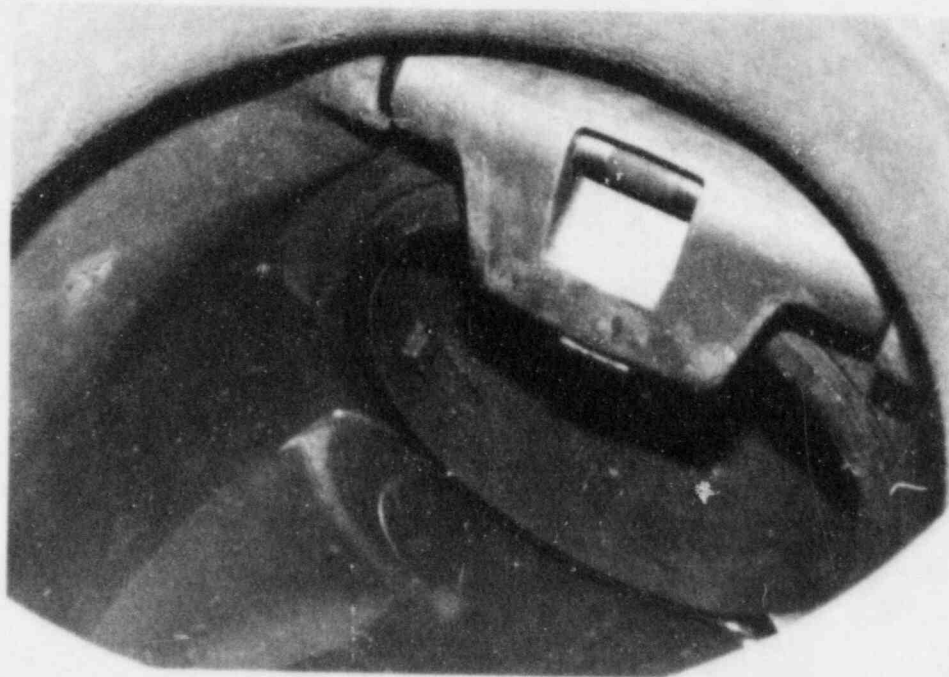
Figure 6.48 FWS-346 Seat Ring Damage

NOTE DAMAGE  
(i.e., CUTS) TO DISC  
SEATING SURFACE

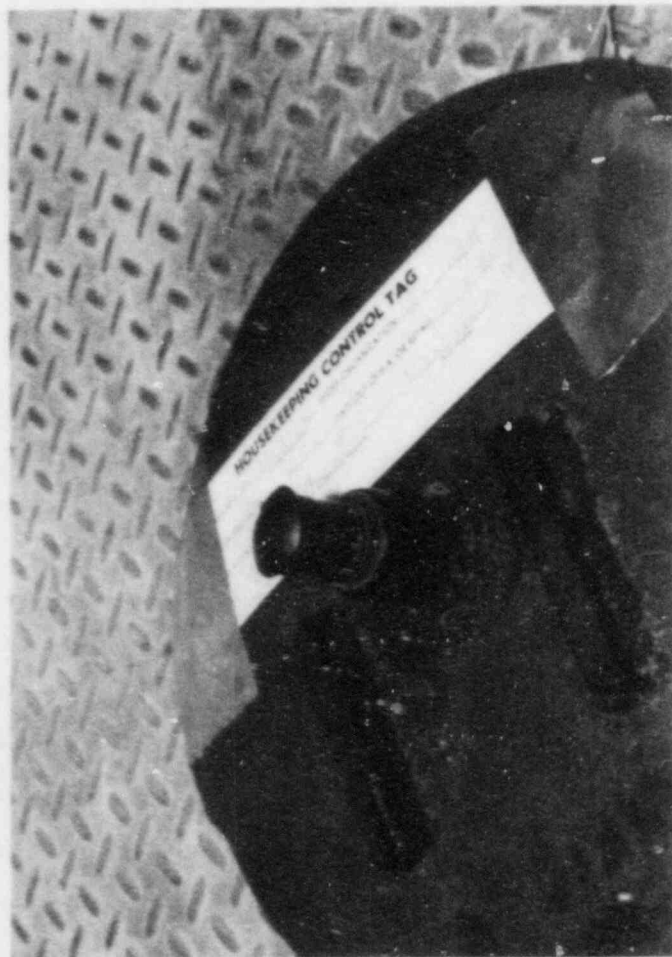
Figure 6.50 Damage to FWS-346 Disc  
Nut Pin

NOTE IMPACT  
DAMAGE AND  
WORN THREADS.  
NUT WAS MISSING

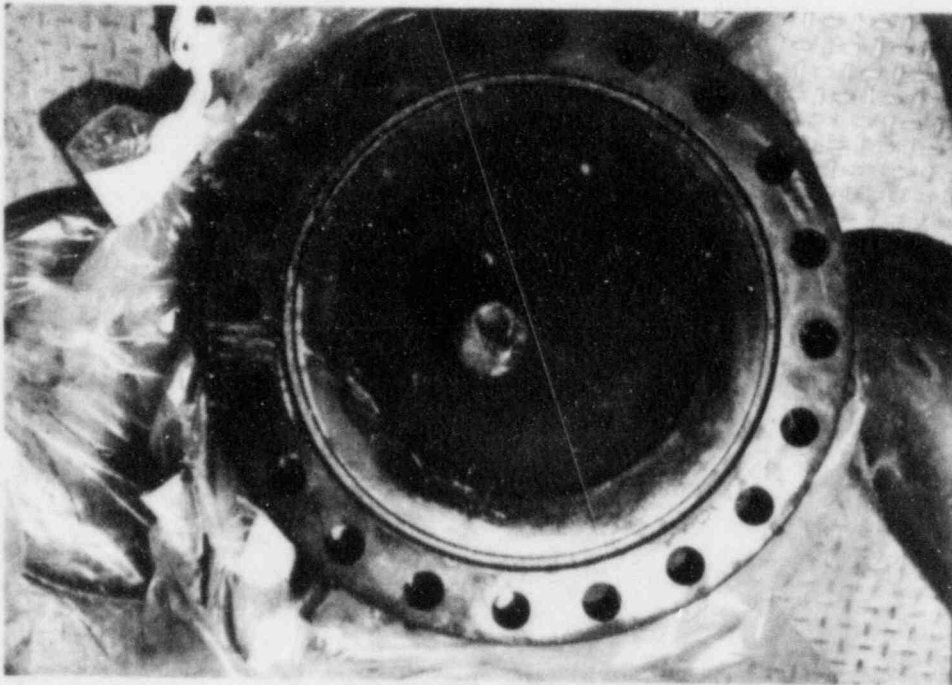
Figure 6.52 FWS-346 Bonnet

NOTE DAMAGED  
DISC STOP  
ATTRIBUTED TO  
CONTINUED  
IMPACT BY  
CHECK DISC

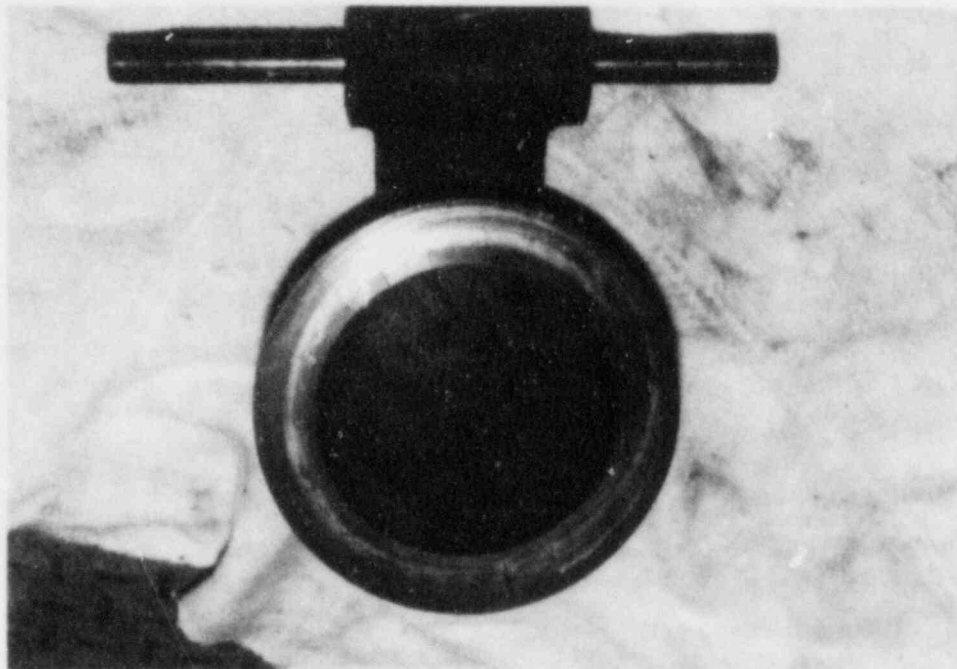
Figure 6.57 FWS-378 Disc Face

NOTE SEVERAL  
HAIRLINE  
CRACKS ON  
SEALING FACE

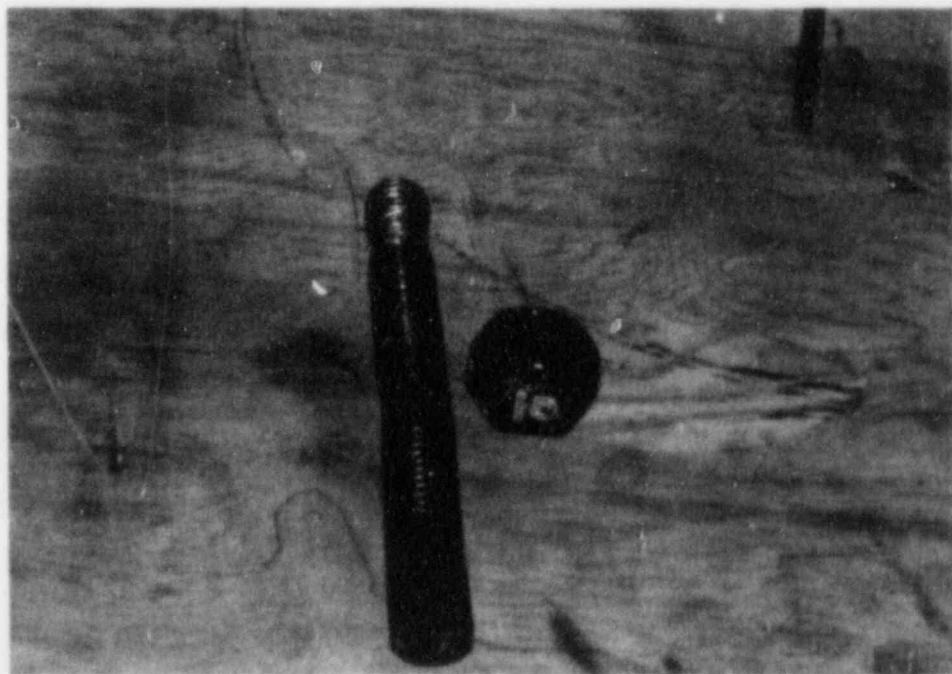
Figure 6.58 FWS-378 Stud and Nut Removed From Bonnet

NOTE ELONGATED  
THREAD SECTION  
AT UPPER END  
OF STUD

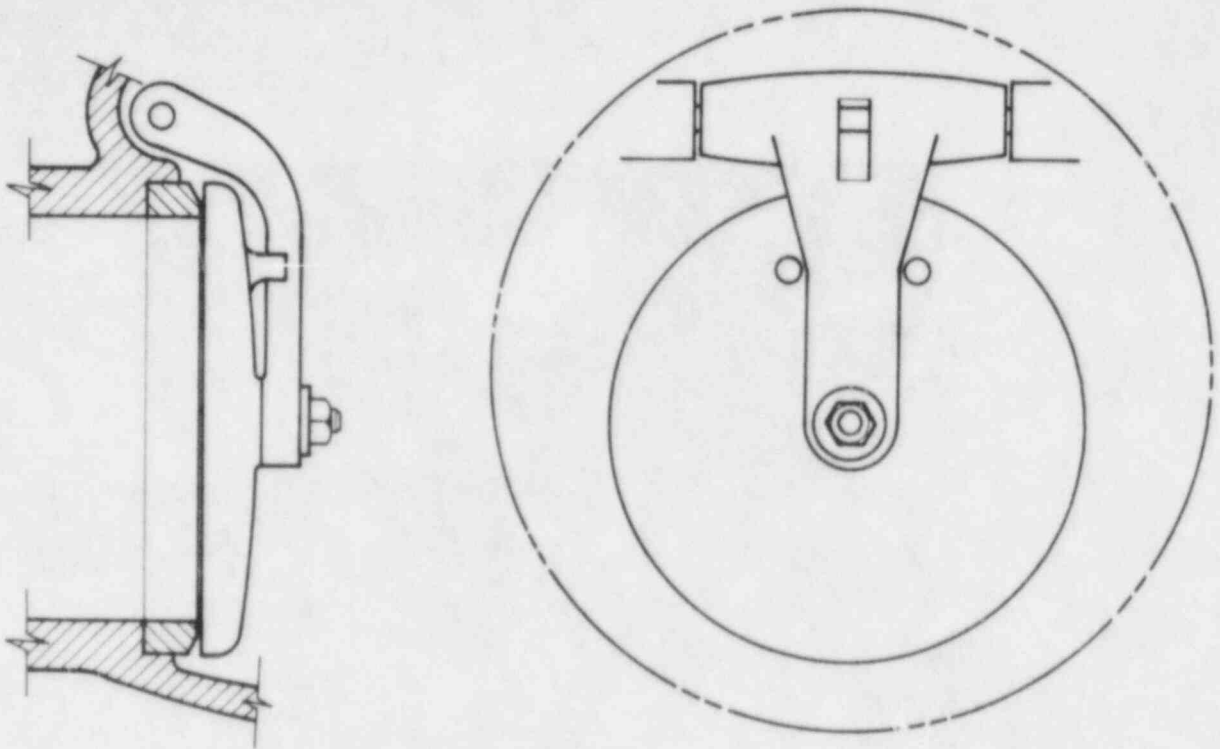
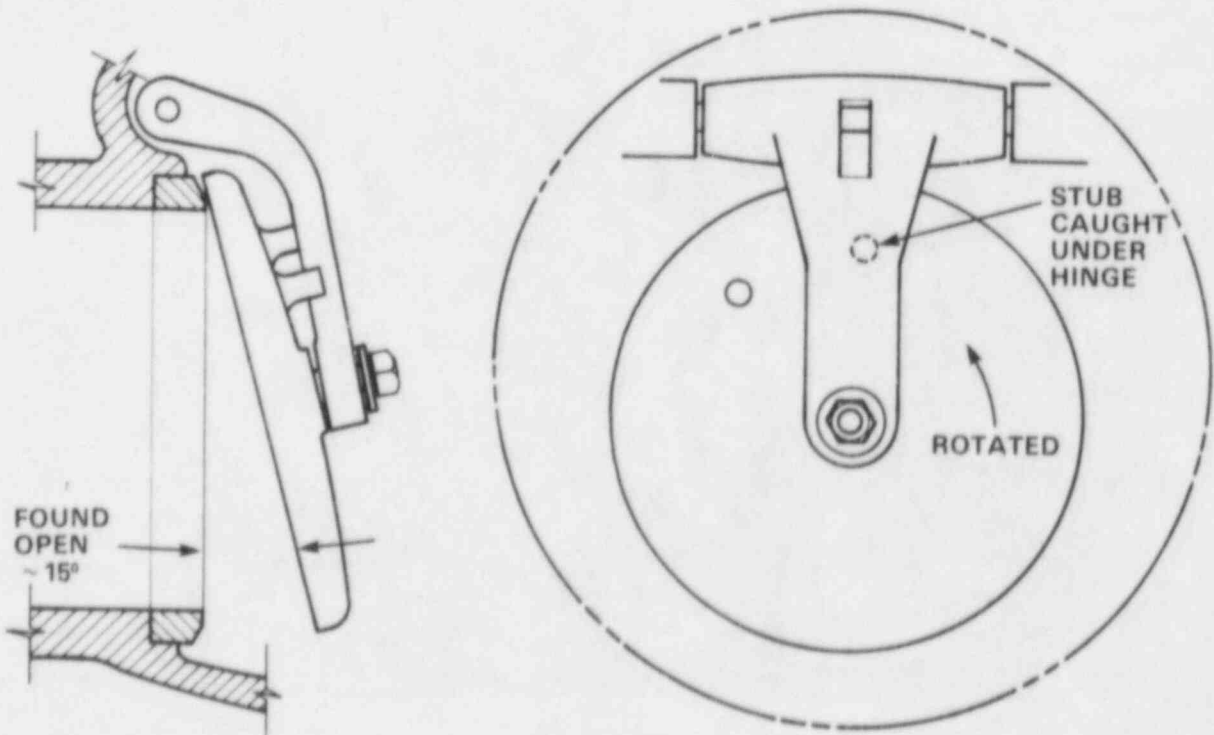
Figure 6.59 Feedwater Swing Check Valve FWS-438

VALVE FWS-438 AS FOUND

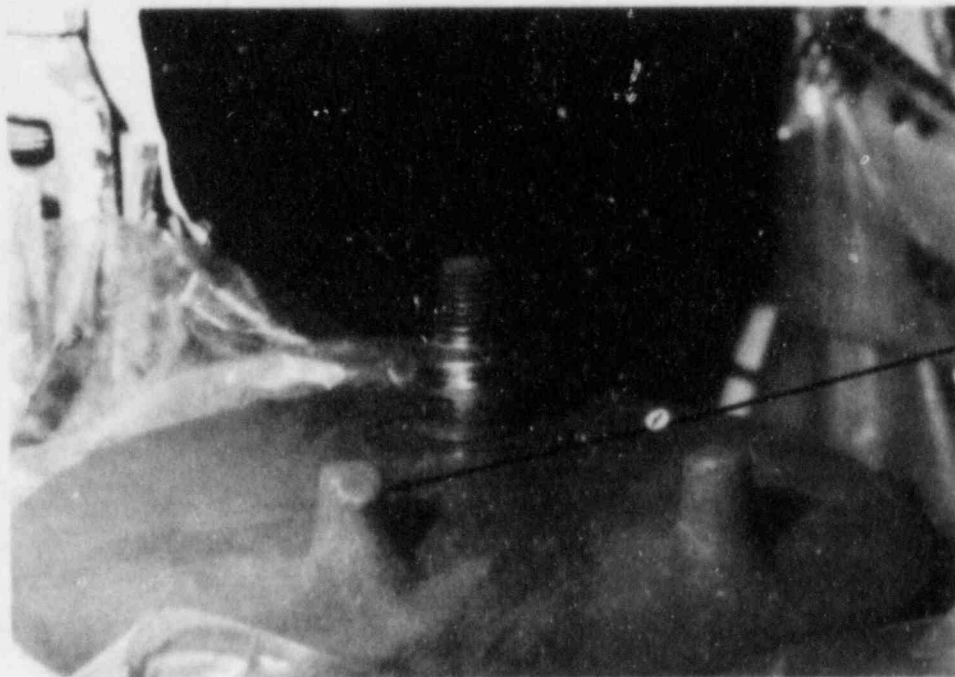
Figure 6.60 FWS-438 Closure Disc

NOTE  
FLATTENED  
POSITIONER  
"NUB"

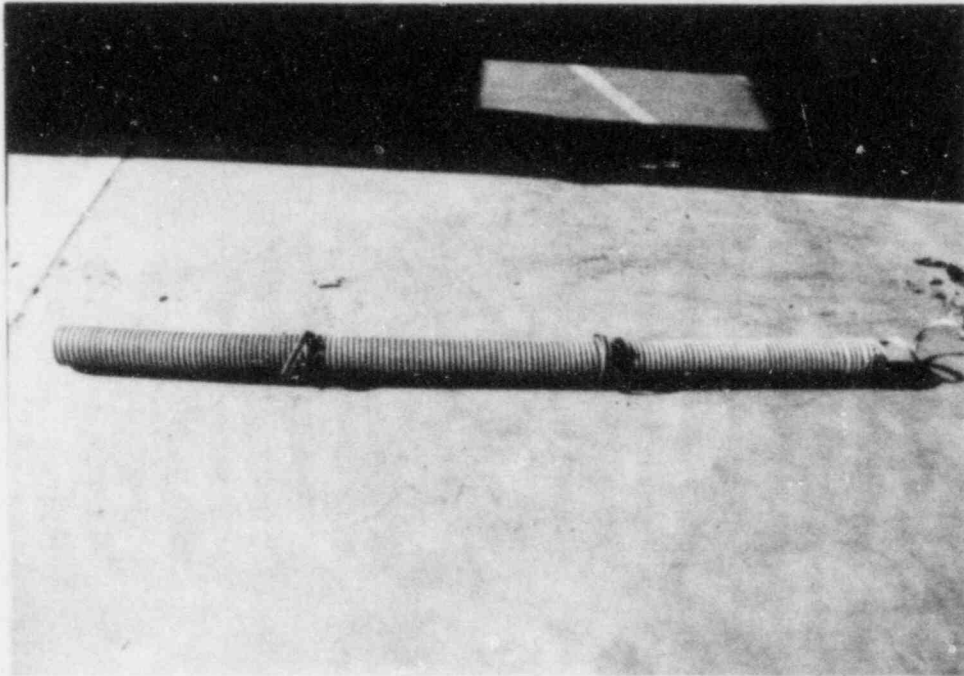
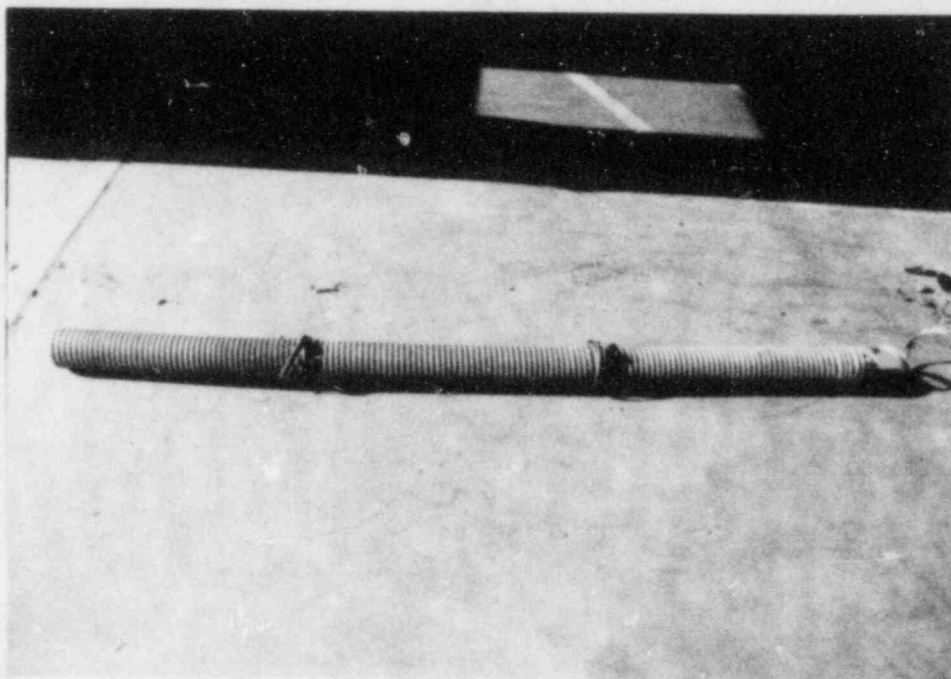
**Figure 8.1 Cable Length Showing Damage**

Post event investigation revealed that a power supply cable from transformer C to bus 1C had failed. The cable had shorted and caused two large openings in the metal jacket covering the wires. When the cable failed, a loud noise, perhaps an electrical arc, occurred. Thus, the noises heard by the fire watches and test technicians may have been the rupture of the flash evaporator located on the turbine building deck above the 4kV room, or the failure of a cable in a cable tray located in the turbine building, or some combination of the two.

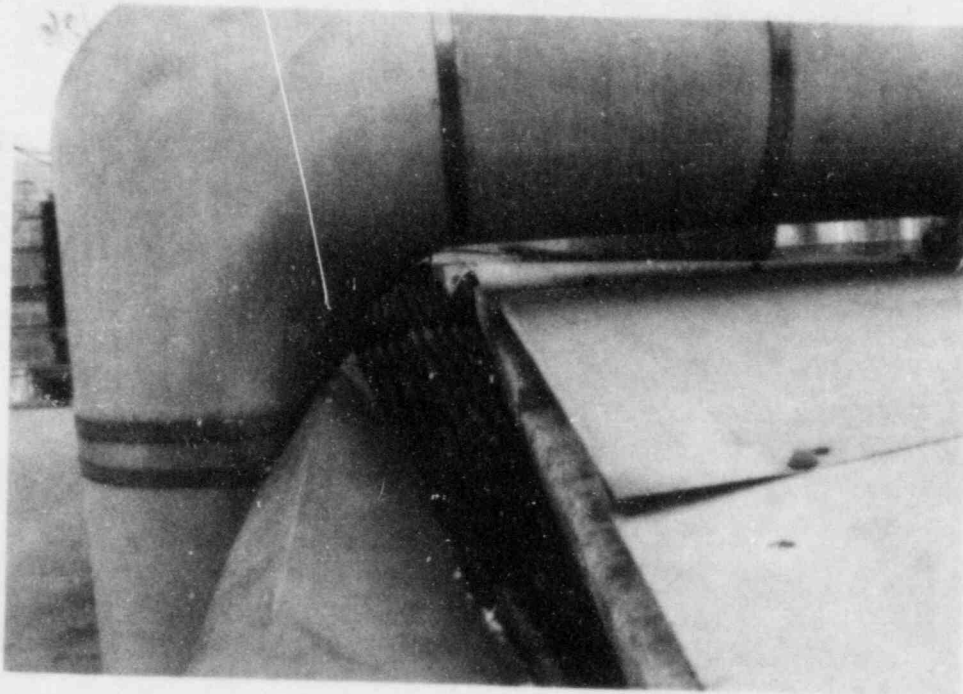
**Figure 8.8 East Flash Evaporator Unit Showing Shell Failure (South View)**

The low pressure flash evaporator condenser had been overpressurized by the backflow of feedwater from the west feedwater pump. The feedwater at high temperature and pressure ruptured a tube in the flash evaporator condenser and ballooned the rectangular shell of the flash evaporator until a 20-foot long 2-foot-wide fishmouth split occurred along the welded seam and relieved the pressure. Water and steam covered the east part of the turbine building and activated fire alarms several levels below the turbine deck.
