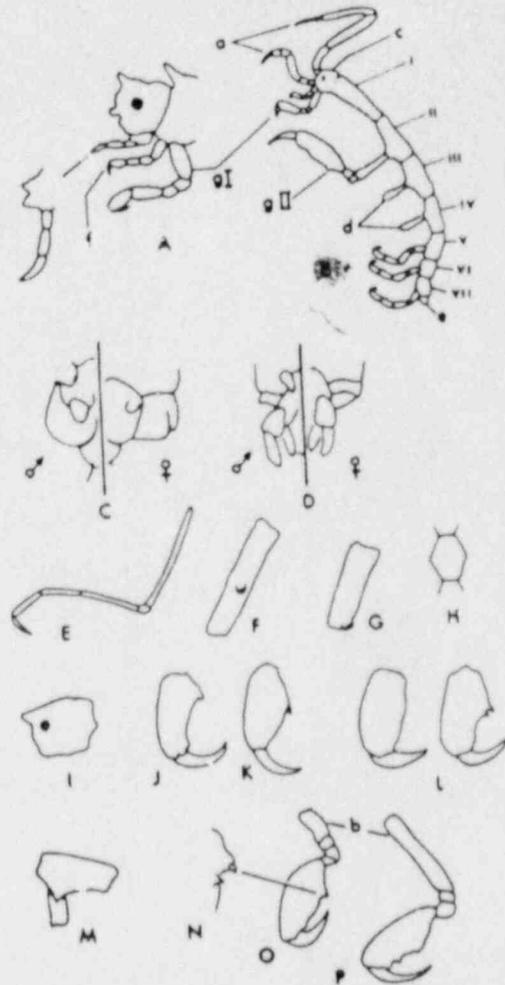
Several sections of the 2B CWIP screen were removed for inspection. The pump was then successfully started (1657 hrs.). The subject screens were observed to be fouled with skeleton shrimp. These shrimp had attached themselves to the screen and severely restricted flow.

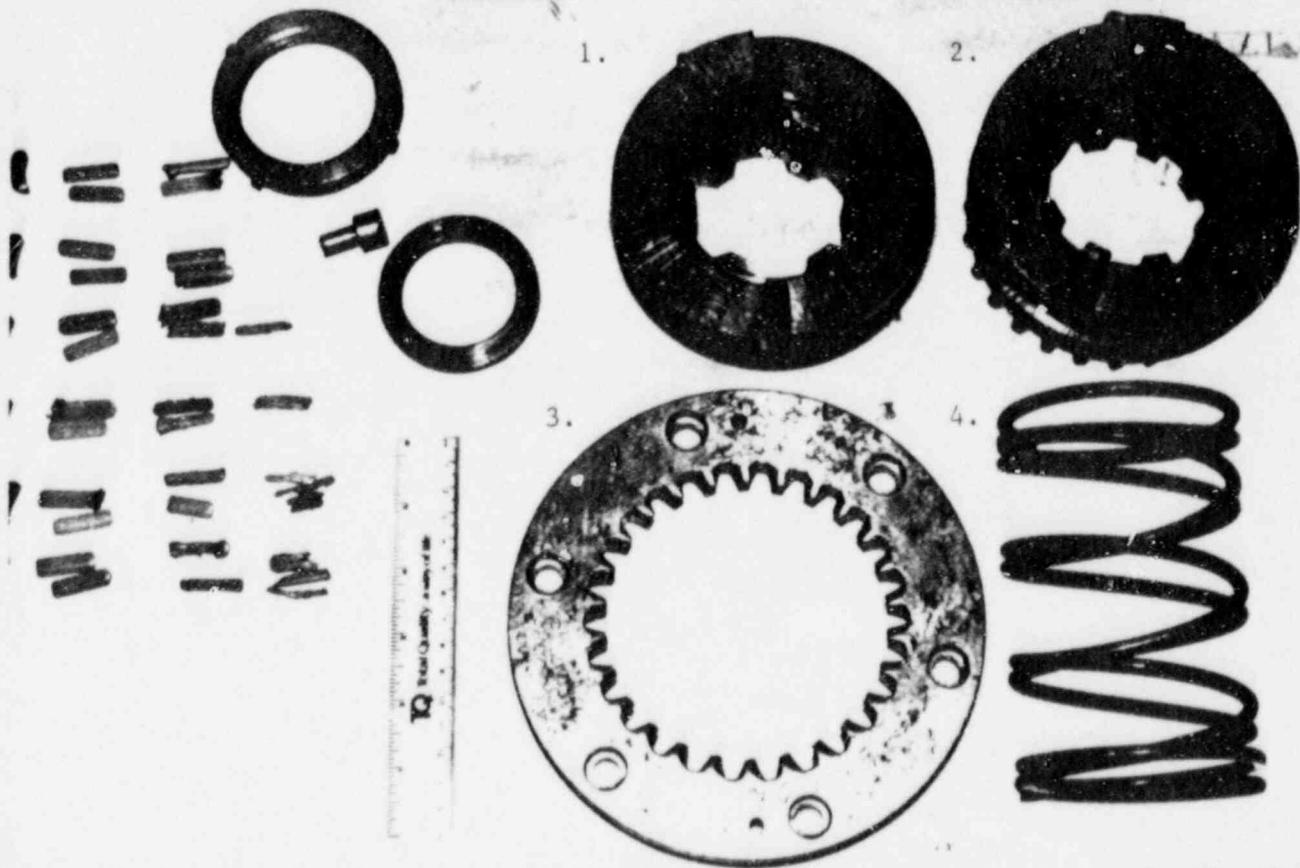
- 1. Flexible Jaw Clutch Housing
- 2. Sliding Gear Clutch
- 3. Splined Insert
- 4. Clutch Compression Spring

On July 14, 1988, while lining up loop B of the residual heat removal (RHR) system to enter the shutdown cooling mode for Unit No. 1 in accordance with Section 5.4 of Procedure OP-17, valve 1-E11-F017B failed to open on demand due to misalignment of the clutch mechanism assembly in the valve operator. There are two identically arranged RHR system loops in each of the two Brunswick Units, and each loop has a 20" x 24" angle valve to allow RHR flow into the recirculation loops. The RHR outboard injection valve 1-E11-F017B is the valve on loop B for this purpose. The F017B valves are routinely used to return flow to the reactor vessel during the cool down process in the plant shutdown process. All F017 valves were made by Rockwell and have Limitorque model SMB-5T operators. Attachment 2 contains a sketch of the RHR shutdown cooling mode.

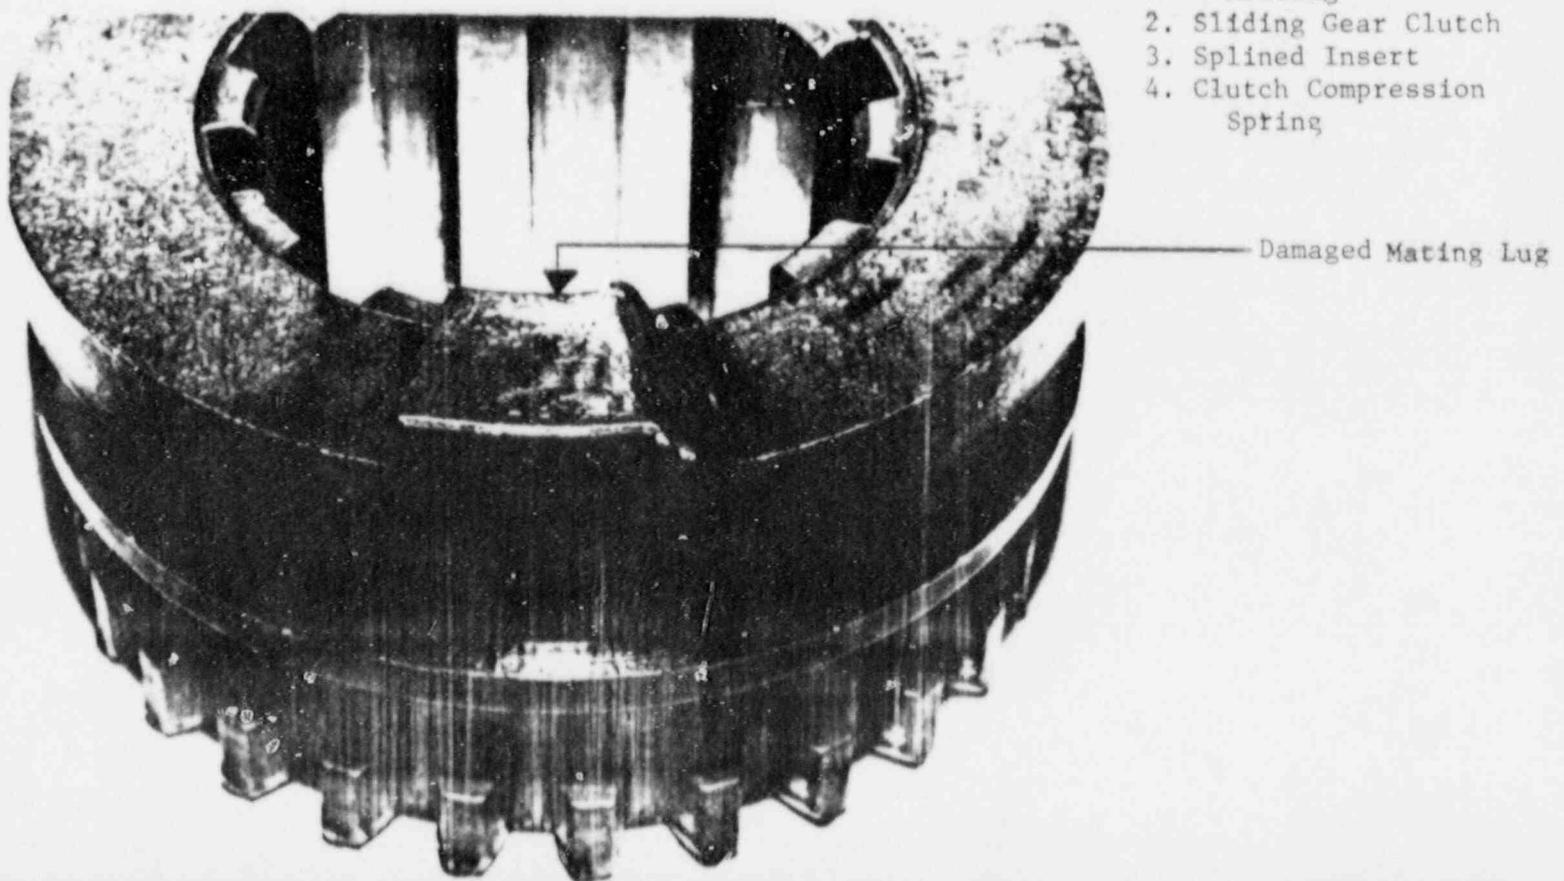
Damaged Mating Lug
