LICENSEE EVENT REPORT (LER)

FACILITY NAME (1) Sequoyah, Unit 1	DOCKET NUMBER (2) 0 5 0 0 0 3 2 1 7	PAGE (3) 1 OF 0 1 5
---------------------------------------	--	------------------------

TITLE AND SUMMARY
Inadvertent Grounding of a Unit 1 Radiation Monitor Input to the Solid State Protection System Resulted in a Containment Ventilation Isolation

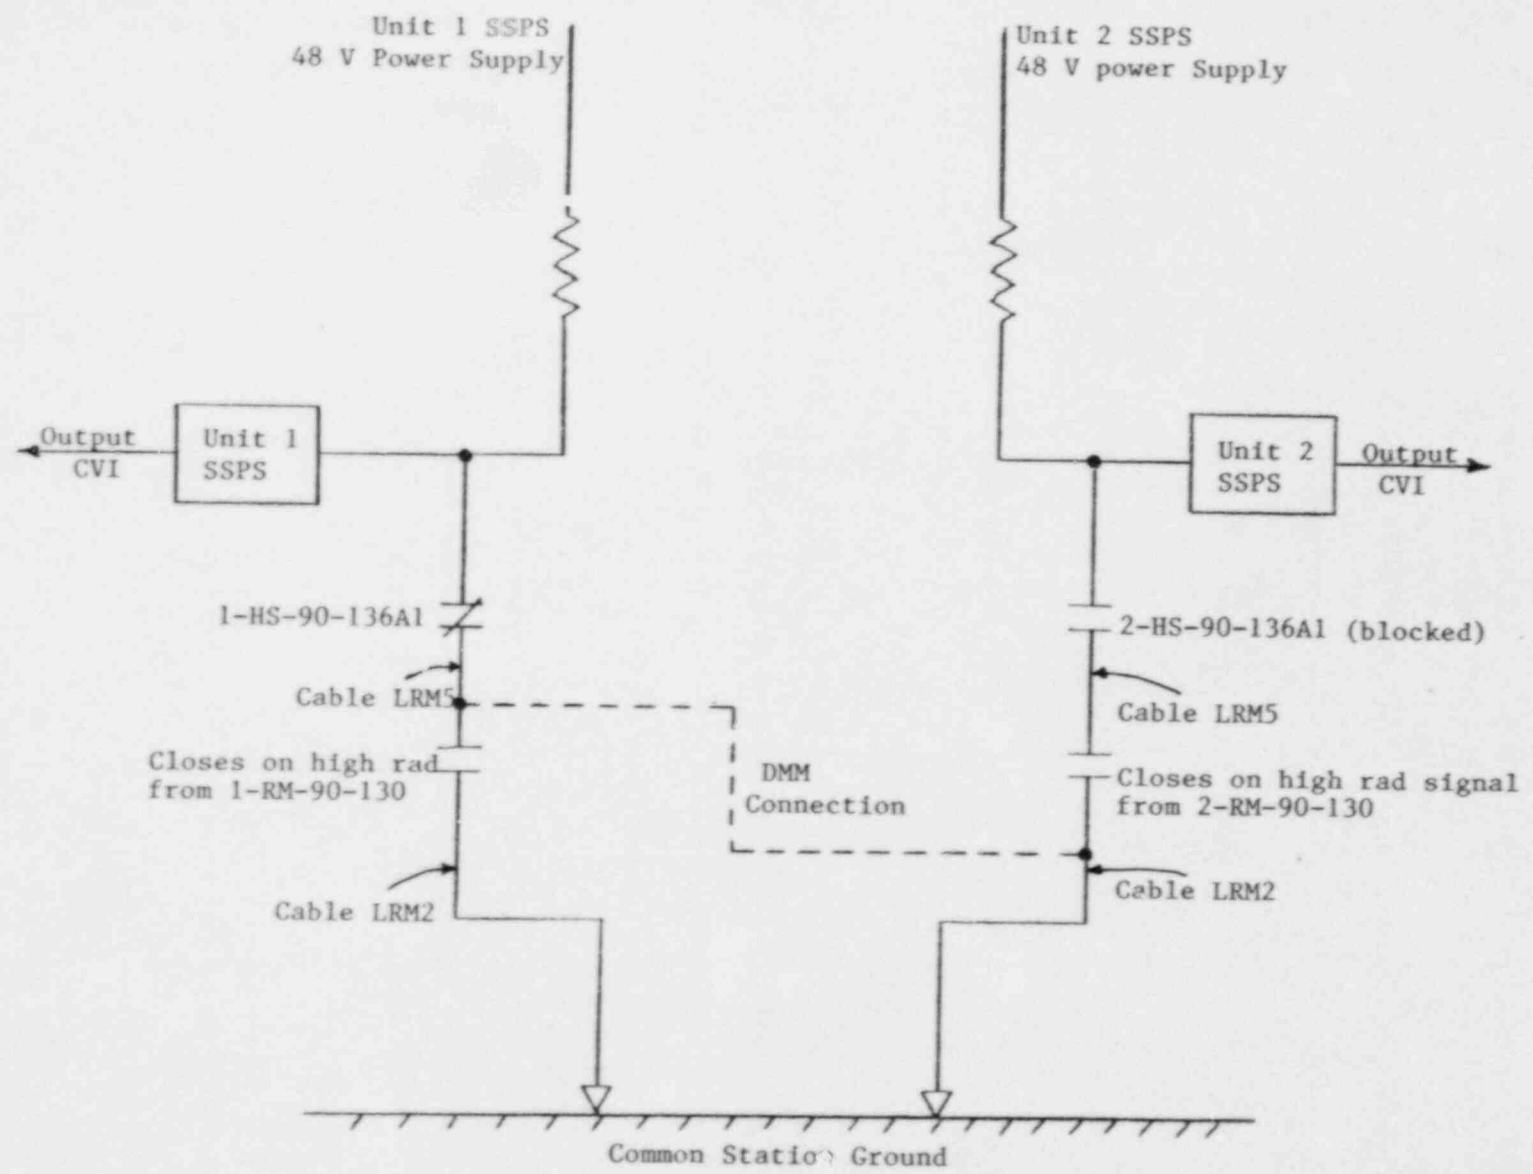
SIMPLIFIED SCHEMATIC

Touching terminal 5 of TB 1-1K with the DMM probe created a current path for the associated unit 1 SSPS 48 volt power supply to flow through the DMM connected to terminal 2 of TB 1-1A to the station ground (see attached figure). Since each of the 48 volt SSPS power supplies is connected to the station ground, the 48 volt input signal to the SSPS logic (through radiation monitor 1-RM-90-130's output timing relay contacts) immediately went low, and a high radiation condition in the unit 1 containment purge system exhaust was simulated. As designed, the SSPS generated a train "A" CVI.

The root cause of this event has been attributed to the use of one terminal block for routing cables associated with RMs from both unit 1 and unit 2 without clearly identifying each cable and/or terminal. In this case terminals 5 and 7 on TB 1-1K were both identified on the back of Riser 1 as being termination points for cable LRMS. Terminal 5 was a termination point for unit 1 cable LRMS while terminal 7 was a termination point for unit 2 cable LRMS. Although the IM technician stated he was aware of which terminal he was supposed to connect his DMM to, the close proximity of two cables and two terminals (one from each unit) that were identified in exactly the same way is conducive to this type of error.
