**DRESSER  
INDUSTRIES**

Docket No. 99900054/85-01  
Reported Violation (85-01-01):

PRODUCT ENGINEERING REPORT SV-221  
3707RA DISC COLLAR FAILURE  
PACIFIC GAS & ELECTRIC COMPANY  
DIABLO CANYON UNIT 2

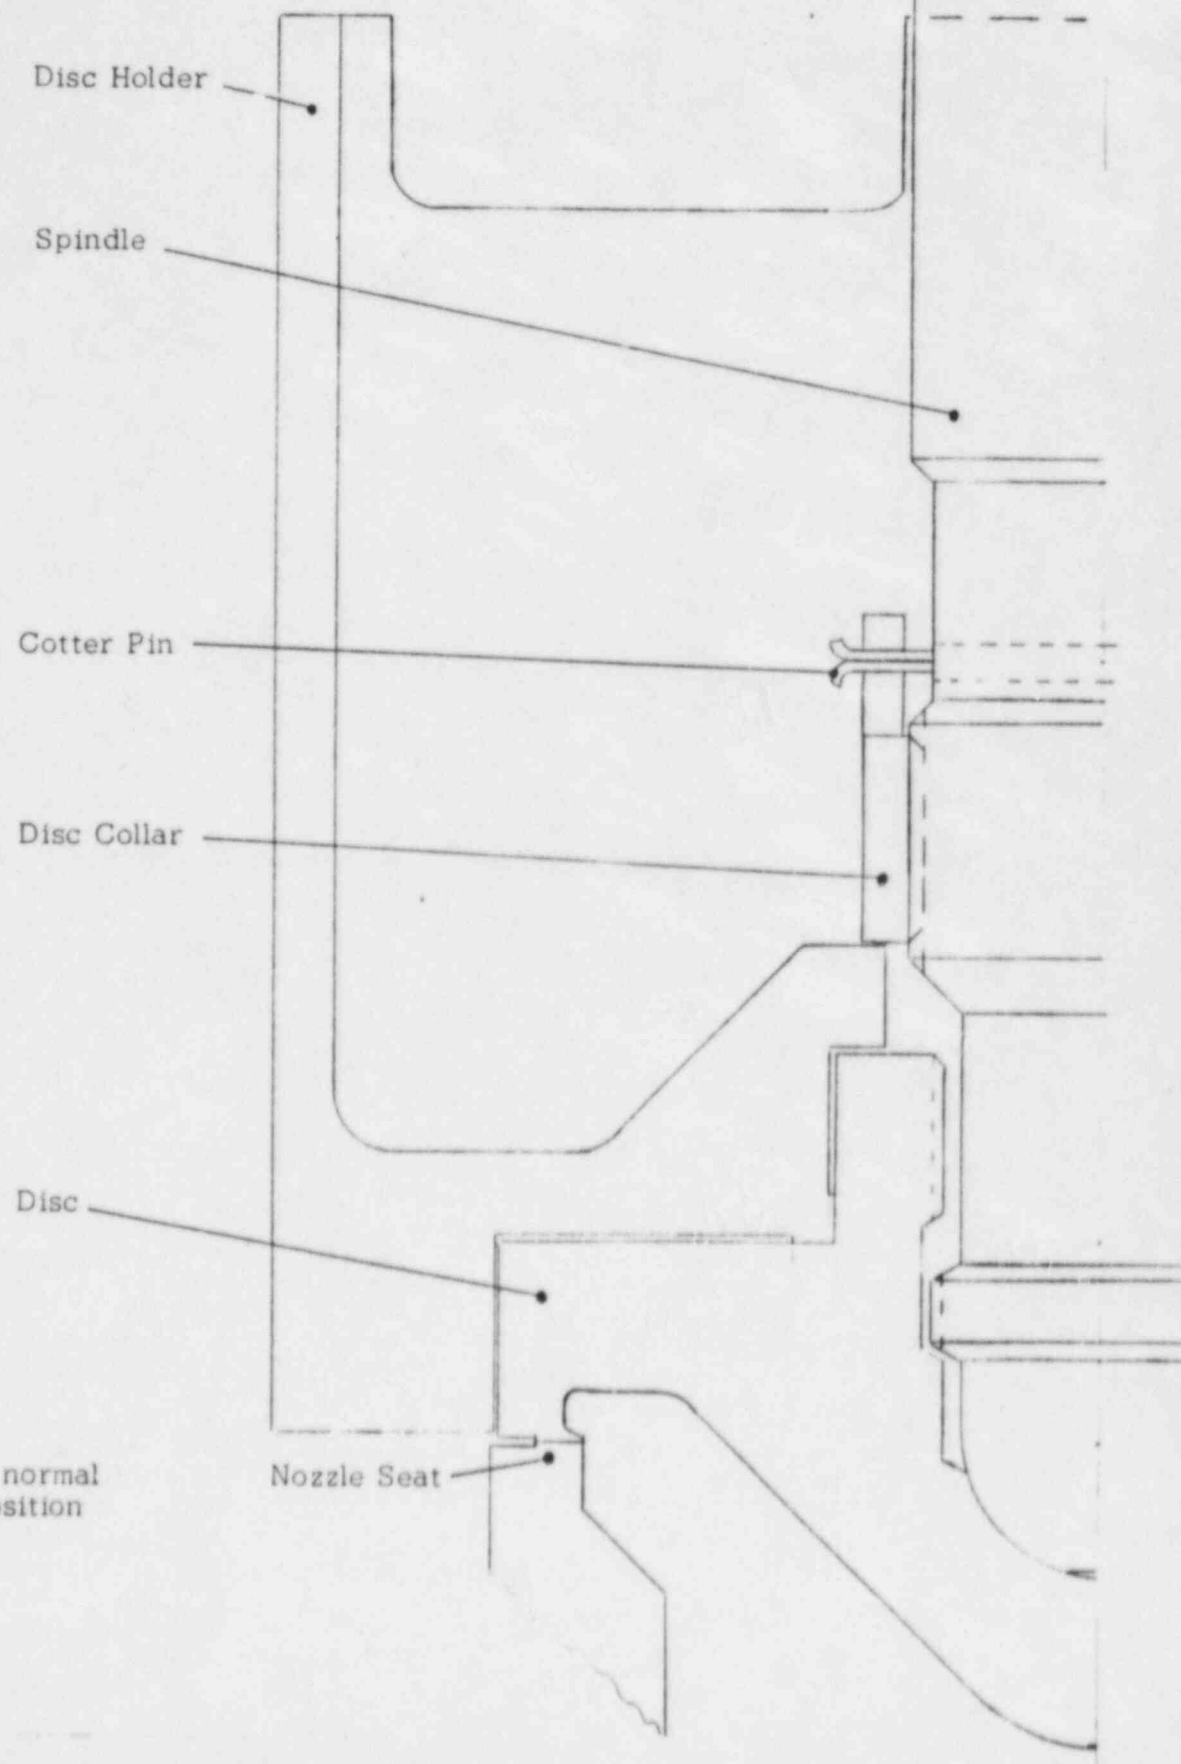
- 1.4 On 5-15-84, safety valve serial number BN 1741, on the first actuation at approximately 1065 psig, lifted with simultaneous shearing of the disc collar/spindle threads and cotter pin. On closing, the disc holder stayed in the full open position as the disc moved downward with the spindle out of the pocket in the disc holder. The disc and spindle deflected sidewise with the disc becoming wedged between the nozzle seat area and the bottom of the disc holder. Thus, the valve became mechanically jammed where it could not open again (see Figures 1 thru 4).

Figure 1 - Valve in normal closed position

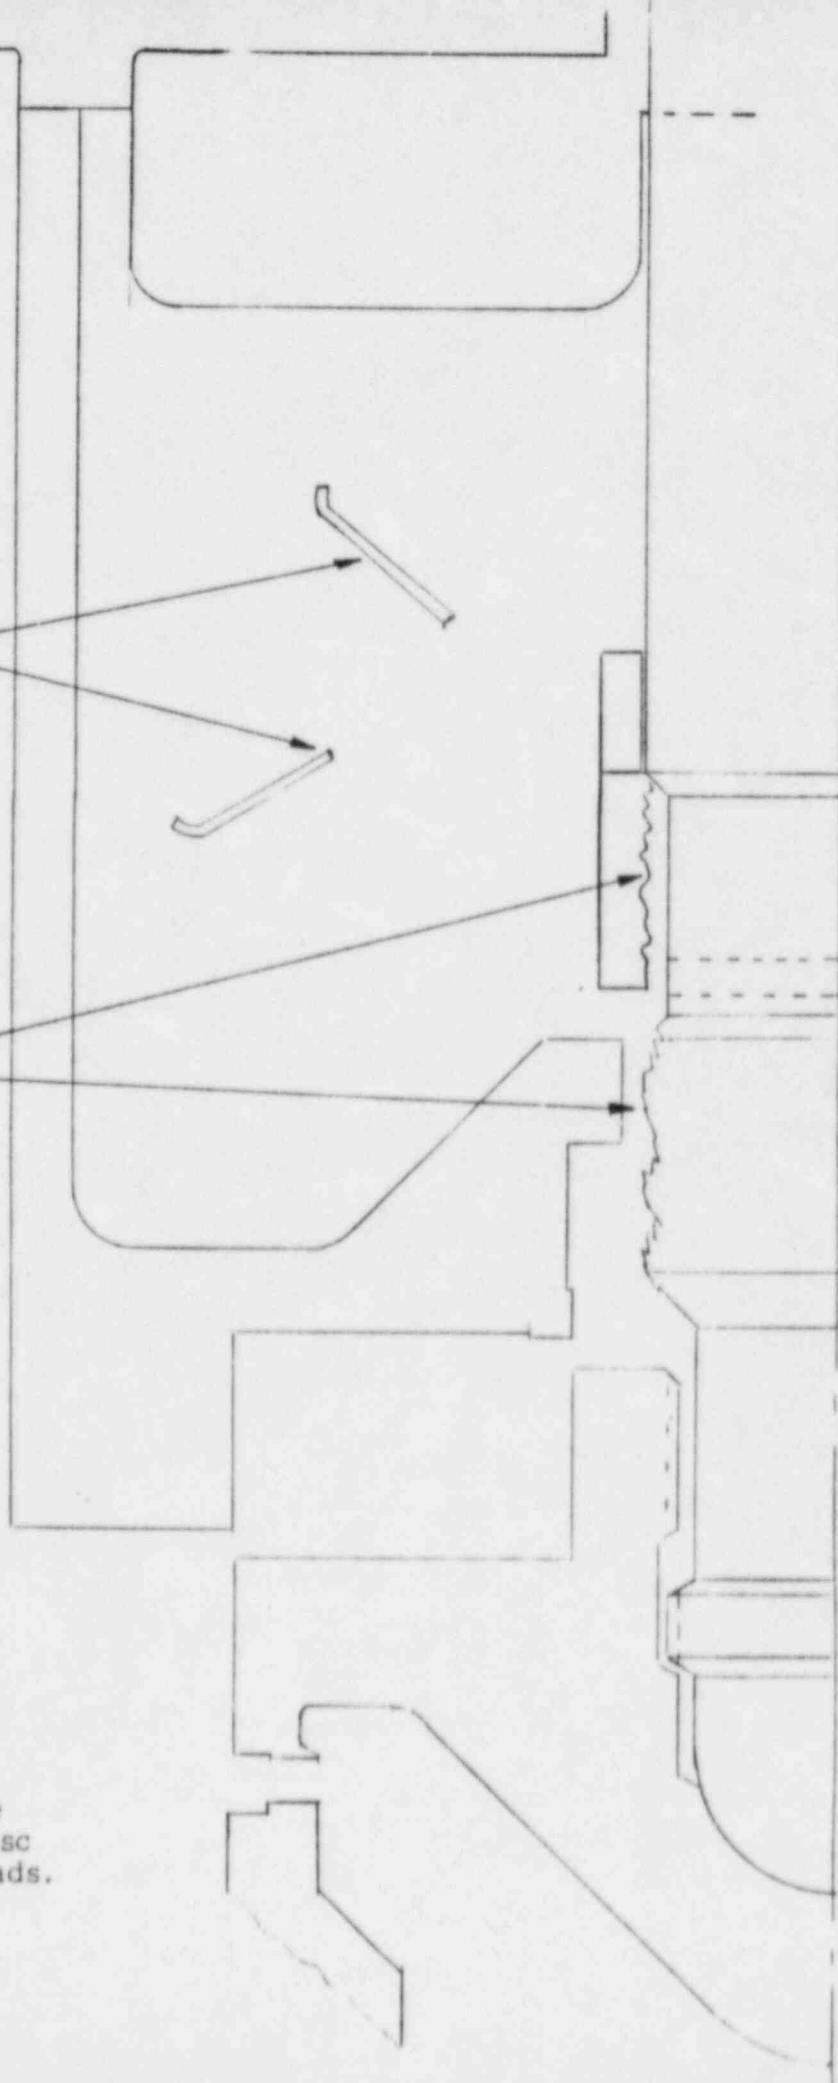
Figure 2 - Valve opens w'ith  
simultaneous failure  
of cotter pin and disc  
cotter/spindle threads.

On 5/15/84, valve serial number BN1741, on the first actuation at approximately 1065 psig, the valve lifted with simultaneous shearing of the disc collar/spindle threads and cotter pin (see Figures 1 & 2). On closing, the disc holder stayed in the full open position as the disc moved downward with the spindle out of the pocket in the disc holder (see Figure 3). The disc and spindle deflected sidewise with the disc becoming wedged between the nozzle seat area and the bottom of the disc holder (see Figure 4). Thus, the valve became mechanically jammed where it could not open again, although it was leaking severely because the disc was not seated properly.

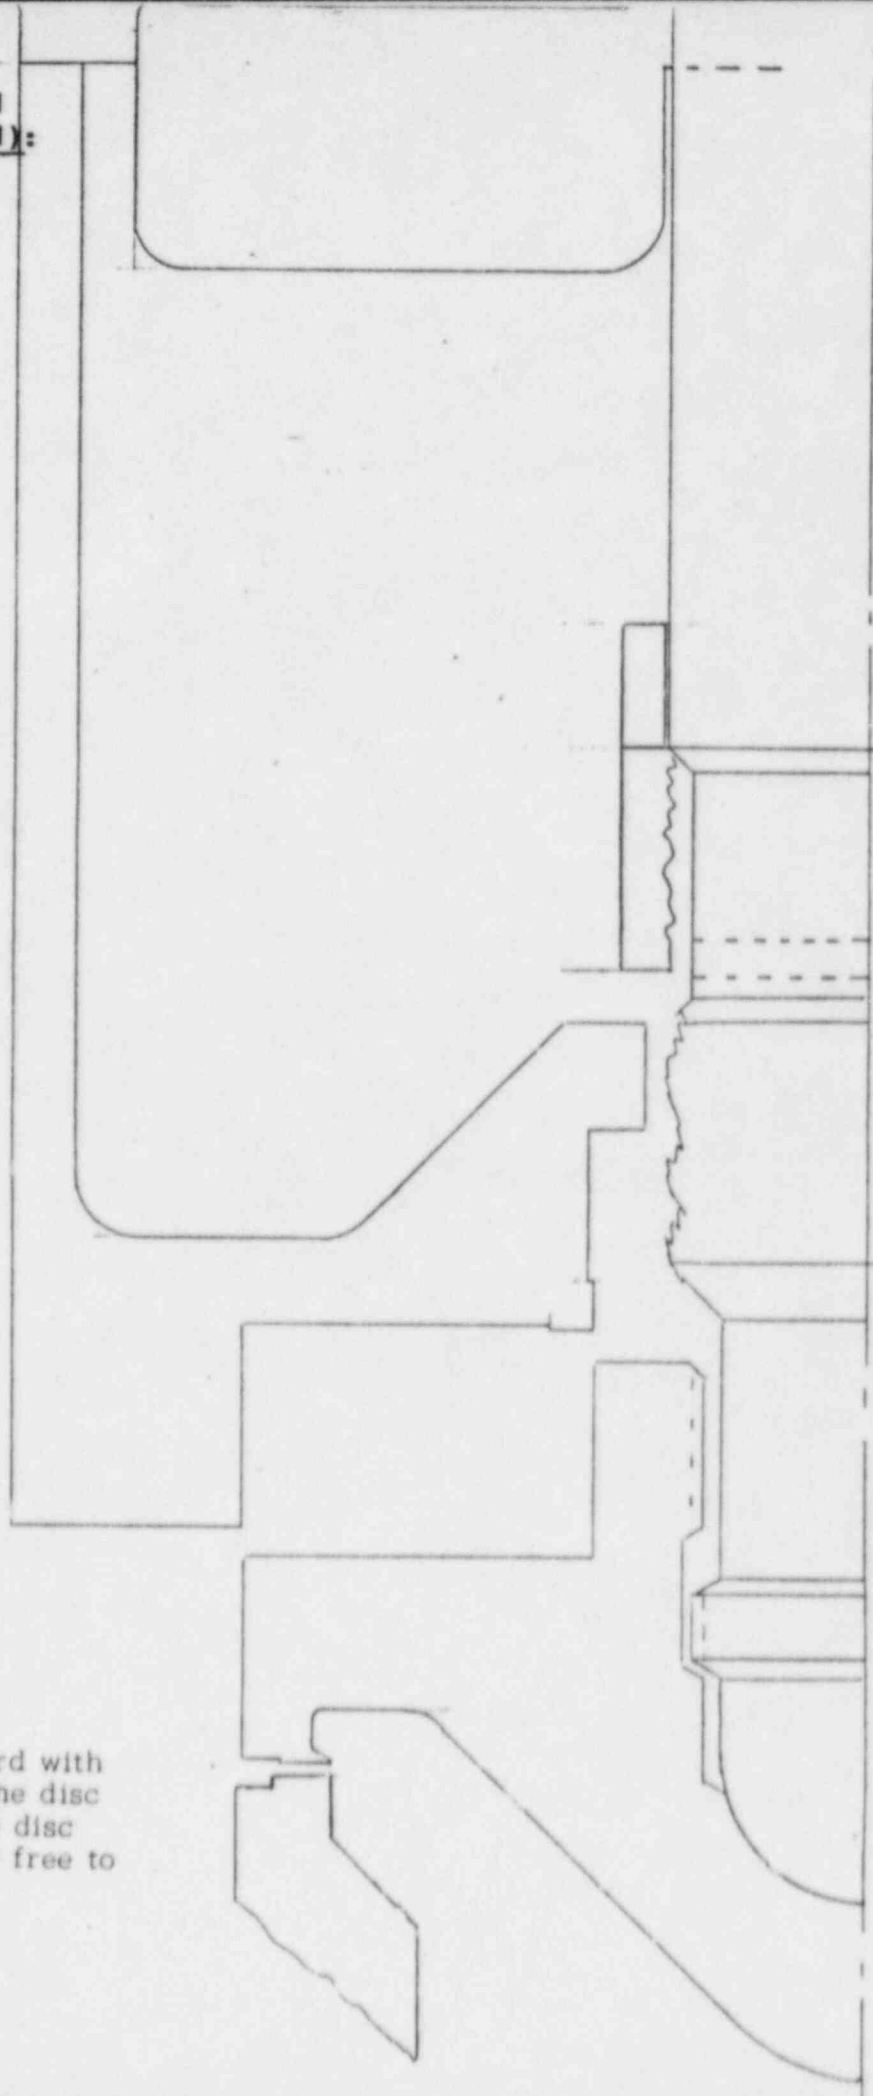
Figure 3 - Disc moves downward with the spindle out of the disc holder pocket. The disc and spindle are now free to deflect sideways.

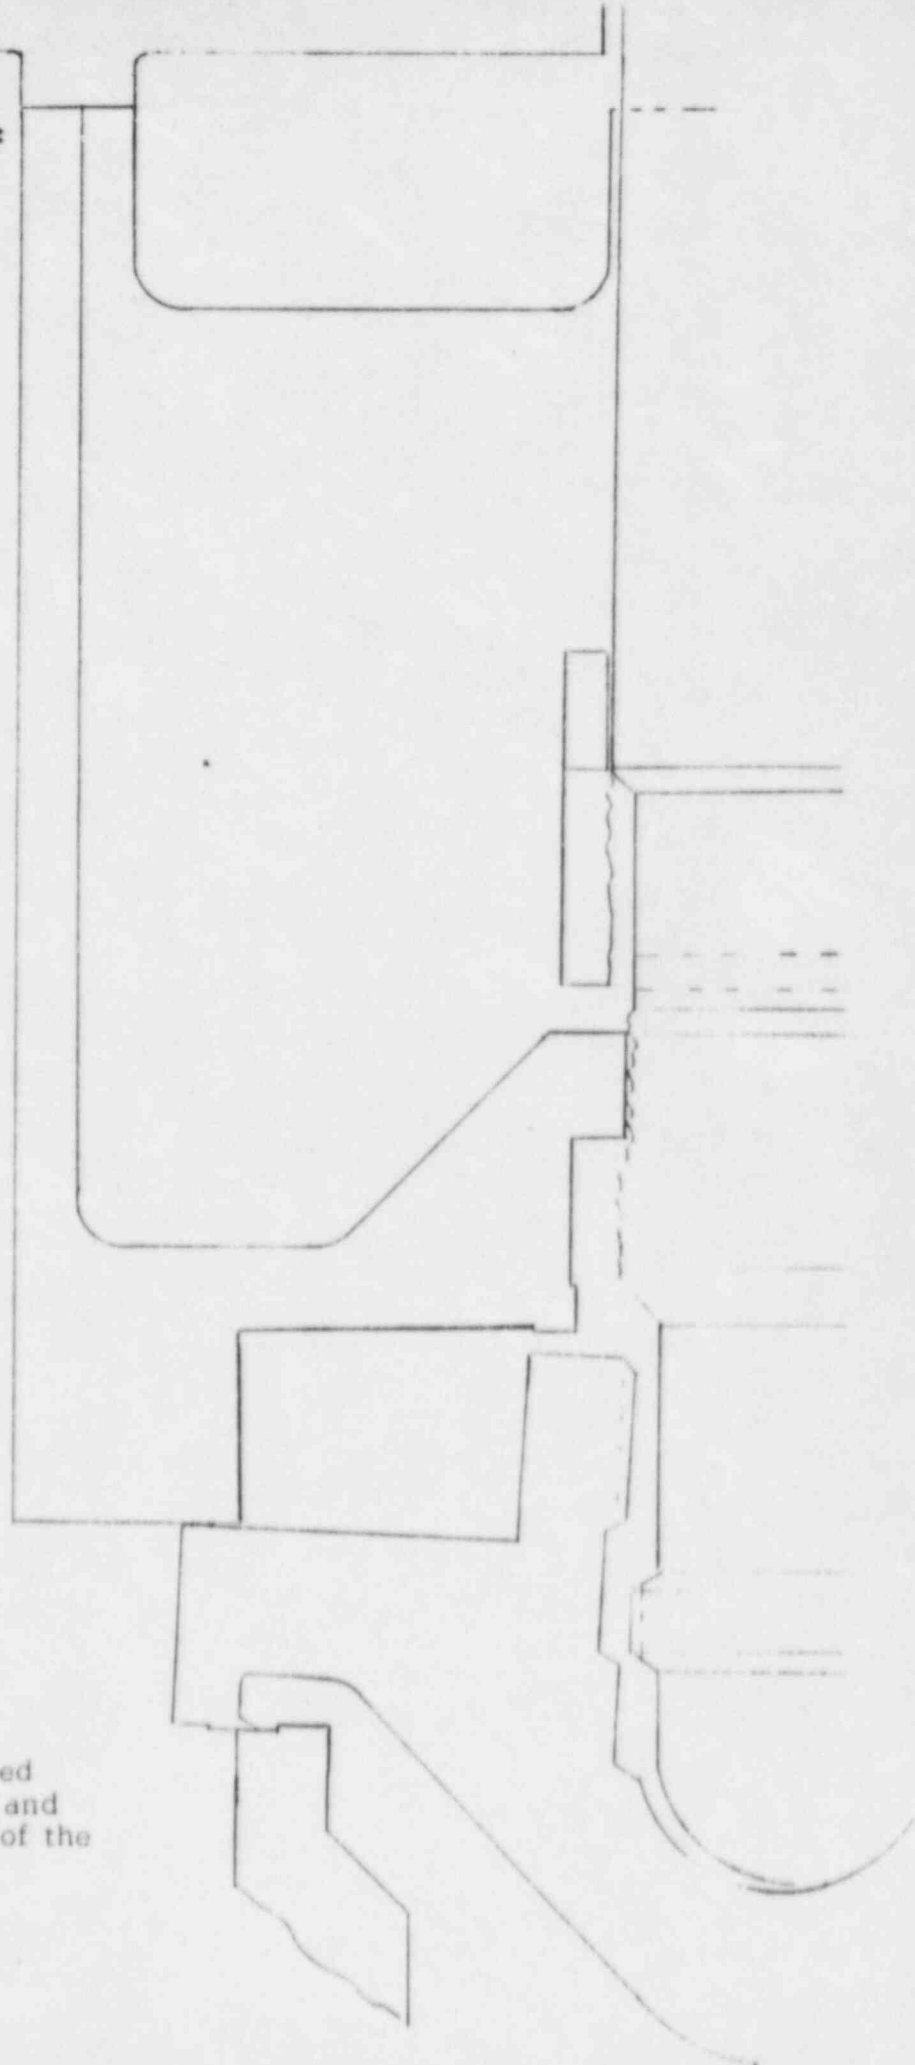
Figure 4 - Disc and spindle  
deflects sidewise.  
Disc becomes trapped  
between the nozzle and  
the bottom surface of the  
disc holder.

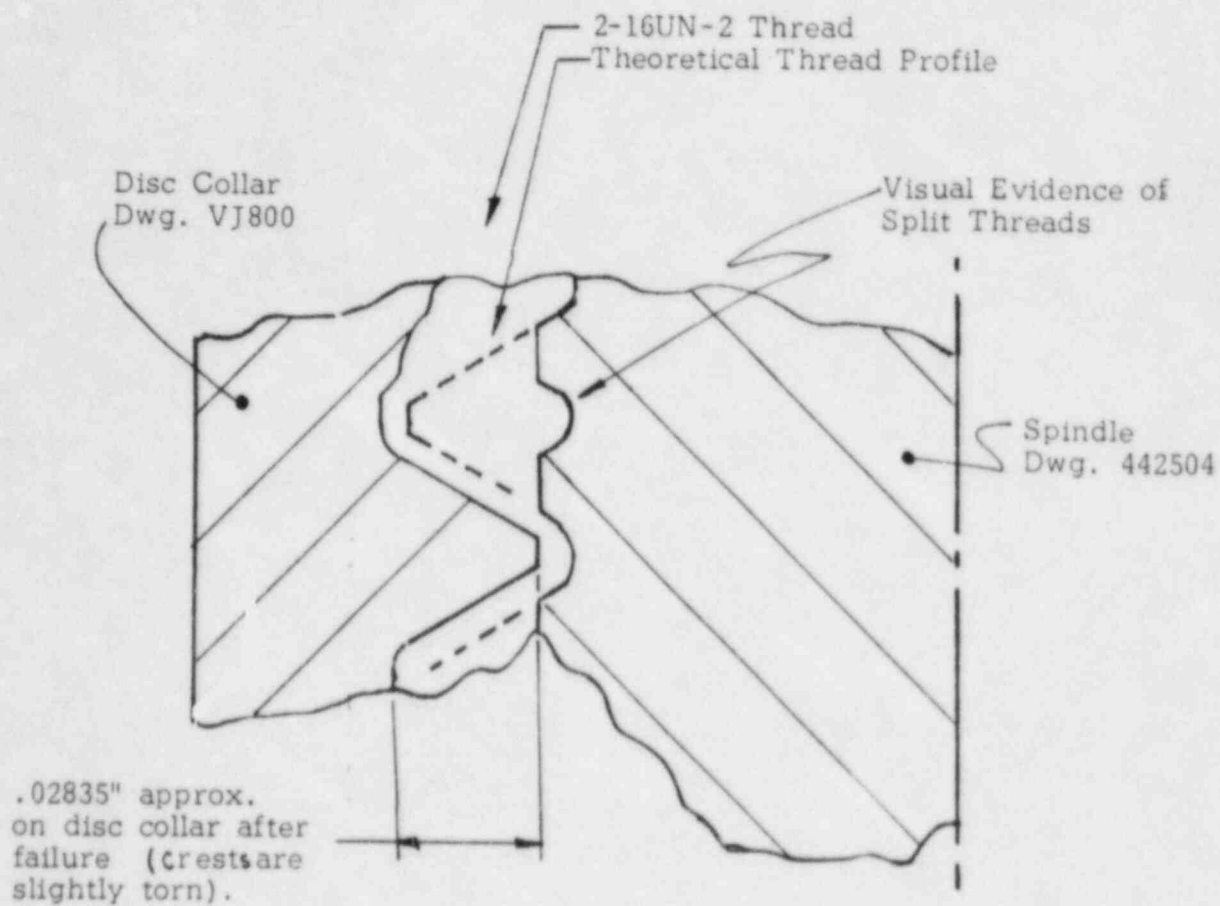
- 1.1 The failure of the disc collar/spindle threaded joint was due to defective (split) threads on the spindle (see Figure 5). This event is considered an isolated quality problem because all other valves shipped in the same time frame have been in service for many years without reported failure. The subject valve was manufactured in 1973 and placed in storage at site prior to testing at Wyle Laboratories.

- 1.5 Subsequent inspection following disassembly indicated that the threads on the spindle were defective (split threads) as manufactured by Dresser, so that proper thread engagement between the disc collar and spindle did not exist. The threads in the disc collar were acceptable. The split threads on the spindle were easily detectable by visual inspection. No other defects were noted during the inspection (see Figure 5).

Note 1: Height for the external thread per ANSI B1.1 is 0.027 to 0.032. Therefore, disc collar thread was correct as manufactured.

Figure 5 Disc Collar/Spindle Threads After Failure

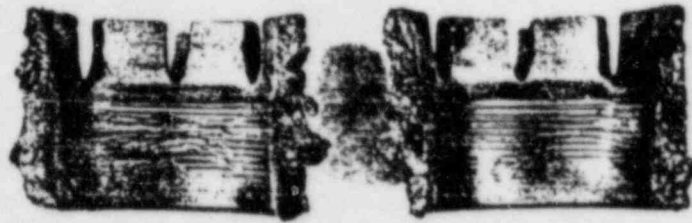
A lift stop collar, Figure 1, and a cotter pin, Figure 2, were submitted for metallurgical evaluation by Rolland Huffman. It was reported that when the valve was disassembled, the cotter pin pieces were found on top of the guide and that the collar had to be cut off of the spindle.

FIGURE 1  
Lift Stop Collar  
Exhibiting Thread Damage  
(Component Was Cut Off Spindle For Examination)

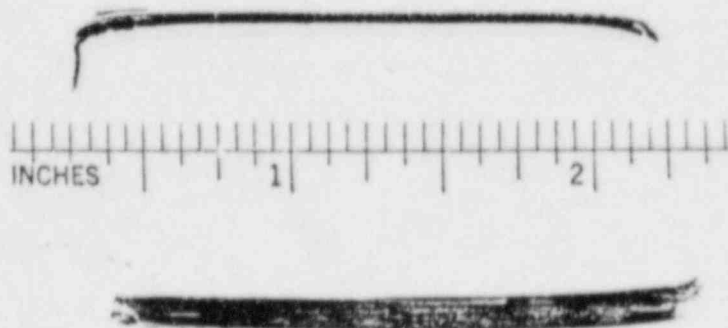
There is also evidence that the cotter pin was sheared off in the process of thread failure. The indications of this behavior are; a straight pin length equivalent to the stop collar I.D. and a marked "ironing" of one pin end. See Figures 2 & 5. The pieces of the pin were probably then "blown" onto the guide shelf by discharging media.

FIGURE 2  
Cotter Pin Pieces  
Pieces Were Found In Upper Recess Of Valve

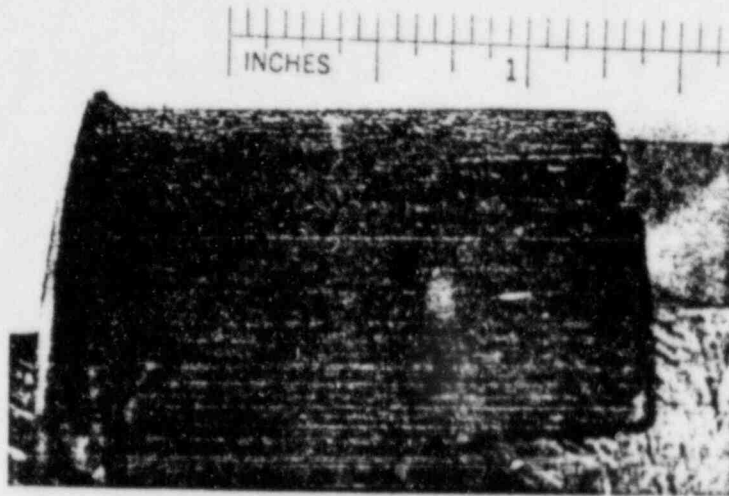
Figure 3 is a profile view of the lift stop collar. It was noted that the top portion of the collar has been flared outwards. This is indicative of numerous impacts of moderate to extreme magnitude.

FIGURE 3  
Lift Stop Collar Profile View  
Note "Flaring" On Left End  
Due To High, Repeated Loading

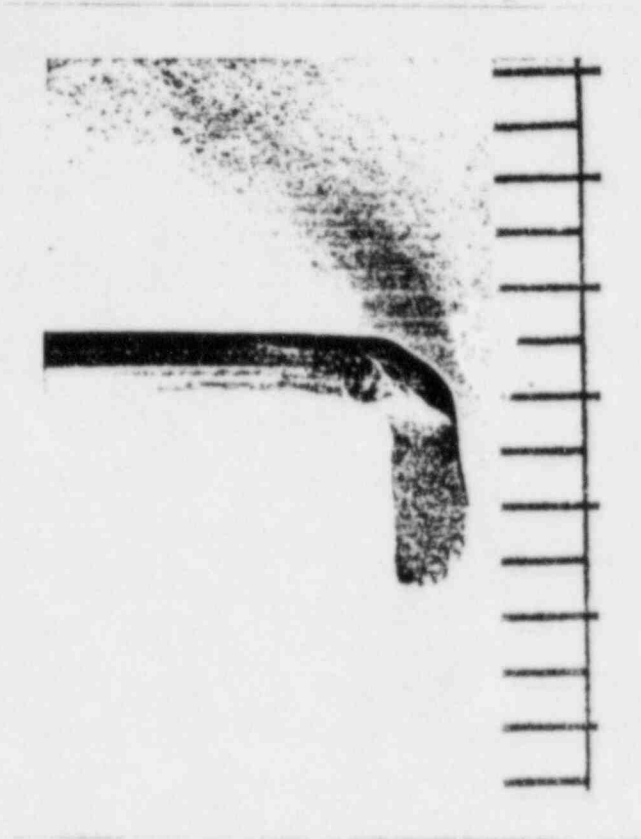
FIGURE 5  
Cotter Pin Segment  
Shows "Ironing" Effect Of  
Stripped Lift Stop Collar
