U.S. NUCLEAR REGULATORY COMMISSION
REGION I

Report Nos. 50-277/88-08
50-278/88-08

Facility Name: Peach Bottom Atomic Power Station, Units 2 and 3

Inspection Conducted: March 14-18, 1988

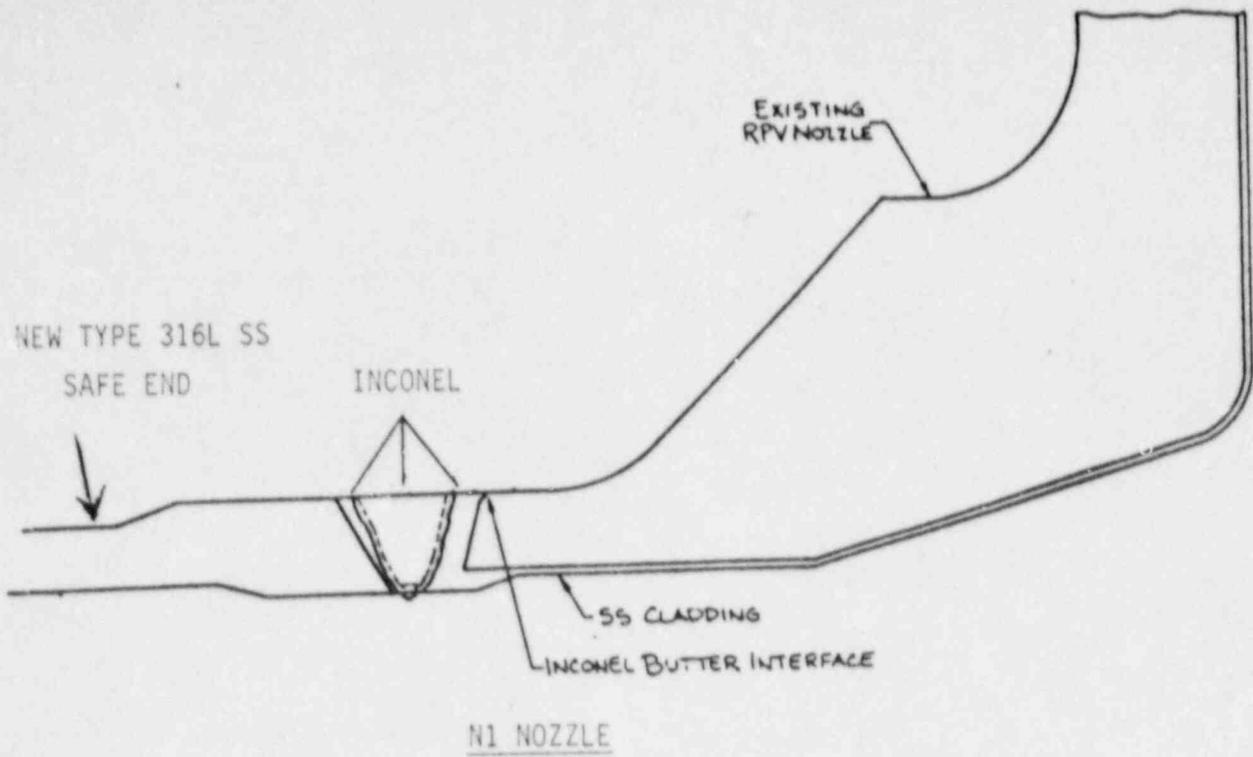
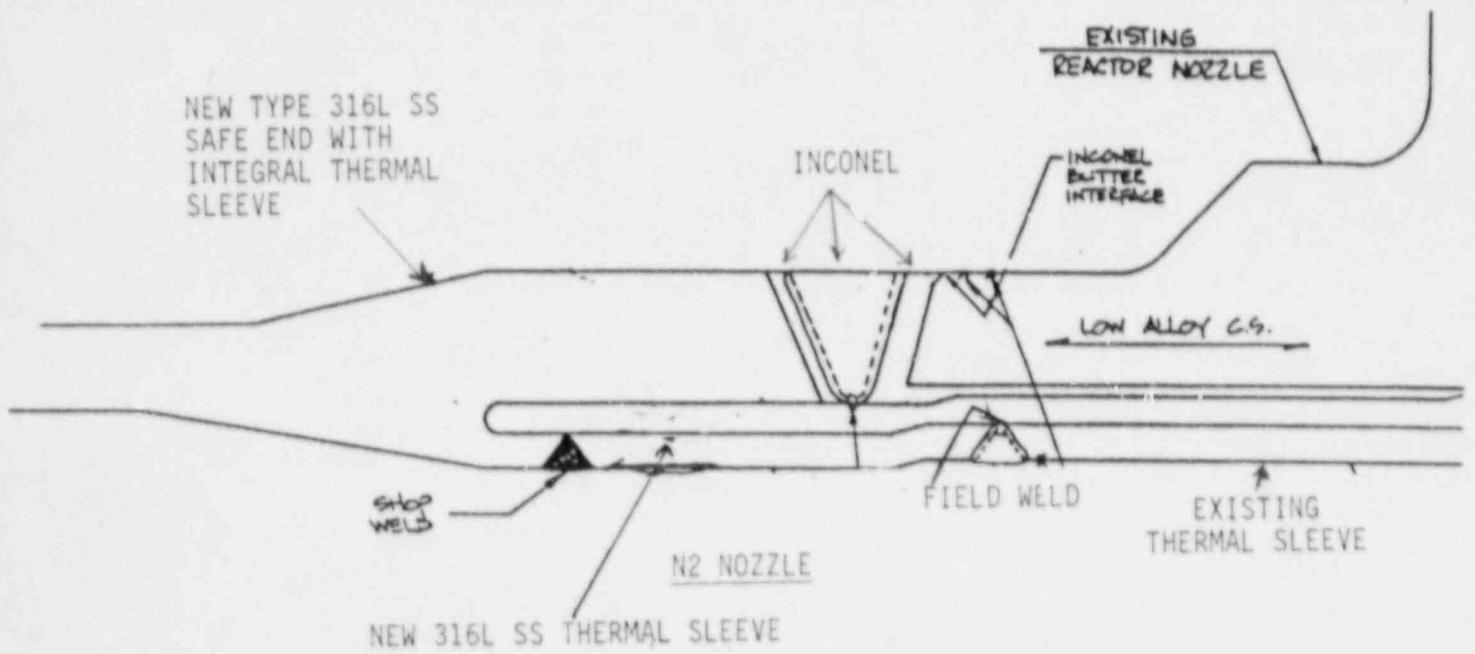
FIGURE 1 SHOWS N1 (OUTLET) + N2 (INLET) RECIRCULATION NOZZLES WITH NEW SAFE ENDS

welds in areas where the radiation dose rates are high to minimize personnel exposure. It is noted that the thermal sleeve extension was fabricated in the shop (Ametek) by welding it to an integral projection of the safe end (see "Shop Weld" in Figure 1). The integral thermal sleeve is a new design that avoids welding directly to the safe end and eliminates a crevice condition that has been found to be a site for IGSCC.

The licensee reported that prior to preparing for the installation of the new GE supplied N2 safe ends, a review of radiographs by the PECO Level 2 radiographer revealed unacceptable root conditions (lack of penetration and/or lack of fusion) in five of twelve thermal sleeve extension butt welds (figure #1). As noted previously, the safe ends were manufactured by Ametek, Straza Division, in 1985 under GE P.O. No. 205-854-142. The inspector reviewed the rejectable radiographs and confirmed the root indications, although in some cases the condition could be considered marginal and possibly related to root concavity. A review of the Ametek packages indicated that the radiographs had been reviewed by both GE and the Authorized Inspector. Even though the thermal sleeve welds are not pressure boundary welds, GE had imposed ASME III NB requirements. The rejected safe ends, identified as SN's 1414, 1415, 1417, 1418 and 1424, were returned to GE in Philadelphia for repair and reradiography along with safe ends 1411 and 1413 for which the Ametek radiographs were not located.

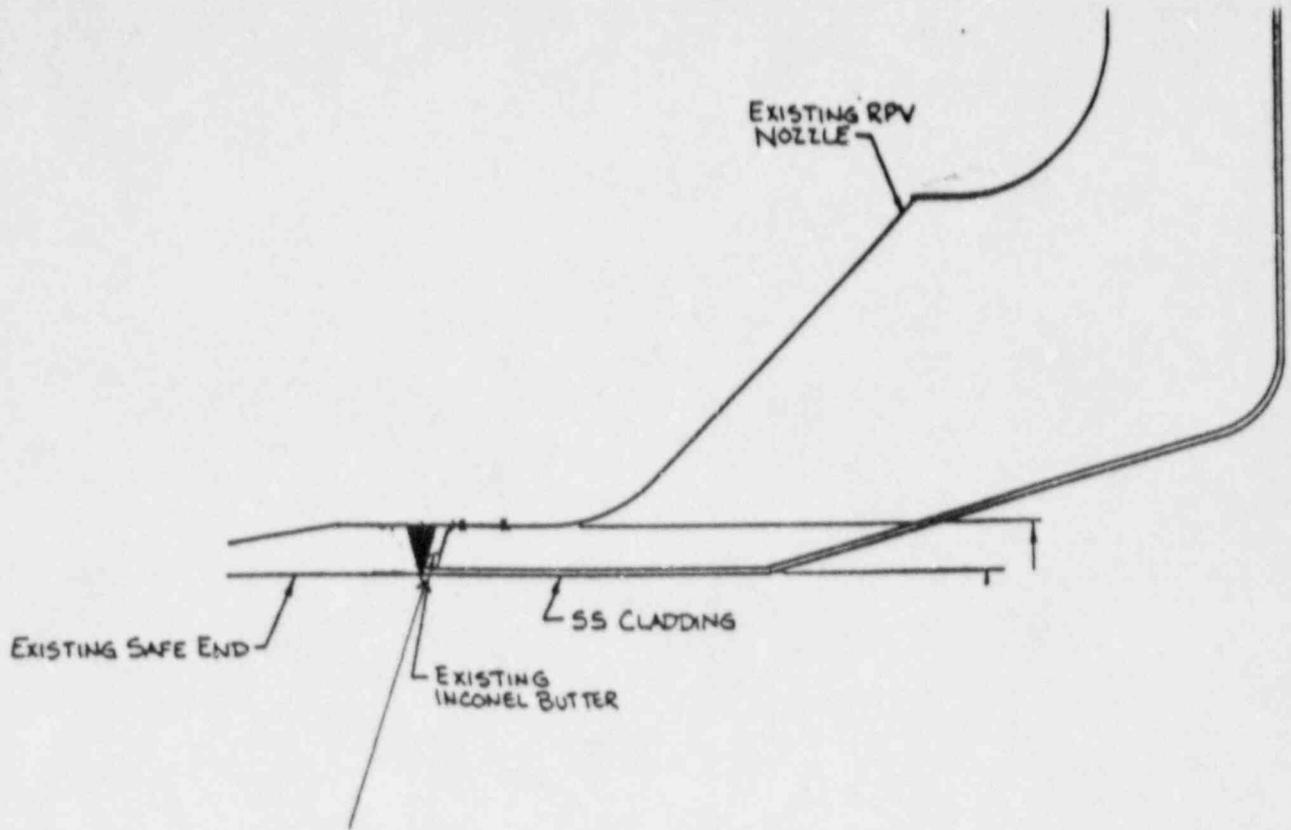
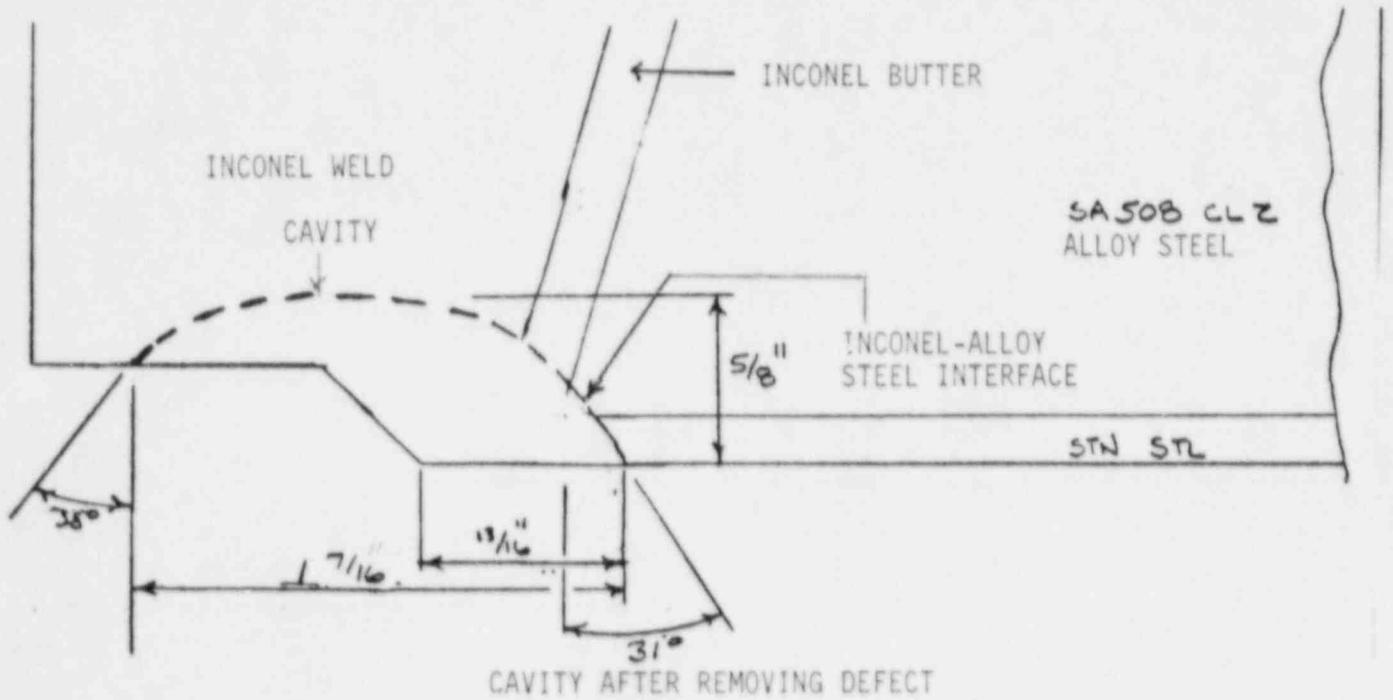
FIGURE 2 SHOWS DEFECT IN NOZZLE N1B

The inspector reviewed the proposed disposition of an axially oriented crack-like indication found in the existing N1B nozzle joint during the replacement of the safe end (see Figure 2). The defect which was revealed by visual, radiographic and liquid penetrant inspection was located on the I.D. surface at the 4 o'clock position. The defect traversed both the RV nozzle to safe end weld and the adjoining nozzle butter. Both the nozzle weld and butter were made of Inconel (alloy 182) weld deposited metal. The defect which was determined to be .287" long was completely removed after grinding to a depth of 5/8". The inspector confirmed the location and physical dimensions of the cavity by visual examination. The cavity was subsequently enlarged to provide 31° and 38° bevels for welding accessibility. The cavity as prepared for weld repair extended into the 308 stainless nozzle cladding and terminated at the interface of the adjoining SA 508 Class 2 alloy steel (Ni-Mn-Mo) nozzle as shown by etching.

The inspector verified that the proposed weld repair procedure and the associated Work Package conformed to the procedural and qualification requirements of ASME XI, Article IEB 4000. The latter included both bend and impact testing and special welder training. The weld repair was initiated on March 16, 1987 and completed on March 17, 1987. The traveler indicated that the repaired area will be subject to liquid penetrant, radiographic and ultrasonic inspection 48 hours after the repair is completed. It should be noted that the repair procedure qualification test assembly is far more conservative than the actual repair. The former consisted of a 1" deep cavity in a 6" thick alloy steel test assembly compared to the condition in the nozzle in which the cavity just barely penetrated the base metal at the nozzle/cladding interface. It should

also be noted at this time that of the twelve recirculation nozzles (2-N1s and 10 N2s) being refurbished, only one nozzle (N1B) has been found to exhibit any significant indications in the existing nozzle Inconel (182) butter; thus, permitting use of the existing weld butter in the installation of the new safe ends without complete removal and rebuttering of the existing RV nozzles.

LOCATION OF DEFECT - DEFECT LOCATED ON ID SURFACE AND ORIENTED IN AXIAL DIRECTION. SEE ENLARGED VIEW BELOW AFTER REMOVAL AND PREPARATION FOR WELD REPAIR.

The inspector reviewed the proposed Weld Repair Procedure E182 HBR and found it to agree with the temper bead repair technique provided by ASME XI - Article IEB 4000. The procedure employs the manual metal arc process with the half bead technique (removal of 1/2 of the first deposited layer prior to depositing the second layer), a 300°F preheat, and a low temperature (500°F) stress relief after welding. The electrode used for the repair in this instance is Inconel 182 which is compatible with the existing materials, i.e., Inconel weld and butter, type 308 cladding and (Ni-Mn-Mo) alloy steel. The preheat and stress relief are intended to protect the alloy steel nozzle. The preheat removes hydrogen and retards the formation of brittle martensite. The stress relief provides a tempering (softening) effect if martensite were to form.
