LICENSEE EVENT REPORT (LER)

FACILITY NAME (1) Peach Bottom Atomic Power Station - Unit 2 DOCKET NUMBER (2) 0 5 0 0 0 2 7 7 1 OF 0 19 PAGE (3)

TITLE (4) Failure of Capacitors Associated with the #1 Bus Tie Line 'A' Phase Potential Transformer due to Normal Wear which Resulted in a Voltage Disturbance and ESF Actuations

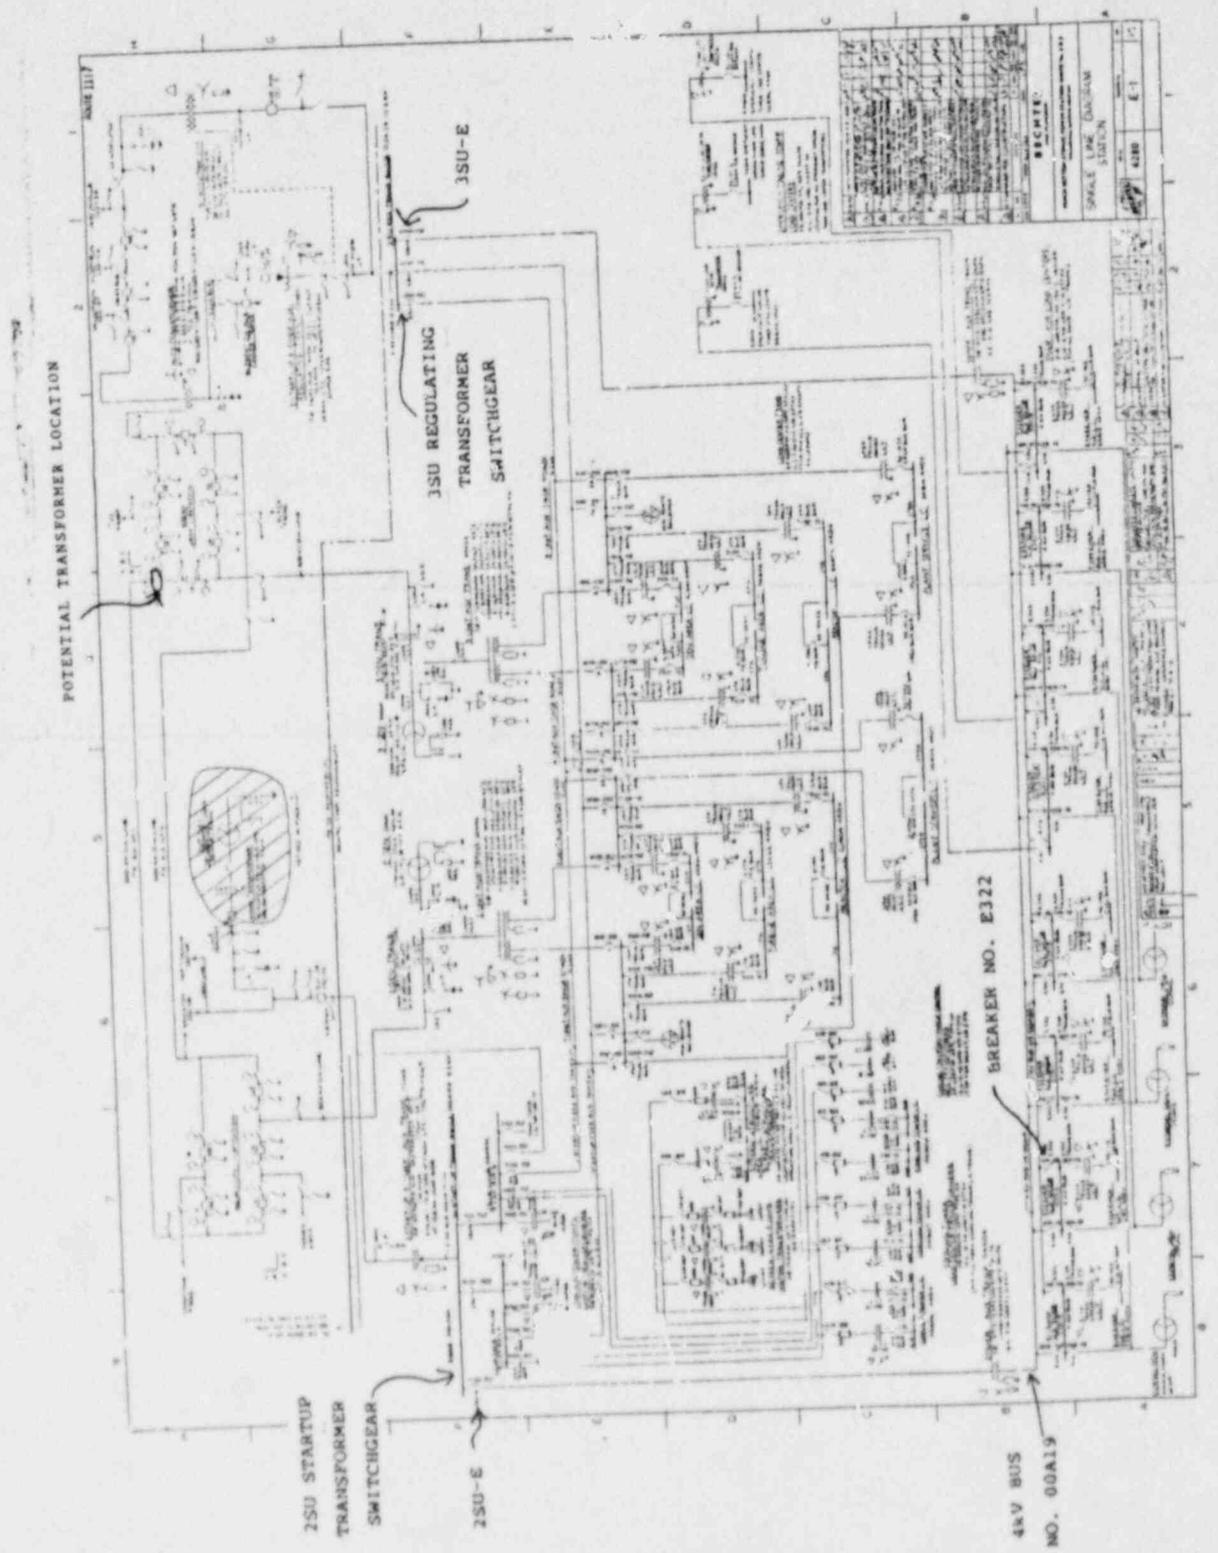
At the time of the event, the 13kV Buses were being fed from the 2SU Startup Transformer Switchgear through the #1 Startup Feed Bus (See attached PBAPS single line diagram, E-1). The 4kV Buses were being fed from the 3SU Regulating Transformer Switchgear through breaker 3SU-E. The first indications of the event in the Control Room were a North Substation general alarm annunciator and a 5007 line transfer trip low signal alarm on the substation breaker supervisory console which occurred at 1858 hours. Additionally, the Control Room received a report of a fire at the North Substation. Plant personnel were dispatched to the North Substation to investigate. The 15 and 25 ring bus breakers at the North Substation and 205 and 235 ring bus breakers at the South Substation tripped, isolating the #1 bus tie line and the Potential Transformer. The voltage disturbance caused the 4kV emergency bus undervoltage relays to trip their respective feeder breakers, except for the E322 breaker which did not trip. Due to the loss of power at the 4kV Buses, a fast transfer of power to the 2SU Startup Transformer Switchgear under normal circumstances should have occurred; however, the 4kV Bus (No. 00A19) was blocked due to maintenance by opening breaker 2SU-E. Therefore, the E-1 and E-3 Diesel Generators (DG) auto-started on 4kV Bus undervoltage.
