Closeout of IE Bulletin 83-08: Electrical Circuit Breakers With an Undervoltage Trip Feature in Use in Safety-Related Applications Other Than the Reactor Trip System

PARAMETER, Inc.

Prepared for
U.S. Nuclear Regulatory
Commission

Manuscript Completed: February 1988
Date Published: April 1988

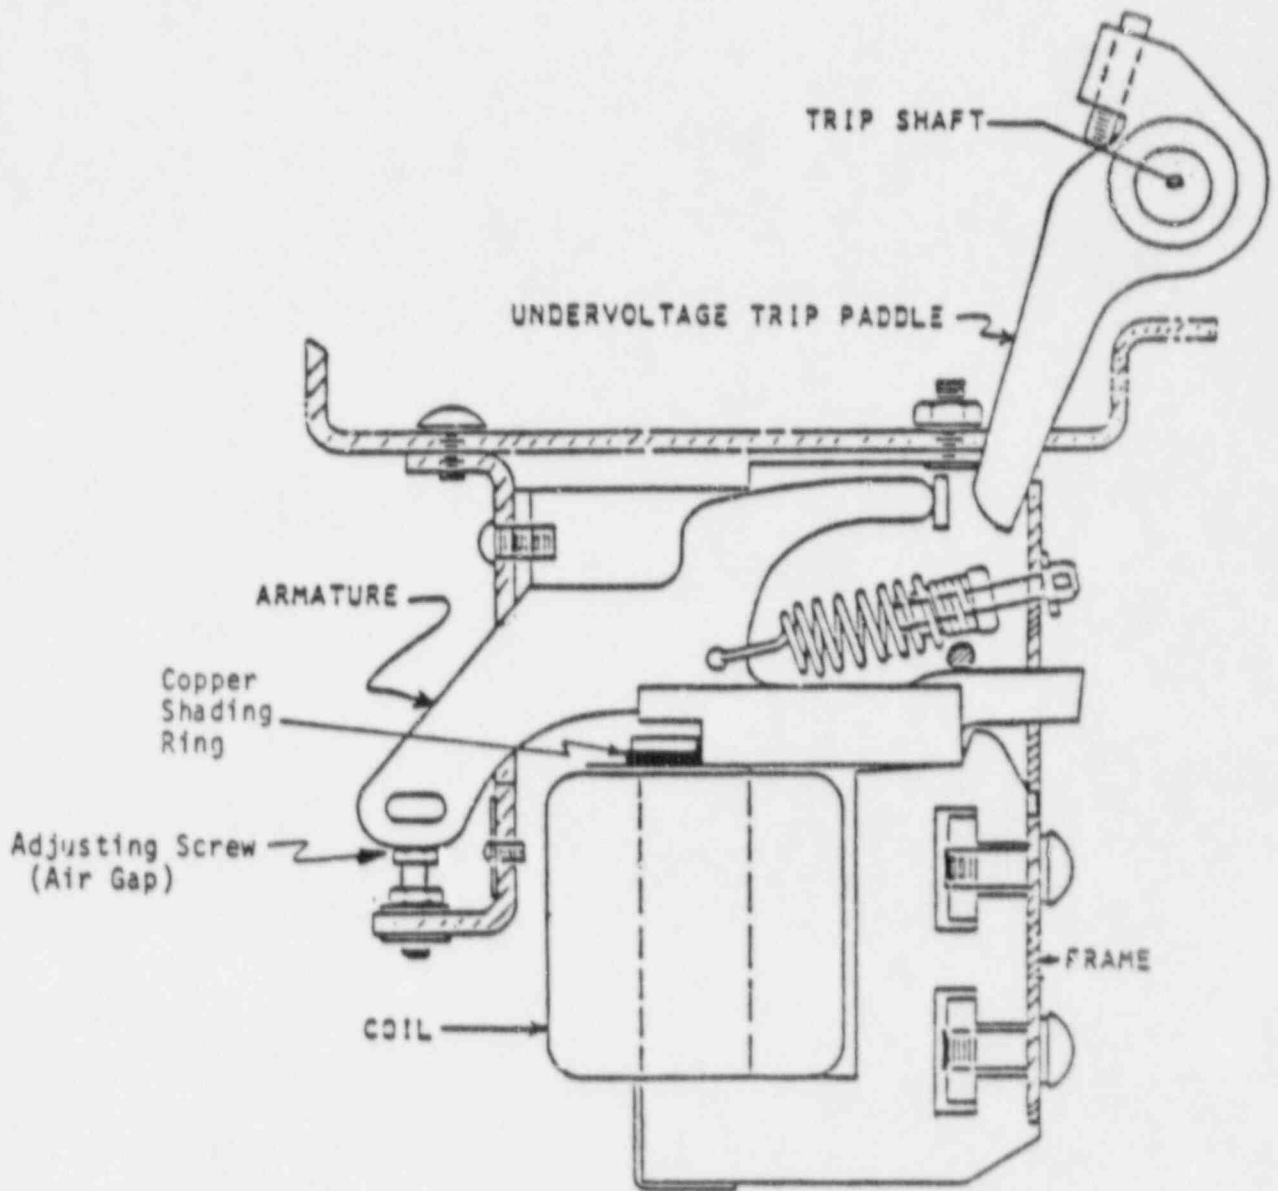
On October 31, 1983, with both Units 2 and 3 in Mode 1 (Power Operation), the positions of all the undervoltage armatures of the RTBs were visually inspected. This inspection revealed that undervoltage armatures of RTB #4 on Unit 2 and RTBs #5 and #8 on Unit 3 were not properly positioned. It has been established that the Unit 3 breakers had been tripped and reset subsequent to the October 28, 1983 event without further UV armature position verification. These RTBs were reset, observed to operate properly and the undervoltage armatures remained properly positioned.

Southern California Edison Company, the licensee, has indicated that these malfunctions (i.e., the undervoltage armature in midposition rather than in contact with the air gap adjusting screw) could result in the RTB failing to trip within the specified criteria of the undervoltage trip device. Southern California Edison Company's preliminary conclusion is that the undervoltage armature can remain in a midposition as a result of interference (vertical)

Figure 1. Undervoltage Trip Device, Coil Energized Position

No action or written response to this notice is required; however, licensees using AK-2 type breakers with undervoltage trip devices may find it prudent to visually inspect each undervoltage armature to assure it is in its proper position after each operation. If the UV armature were to be found in an improper position, the NRC would consider the RTB to be inoperable. If you have any questions regarding this notice, please contact the Regional Administrator of the appropriate NRC Regional Office, or a Technical Contact listed below.
