DESCRIPTION AND RESOLUTION OF ISSUES REGARDING
THE DECEMBER 26, 1985 REACTOR TRIP

Prepared by the Staff
of the

SACRAMENTO MUNICIPAL UTILITY DISTRICT

February 19, 1986

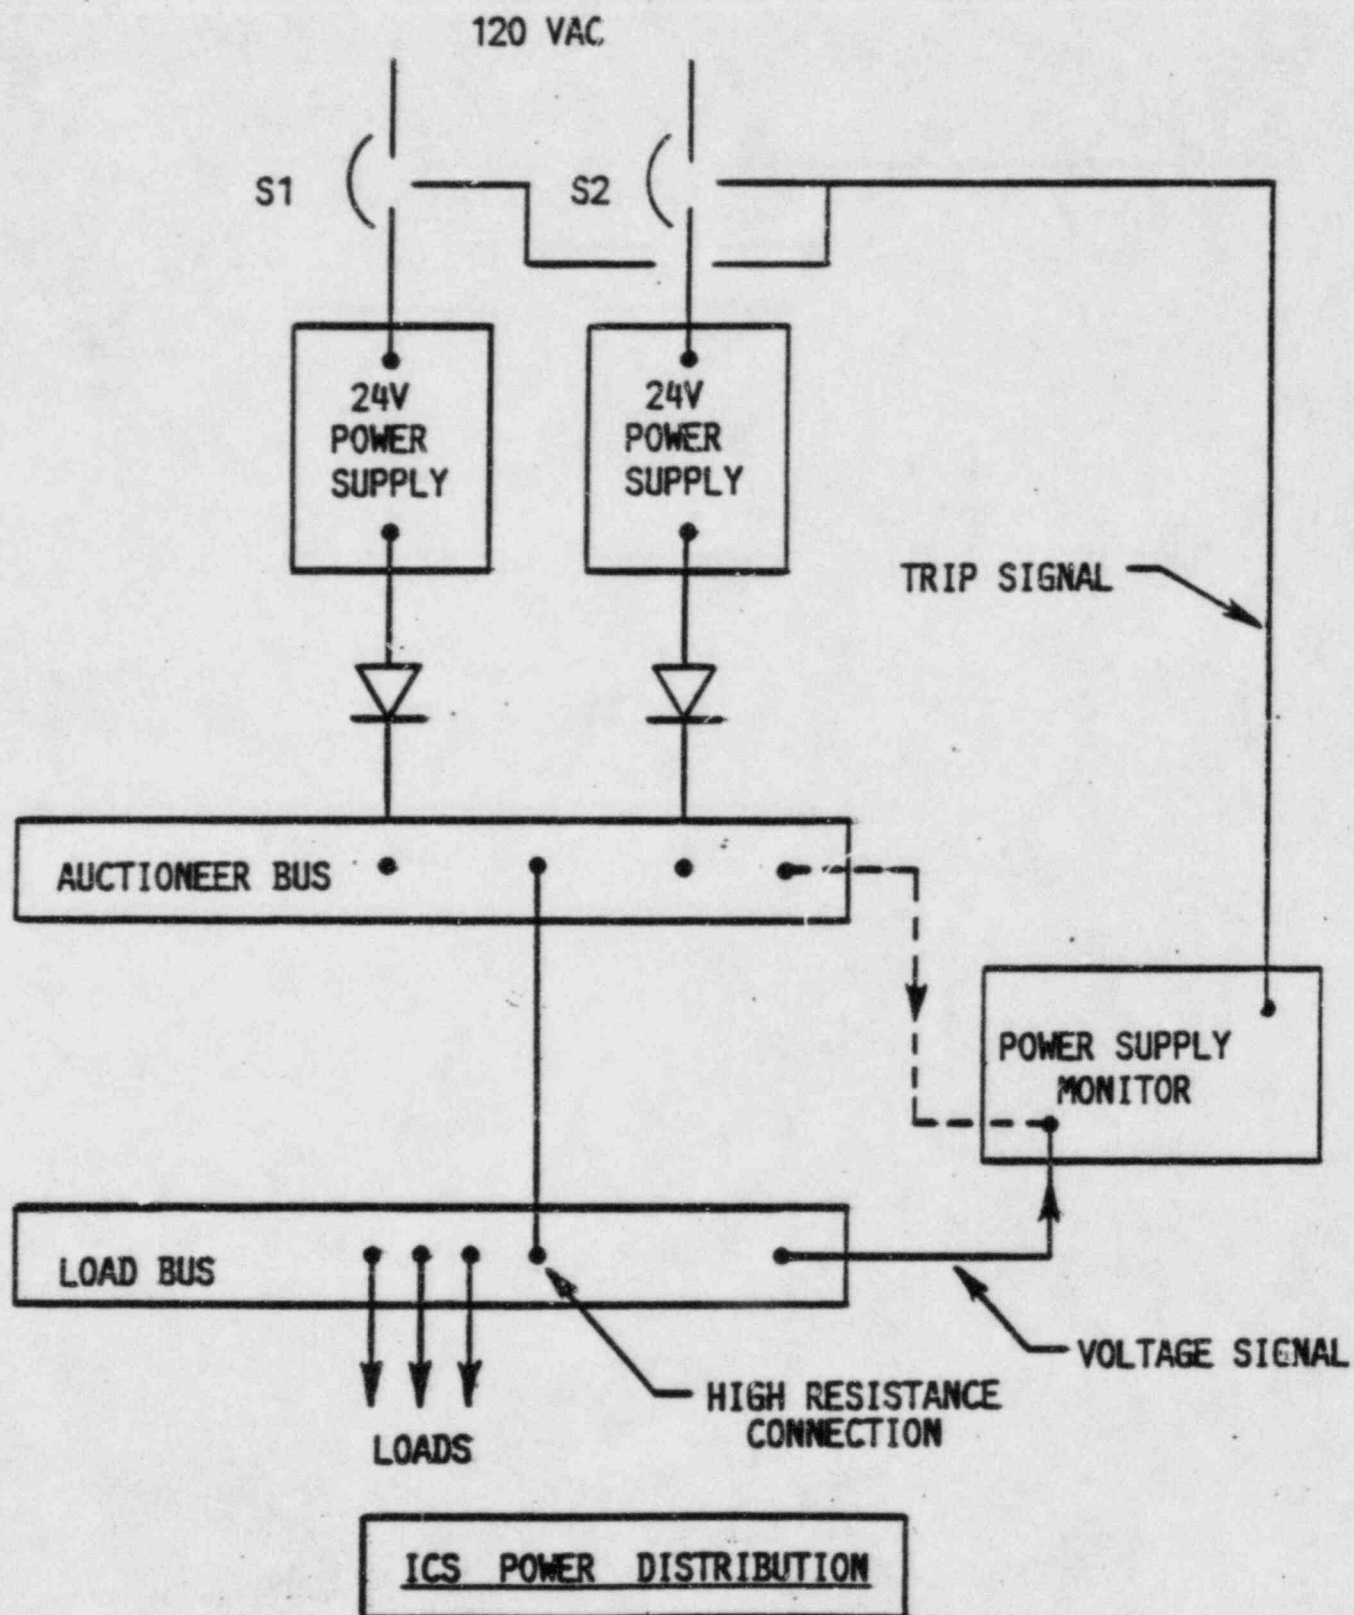
ICS POWER SUPPLIES AND DISTRIBUTION

Early studies of the potential causes of the loss of ICS DC power clearly eliminated the independent and redundant supply sources of 120v. AC, single phase, 60 Hertz, power as being involved. These studies looked at the performance of other equipment powered by these sources and how that equipment performed during the event. In addition, the Automatic Bus Transfer switch did not shift, meaning that its normal positioning to the vital bus had not been changed; hence, there had been no interruption in the normal supply from the vital bus. Attachment 8 schematically shows the ICS Power Supplies and Distribution.

The root cause for the loss of ICS event has been identified as the loose power connection on the bus ICS Cabinet 1 supplying power to the PSM. The factory bus wiring has subsequently been replaced with current standard wiring. Investigations into the PSM and its sensitivity to input resistance are continuing, although this will be pursued as a B&W Owners Group issue.

- Making ICS DC Power more reliable.
 - Enhancing ability to mitigate Loss of ICS Power transients from Control Room.
- .1 Within the ICS itself, the rewiring will ensure that system components receive full electrical power, and the PSM is being separately wired directly to the ICS Power Auctioneer Panel ± 24 VDC buses it monitors. Failures as occurred on December 26 will be eliminated.
