DONALD C. COOK NUCLEAR PLANT
SAFETY SYSTEM FUNCTIONAL INSPECTION
Auxiliary Feedwater System

American Electric Power Service Corporation
Indiana & Michigan Electric Company
One Riverside Plaza
Columbus, Ohio 43216-6631

WESTEC Services, Inc.
2260 Butler Pike
Plymouth Meeting, PA 19462-1412

October 5, 1987

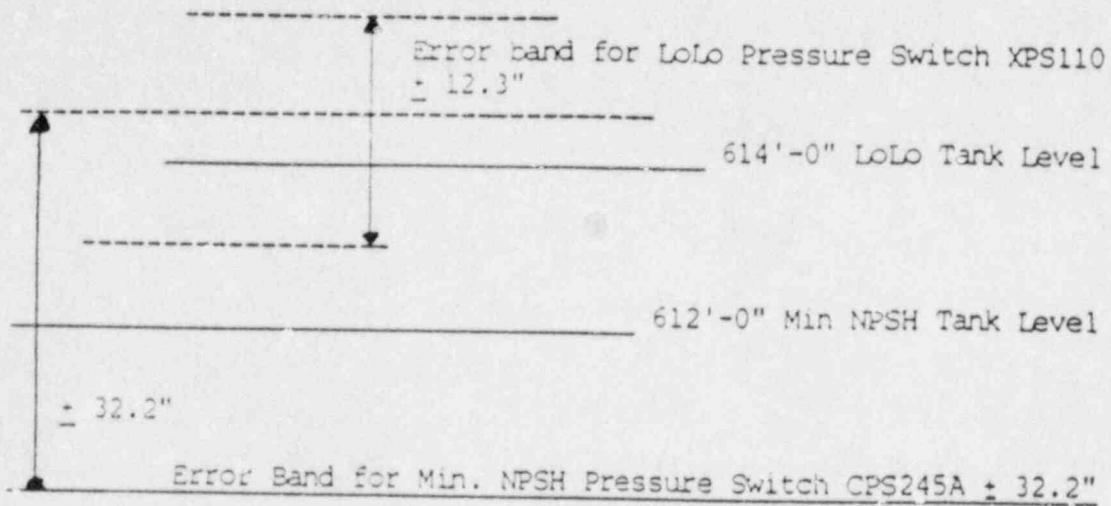
SKETCH 1
CONDENSATE STORAGE TANK
ERROR BAND BETWEEN LOW-LOW TANK LEVEL AND MIN. NPSH

If the minimum NPSH activates at 609'-3.8", the 3 auxiliary feed pumps could run dry and be damaged. They would not be available to provide auxiliary feed water.

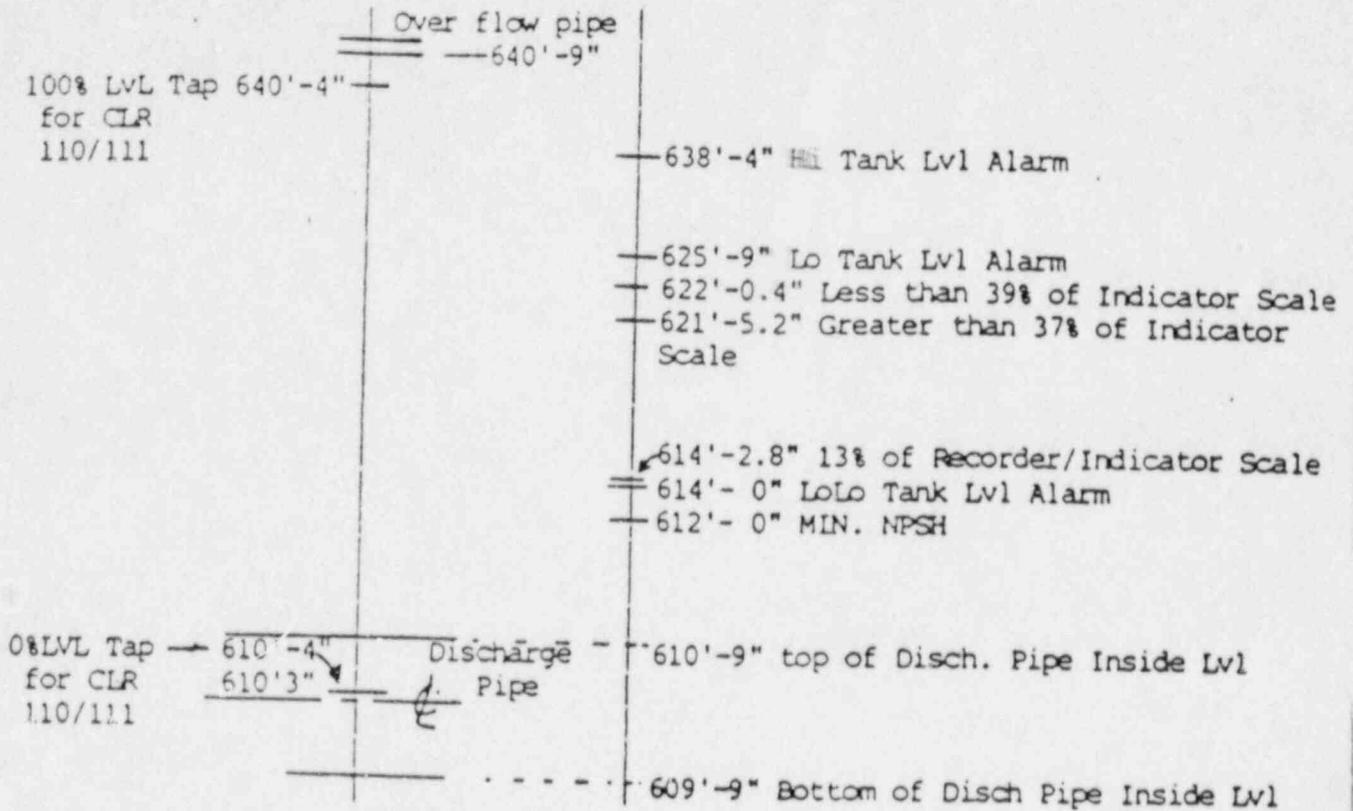
SKETCH 1
CONDENSATE STORAGE TANK
LEVEL MONITORING

than 175,000 gallons of water to ensure 9 hours supply of water for the CST at hot shutdown conditions. The requirements of the CST Level should be reviewed and revised. All documents related to the CST Level should be changed to agree with the actual needs.

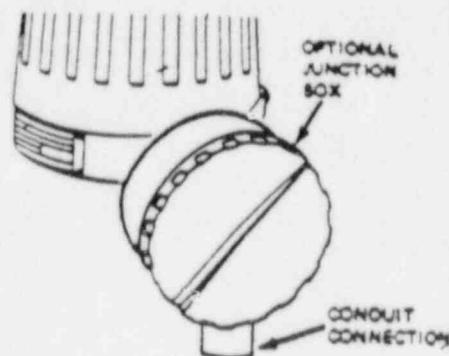
DISCUSSION: Optional flow transmitter junction boxes for flow indicators FFI 220 and FFI 230 are not installed in accordance with Foxboro requirements to maintain qualification. The flow transmitters are Foxboro Series NE13 DM MI H1. The vendor instruction manual (Vendor Information Control No. P-0585-023-N dated 6/17/85) for N-E11 and N-E13 series transmitters states that these devices can be equipped with an optional junction box which must be mounted with the conduit connection facing downward. Contrary to this installation requirement the optional junction boxes are installed with the conduit connection facing upward for FFI 220 and FFI 230. The correct configuration is shown below.

The current installation invalidates the equipment qualification of the flow transmitters. The concern is water egress into the internals of the transmitter. This observation suggests a potential weakness in the installation procedures used to install safety related environmentally qualified equipment.

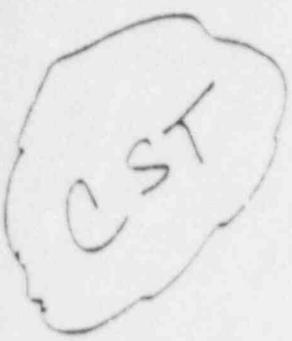
CST
LO
LEVEL } 625' 9"

TOTAL INSTRUMENT
LOOP ERROR
-- ± 7.8"

CST
LO-LO
LEVEL

614'
