SYSTEMATIC ASSESSMENT OF LICENSEE PERFORMANCE
INSPECTION REPORT 50-293/85-99

BOSTON EDISON COMPANY

PILGRIM NUCLEAR POWER STATION

ASSESSMENT PERIOD: OCTOBER 1, 1984 - OCTOBER 31, 1985

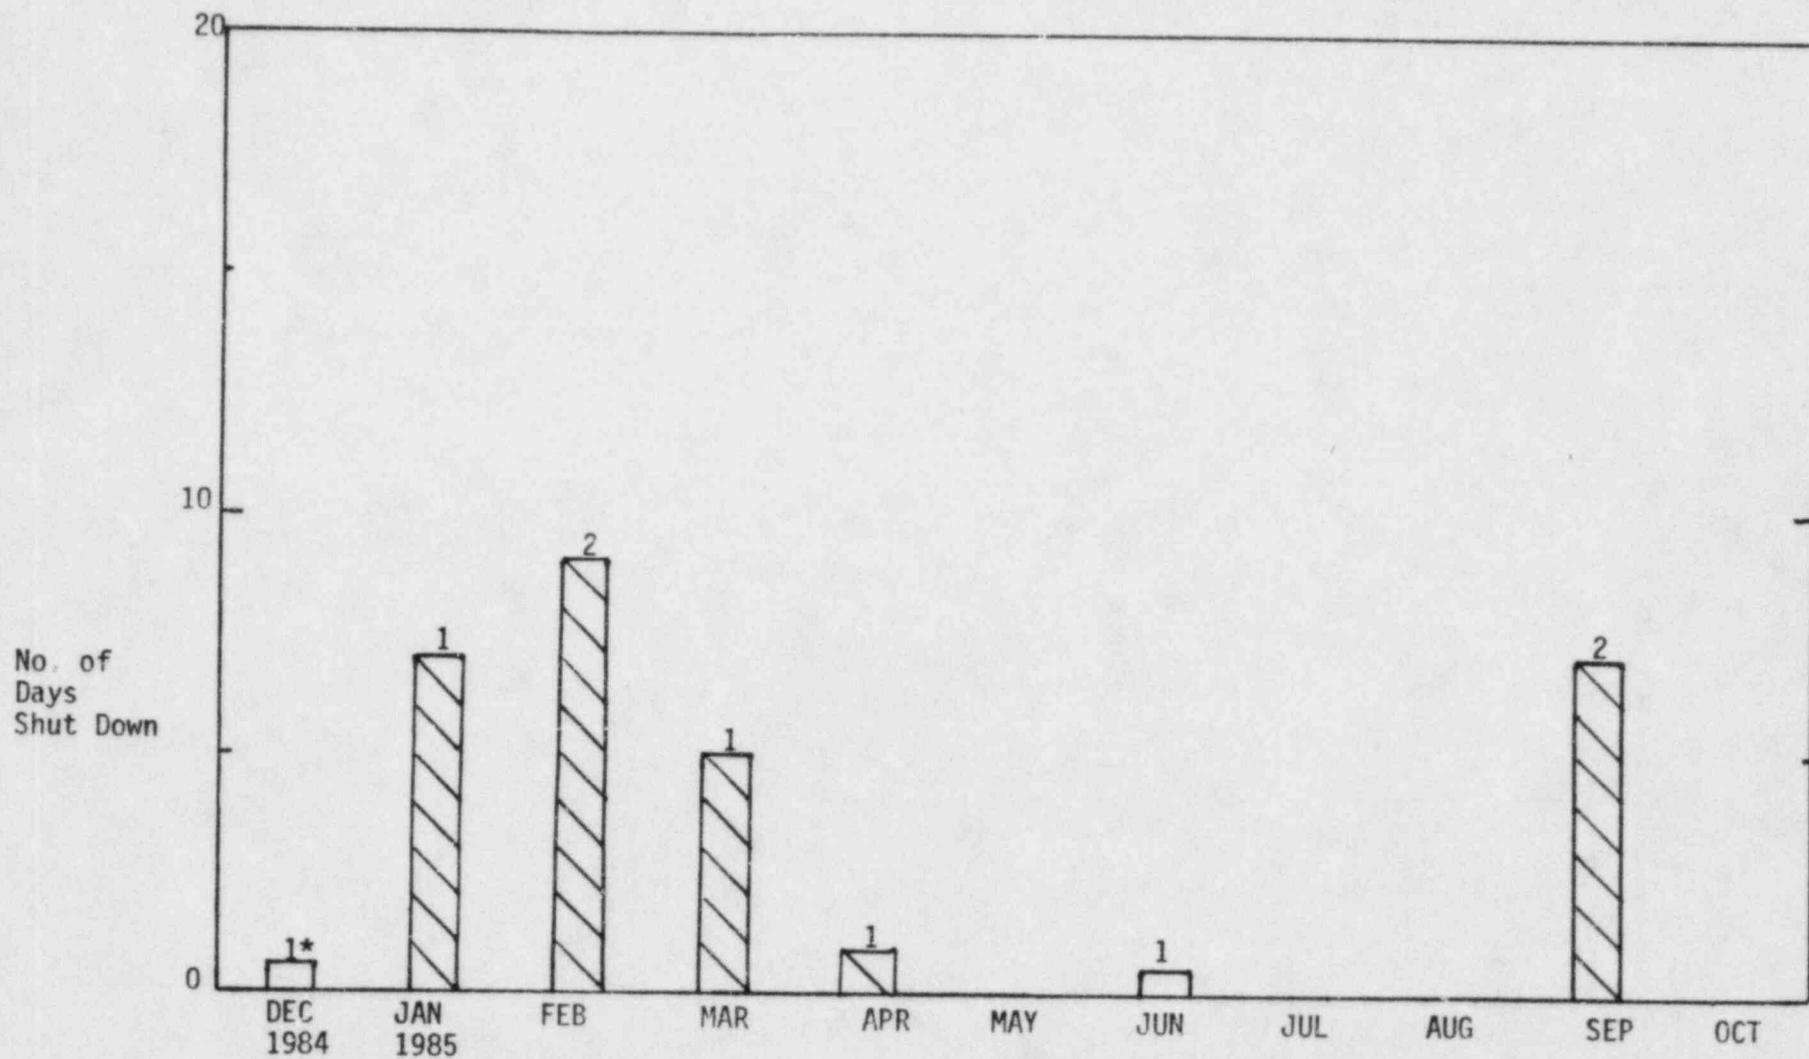
FIGURE 1. Pilgrim Unplanned Reactor Shut Downs

*Number of shut downs per month. The recirculation pipe replacement outage ended on December 24, 1984.
