LICENSEE EVENT REPORT (LER)

FACILITY NAME (1) THREE MILE ISLAND, UNIT 1		DOCKET NUMBER (2) 05000289	PAGE (3) 1 OF 9
--	--	-------------------------------	--------------------

TITLE (4)
POTENTIAL LOSS OF HIGH PRESSURE INJECTION DURING POSTULATED LOSS OF COOLANT ACCIDENT DUE TO MISAPPLICATION OR INTERPRETATION OF DESIGN INPUTS

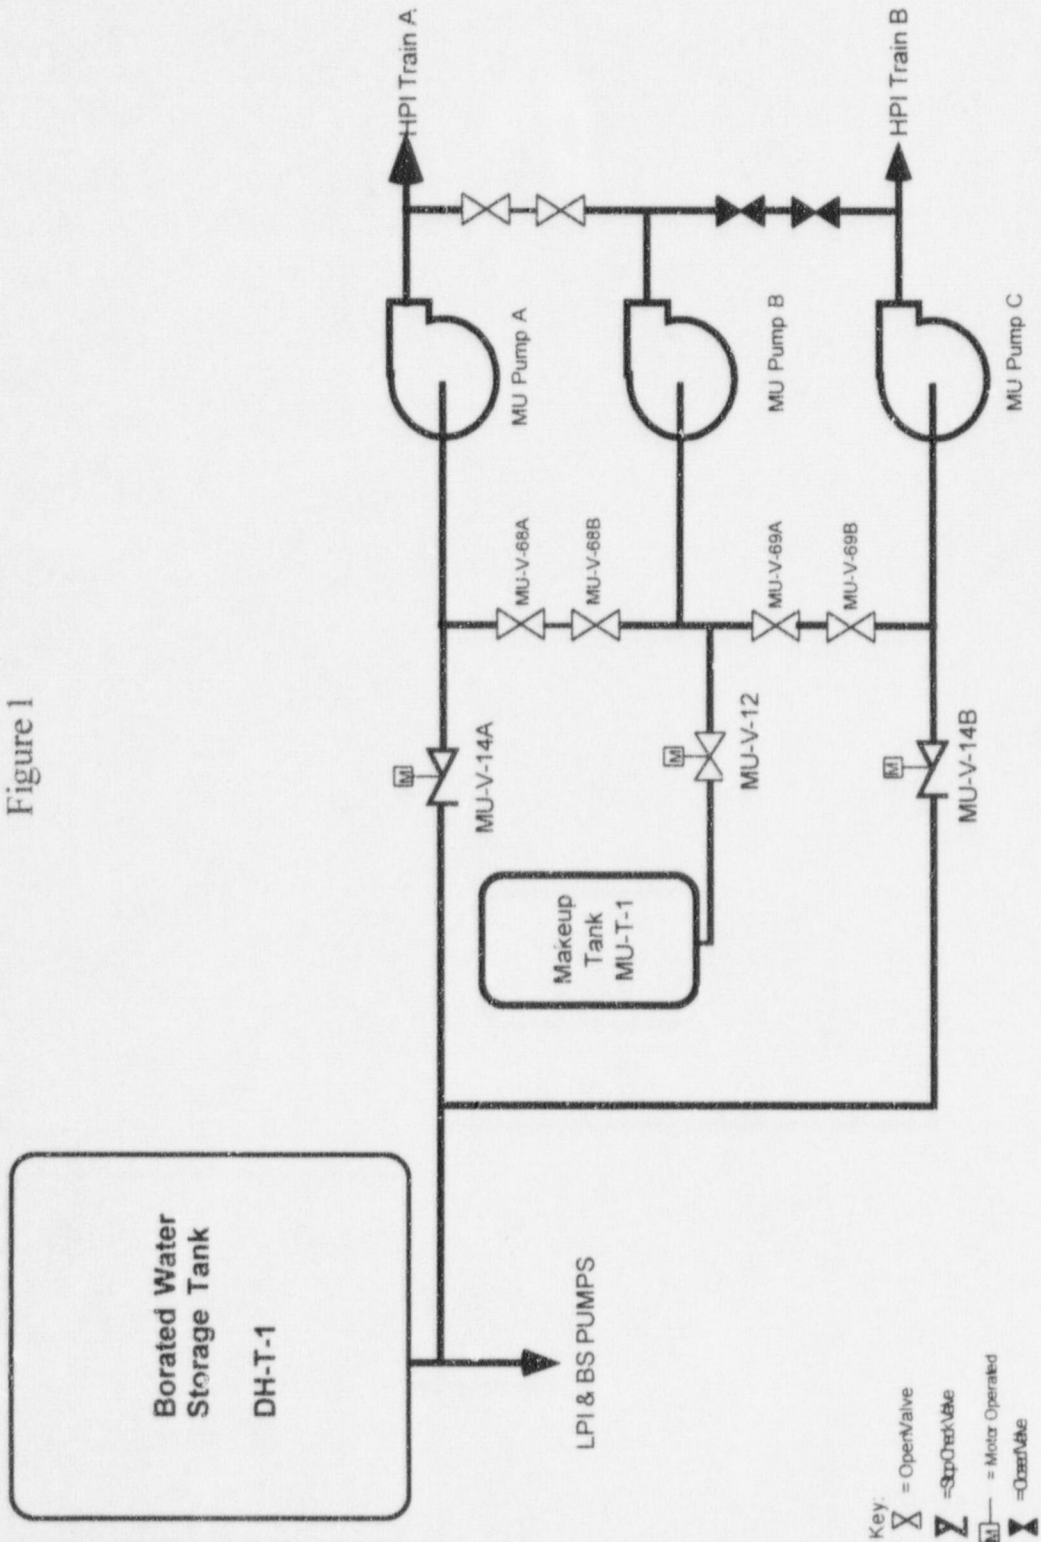
The Makeup & Purification/High Pressure Injection (MU/HPI) System depicted in Figure 1 provides the operational support function of Reactor Coolant System (RCS) chemistry and volume control as well as the Emergency Core Cooling System (ECCS) function of HPI. The MU Pumps are normally lined up to take suction from the Makeup Tank (MUT). When engineered safeguards (ES) actuates, the Borated Water Storage Tank (BWST) outlet to MU/HPI suction header isolation valves, MU-V-14A and MU-V-14B, are opened automatically. The MUT outlet to the MU/HPI suction header isolation valve, MU-V-12, is not an engineered safeguards (ES) valve and thus remains open following an ES actuation.

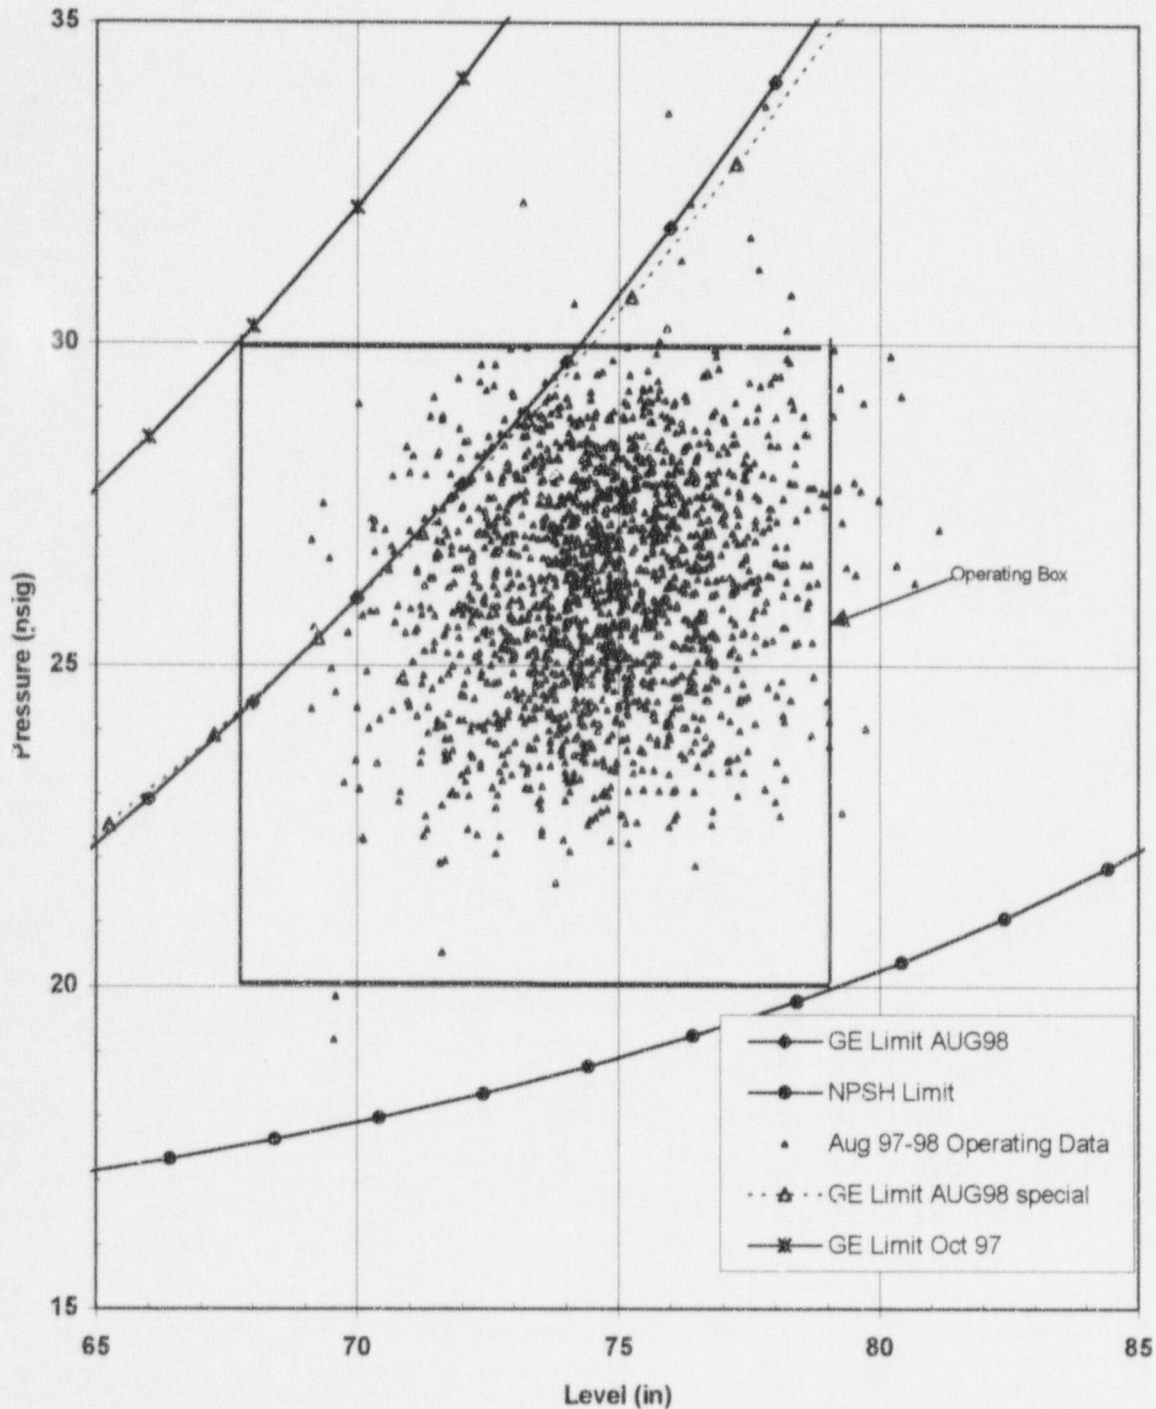
The operating limits for the MUT are provided to operators in the form of two curves. There is an upper limit to prevent gas entrainment (GE) and a lower limit to ensure design MU pump NPSH (see the "GE Limit Oct 97" and "NPSH Limit" curves in Figure 2). To simplify the operators task and provide additional margin of safety, the procedures specify that pressure and level should be maintained within an operating box as shown on Figure 2. The operating box is more conservative than the operating limit curves. The gas entrainment limit during the period from October 1997 through August 20, 1998 was based on an analysis which had not evaluated the case with all three MU/HPI Pumps operating and failure of MU-V-14A or MU-V-14B to open. When the appropriate case was analyzed on August 20, 1998 the operating limit was reduced (see the "GE Limit Aug98" curve in Figure 2).

An otherwise unrelated issue, which effects the probability of occurrence of MU Pump gas entrainment was considered by the GPU Nuclear PRG on September 4, 1998. The MUT level instrument calibration was reviewed in May 1997. At that time, an error was identified in the transmitter elevation correction used in the calibration. The effect of this error on the safety significance of the improper gas entrainment operating limit is shown on Figure 2 as "GE Limit AUG98 special." This curve shows the effect of the 1.25" level instrument calibration shift, discounted by the removal of an additional 1 psig of pressure instrument error normally included in the operating limit. It can be seen that this issue (calibration shift) had little safety significance.

The operating history (a data point for each 4 hours of operation shown as on Figure 2) was reviewed and it was determined that operation in the region where gas entrainment may have occurred, given the revised accident scenario, was limited to less than 3% of the time.

1. CAP T1998-0695 was initiated and the potential operability implications were discussed with the operating staff. The control room staff supervision were directed to avoid operation in the disputed region of the operating envelope pending a PRG determination.
2. A revised operating limit to prevent Makeup Pump gas entrainment during the postulated accident scenario was implemented immediately after the PRG meeting. Temporary Procedure Change (TCN) 1-98-0082 to operating procedure 1104-2 "Make Up and Purification System" was implemented on August 20, 1998.
3. MUT pressure and level limits analysis in support of the temporary procedure change was revised in Calculation C-1101-211-E610-066, Rev 2, dated September 3, 1998.
