LICENSEE EVENT REPORT (LER)

FACILITY NAME (1) Waterford Steam Electric Station Unit 3 DOCKET NUMBER (2) 05000382 PAGE (3) 1 OF 019

TITLE (4) Missed Penetrant Test on Two Welds Due to Personnel Error

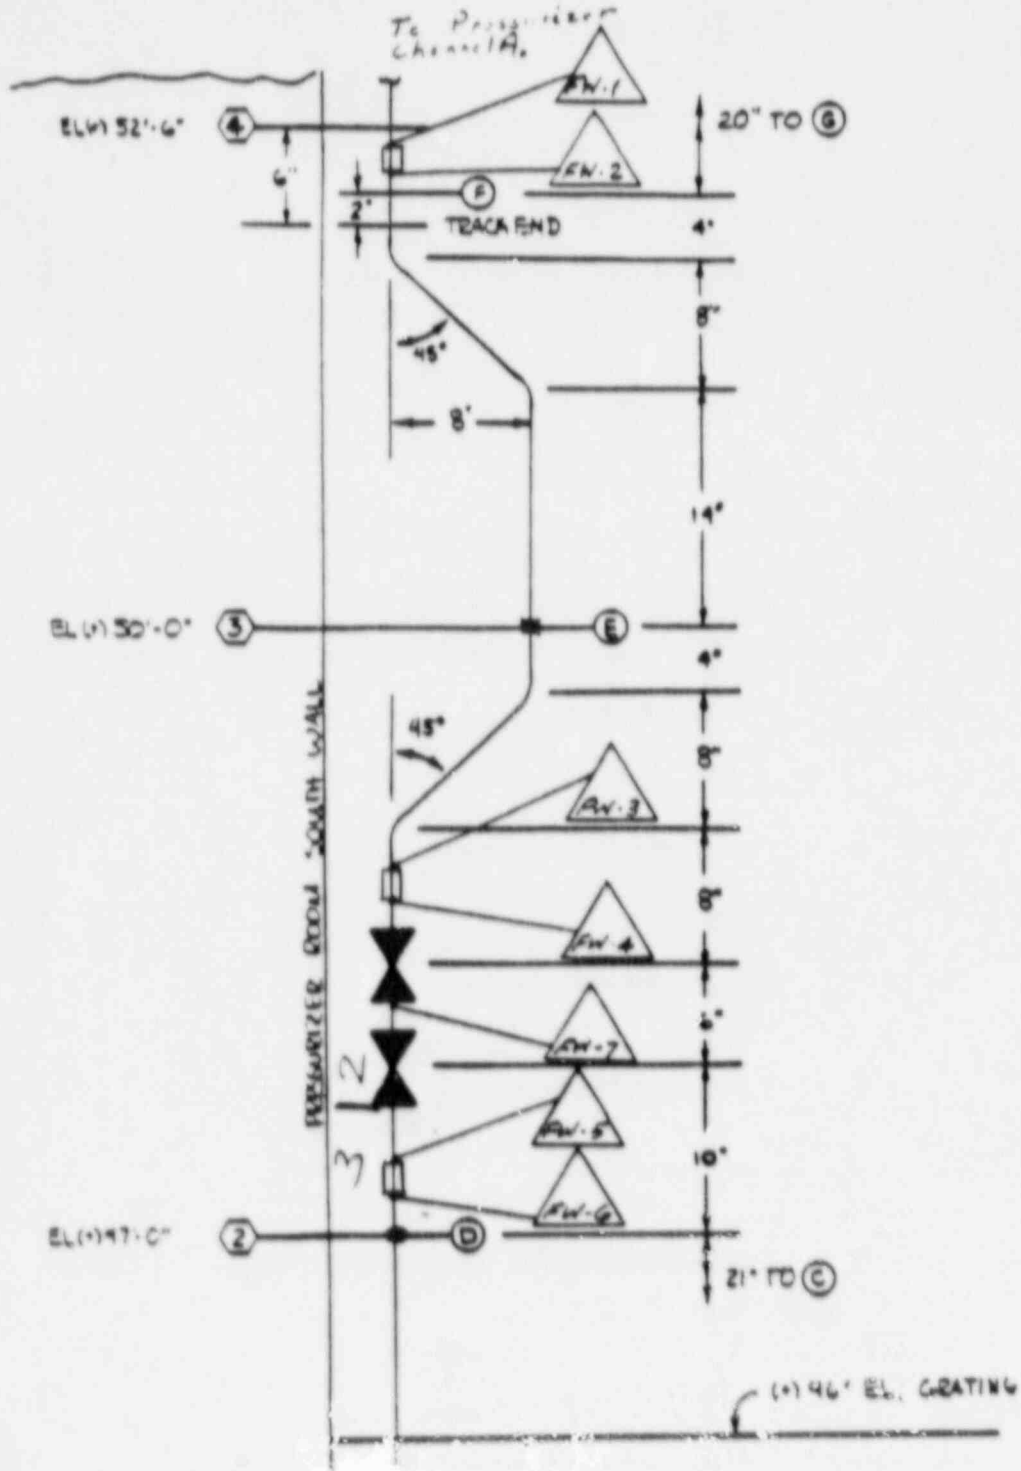
QS 88-062 identified a failure to perform non-destructive evaluation (NDE) dye penetrant testing (PT) on five safety class 2 socket welds. The five welds are located on stainless steel tubing which connects to a pressurizer condensate pot. Four of the welds, Field Welds (FWs) 1, 2, 3, and 4, experience RCS normal operating pressure and the fifth weld, FW 7, is isolated from the RCS by a single valve (See Figure 1).

On May 15, 1988, PT's were performed on FWs 1, 2, and 3. The NDE inspector placed his signature on the old page 2 WSDS's for the original FWs 1, 2, and 3 which were cut out and discarded versus the new page 2 WSDS's generated per DCPC 15. Evidently, it was not clear to the NDE Inspector on which page 2 WSDS's in the work package to place his signature. This oversight by the NDE Inspector resulted in FWs 4 and 7 not receiving a PT on May 15, 1988.

The root cause of this event was a failure to follow procedures. A Justification for Continued Operation has been approved. The procedures will be revised, training will be held, and the welds will be PT'ed during the next cold shutdown.

Revision 7 to MM-1-054, approved on August 8, 1988, added the term "replacement weld" to the procedure. This provides a means to distinguish by weld identification number the welds which have been completely replaced versus repaired. MM-1-054 and MM-1-056 are also being revised to adequately address the design change program and identify paperwork for welds removed during a design change. The WSDS form will be upgraded to adequately identify which NDE tests were performed and to ensure these tests are completed for the final weld. Additional training of NOE/NOC personnel will be conducted to stress the significance of this event. These actions are expected to be complete by October 31, 1988.
