LICENSEE EVENT REPORT (LER)

FACILITY NAME (1) CRYSTAL RIVER UNIT 3	DOCKET NUMBER (2) 050003102	PAGE (3) 1 OF 05
--	---------------------------------------	----------------------------

TITLE (4) **INCORRECT DESIGN INPUT CAUSES FAILURE TO ENVIRONMENTALLY QUALIFY EQUIPMENT, RESULTING IN A CONDITION OUTSIDE THE PLANT DESIGN BASIS**

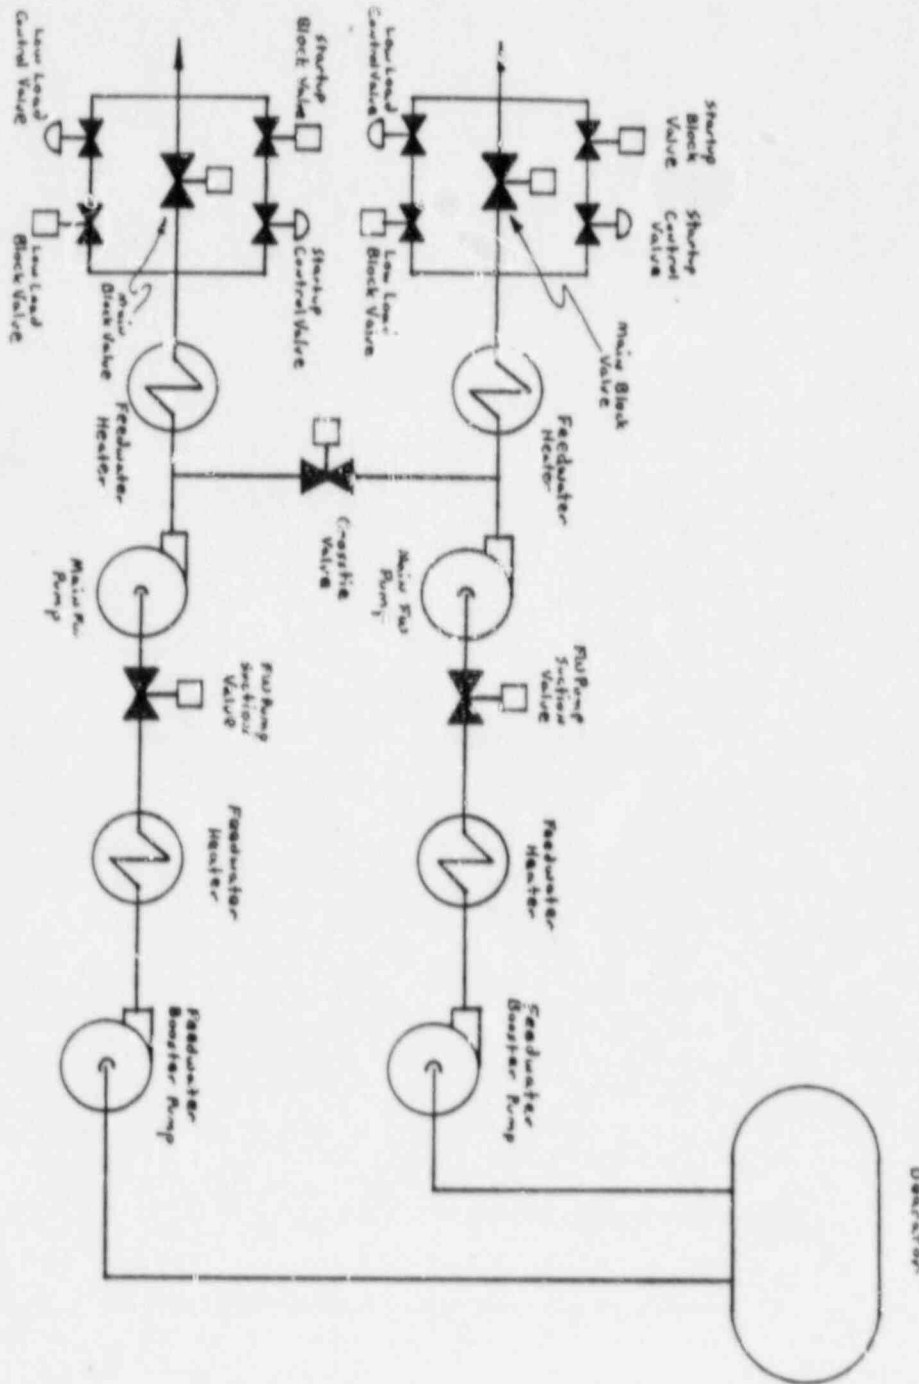
Figure 1 - Simplified Feedwater System Diagram

Crystal River 3 design incorporates two Main Feedwater [SJ] trains. Each train contains three parallel block valves sized for different flow capacities. (Please refer to Figure 1.) The Startup Block Valves supply feedwater during operations below 15% of full power. Block valves are normally opened and closed by the Integrated Control System [JA] during power increases and decreases. Block valves also receive commands to close from the Emergency Feedwater Initiation and Control (EFIC) system [BA] when it becomes necessary to isolate a Steam Generator (SG) [AB,BLR]. In order to isolate Main Feedwater, the EFIC system also trips the Main Feedwater Pump (MFWP) [SJ,P], and closes the crosstie and MFWP suction valves.
