LICENSEE EVENT REPORT (LER)

FACILITY NAME (1) CRYSTAL RIVER UNIT 3	DOCKET NUMBER (2) 05000302	PAGE (3) 1 OF 08
--	--------------------------------------	----------------------------

TITLE (4) **BROKEN STEM NUT IN "B" FEEDWATER MAIN BLOCK VALVE RESULTS IN A FEEDWATER TRANSIENT AND SUBSEQUENT REACTOR TRIP**

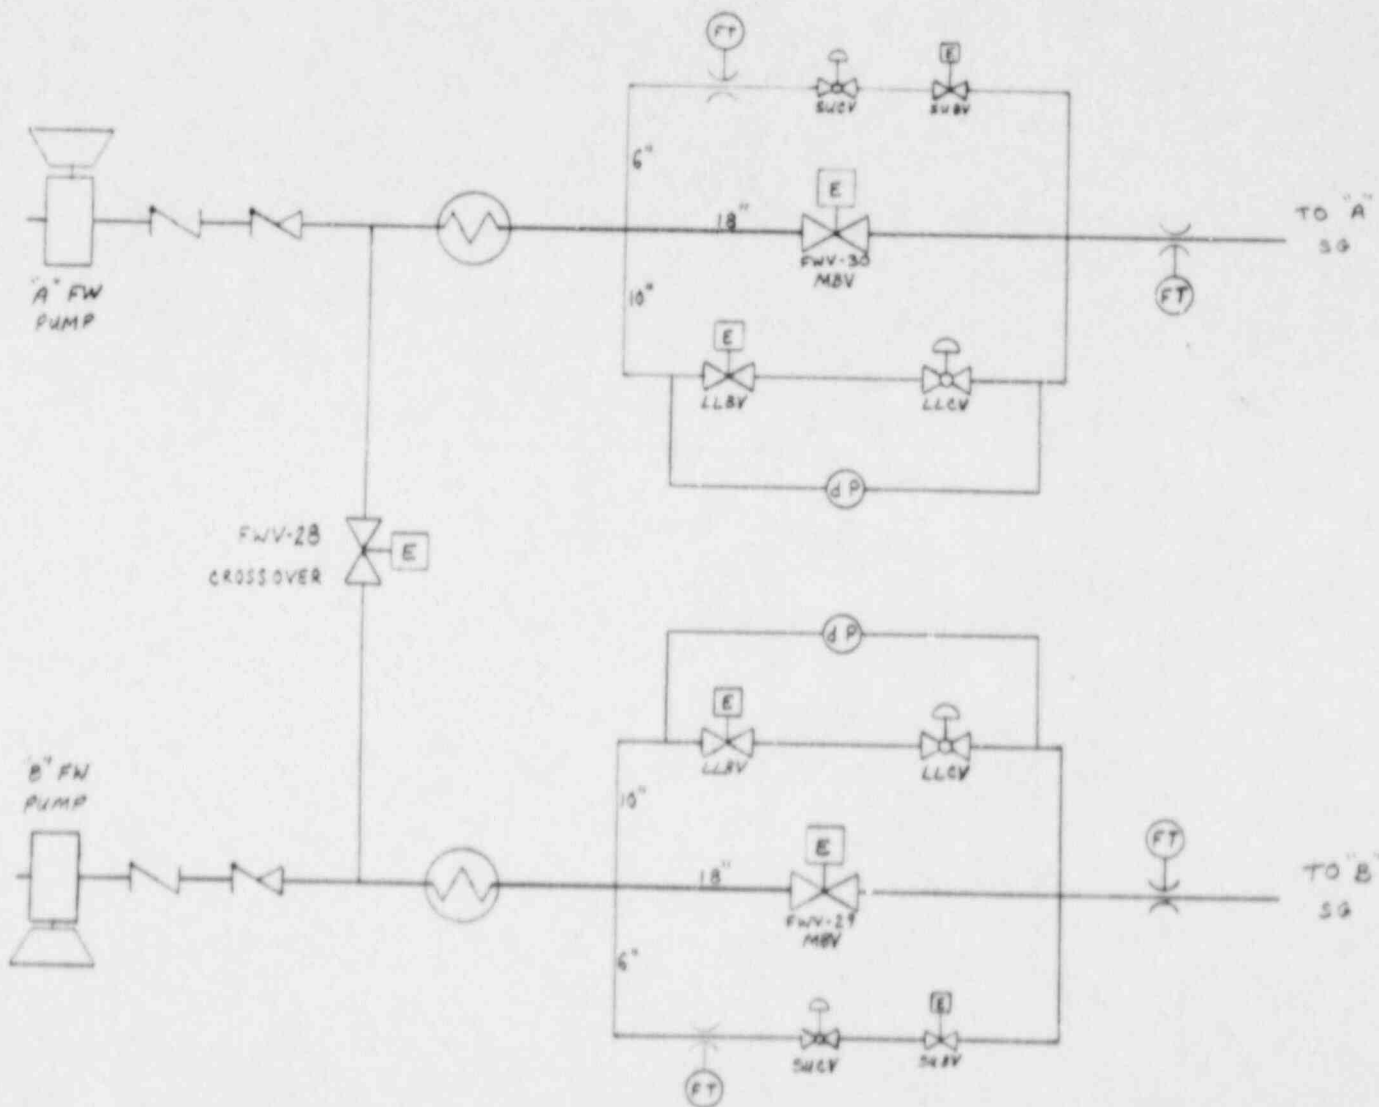
In an attempt to lessen the severity of the FW transient in progress, a control room operator opened the FW crossover valve FWV-28 [SJ,20] (see Figure 1). When this valve was opened, a "close" signal was also sent to the MBV's, as designed. Within seconds, the FW flow to "B" SG decreased such that an underfeed condition occurred. Approximately one minute later at 1149, a reactor trip occurred due to high RCS pressure on 2 out of 4 Reactor Protection System (RPS) [JC,CH] channels.

5. Q - Provide P&ID's for the MFW system and ICS system schematics.
A - Figure #1 of LER 88-006 shows the arrangement of the FW valves. Item #1 describes the ICS control of FW from 0% to 100% power. Additional drawings have been provided to the Project Manager.
