Report Nos.: 50-325/88-17 and 50-324/88-17

Facility Name: Brunswick 1 and 2

Scope: This routine, announced inspection at the licensee's laboratory in New Hill, North Carolina, concerned the evaluation of cracks in the Insert and Withdraw lines of Unit 2 Control Rod Drives.

5. Cracking in Control Rod Drive Mechanism (CRDM) Insert and Withdrawal Piping (Unit 2)

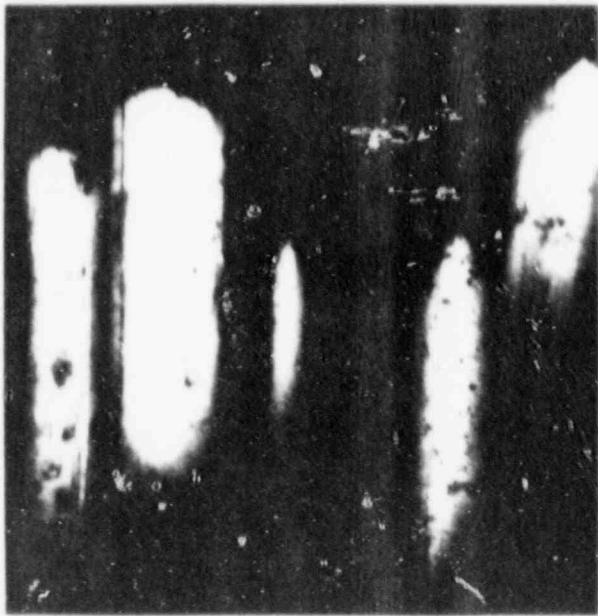
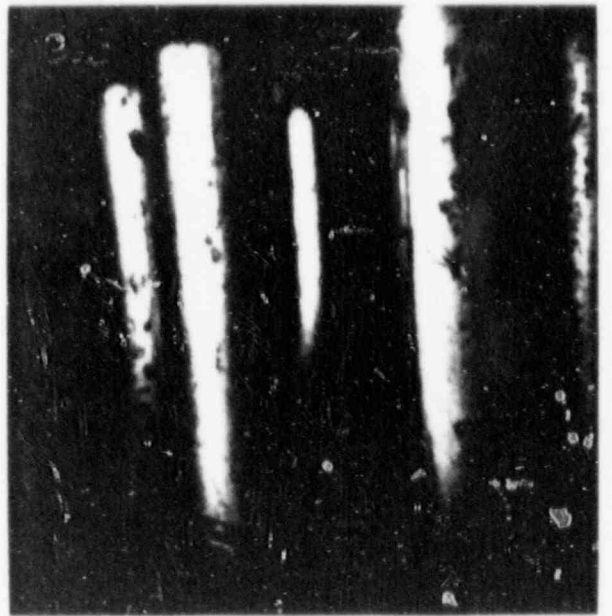
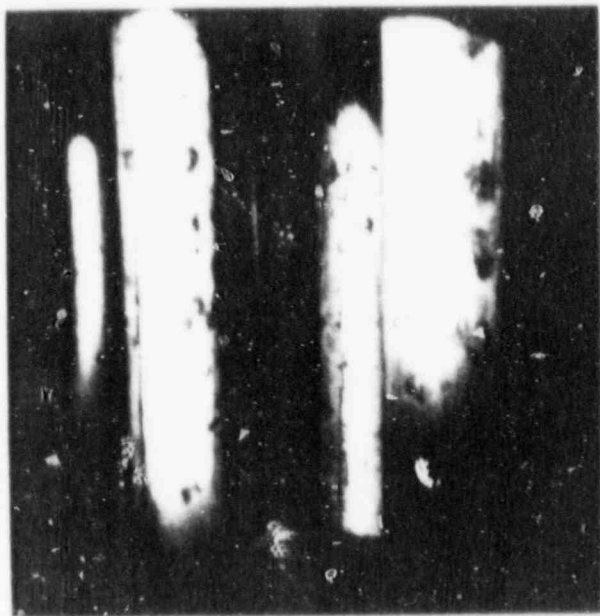
BROWNISH DEPOSITS AND TUBES AT 245° AZIMUTH

The corrosion problem has been identified as transgranular stress corrosion cracking by the CP&L materials lab. The indication of the problem observed in Unit 2 is a brownish deposit. (See attached photos of affected tubes at 245 degrees azimuth.) Chloride has been identified in the brownish deposits and is considered to be the initiator of the problem.

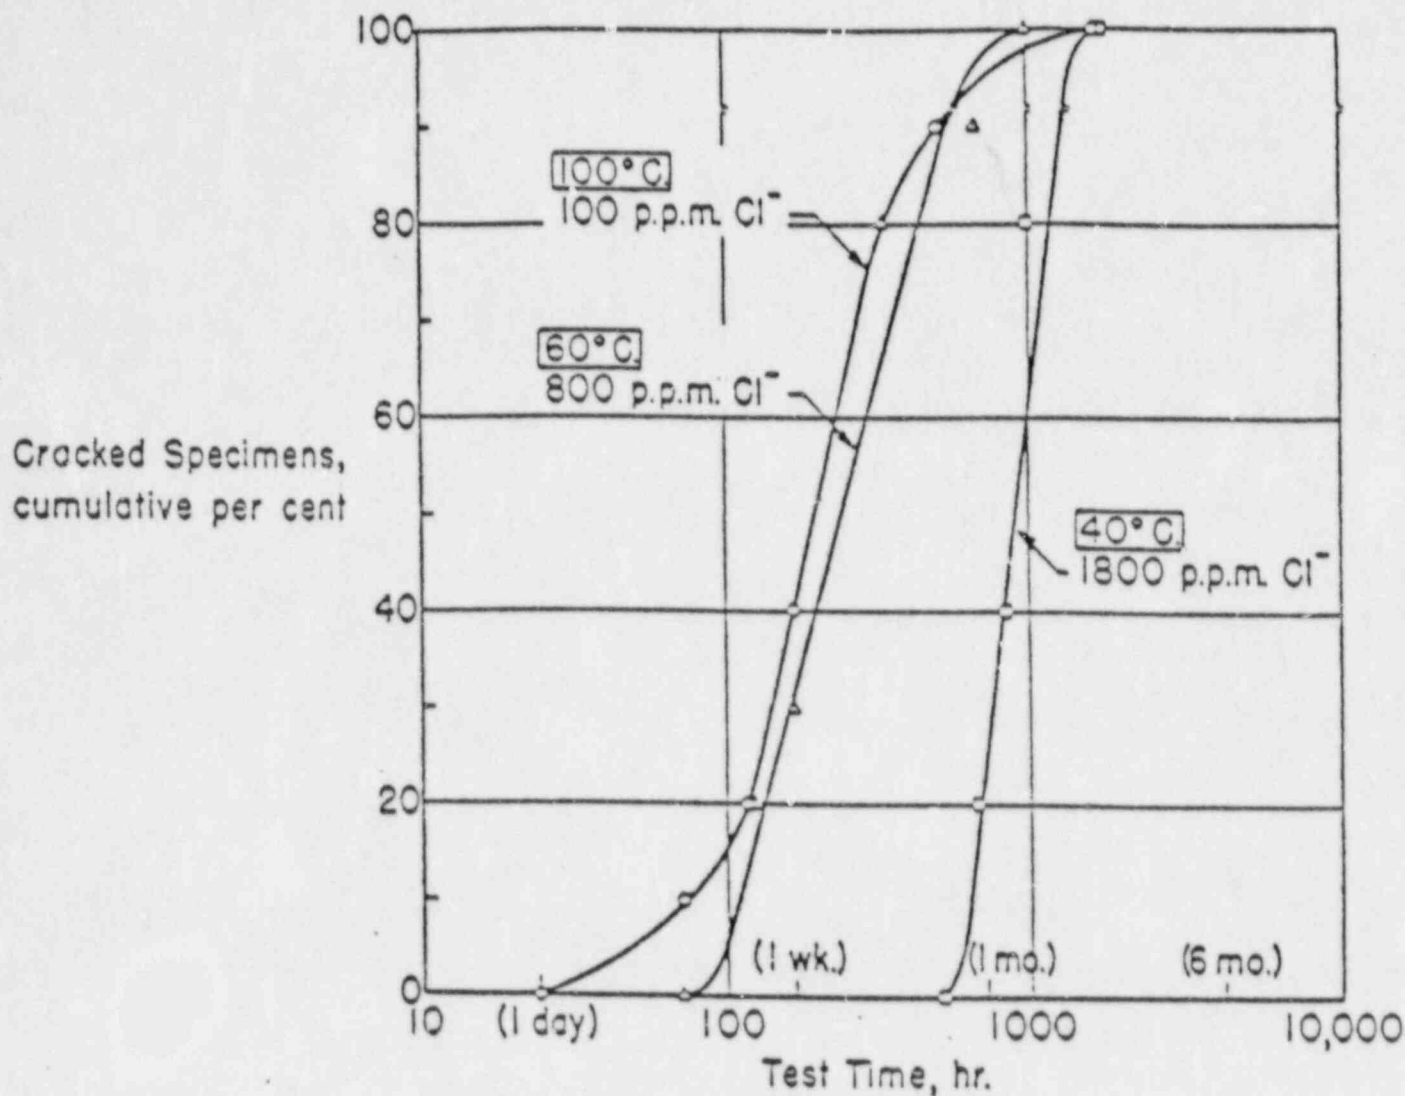
Investigation of drywell temperature records at Brunswick Units 1 and 2 revealed that from plant startup through February, 1984, the average temperature at the location of the CRD tube bundles was 95°F in Unit 1 and 120°F in Unit 2. Based upon the laboratory and field data described above regarding TGSCC cracking in chlorides, the tubes in Unit 2 were near or slightly above the threshold temperature for chloride stress corrosion cracking (~100°F), while the CRD tubes in Unit 1 may be at or slightly below the TGSCC threshold for annealed type 304 stainless steel. This difference in drywell temperature translates to a difference in failure time of a factor of two or more, based upon an activation energy extrapolation of the 60°C, 80°C and 100°C temperature data described above [1].

Figure 1. Effect of temperature on the time to cracking of Type 304 stainless steel exposed to water with chloride adjusted to provide the same rate of chloride concentration at three temperatures. U-bends from 16-gauge stock. (Warren 1)

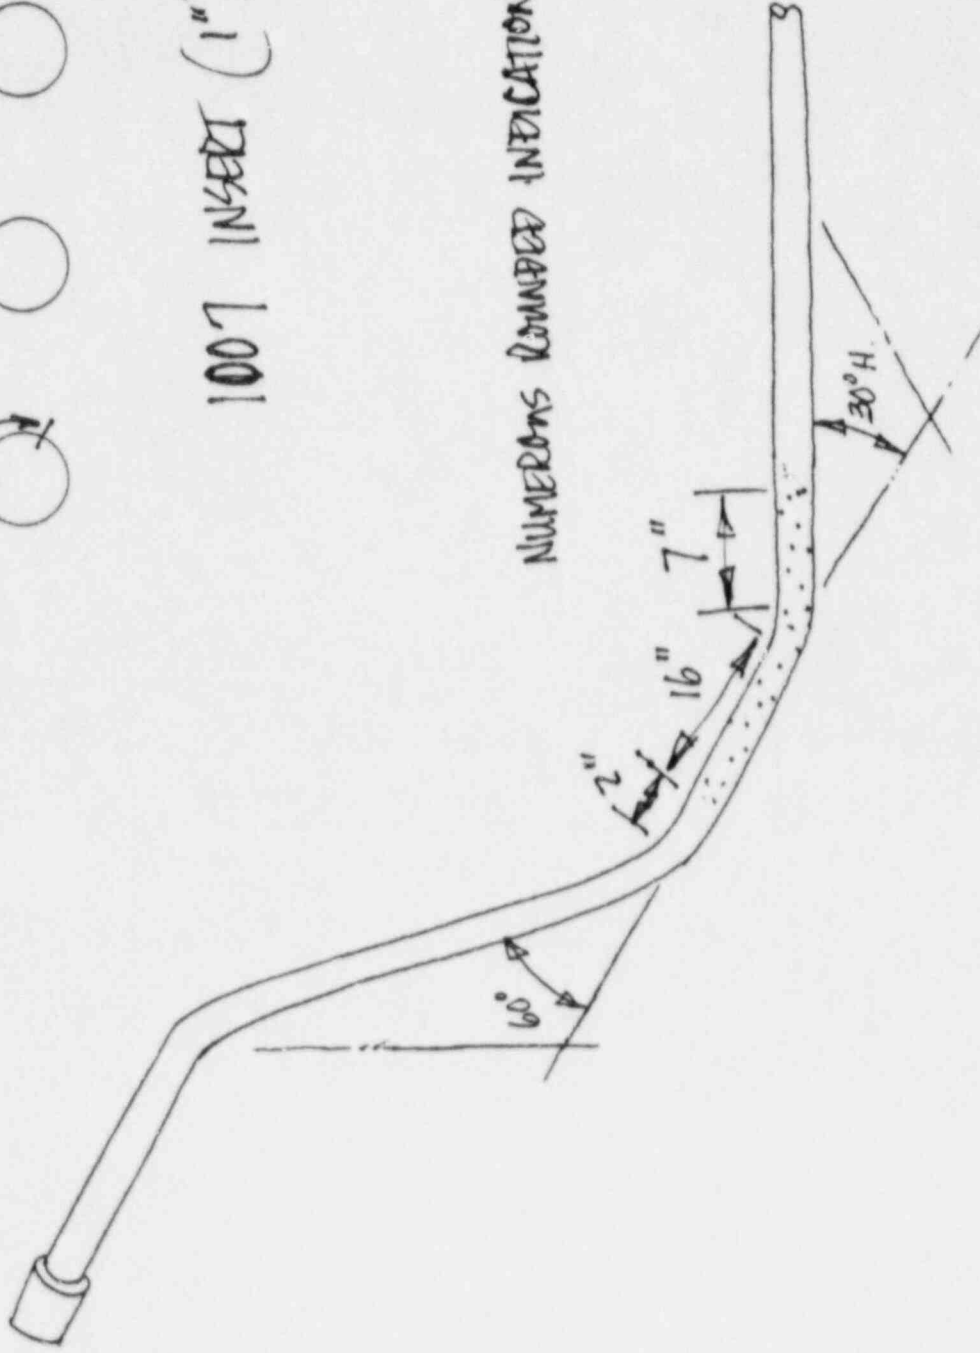
(1") INSERT L001

NUMERONS DIMMERED INDICATIONS

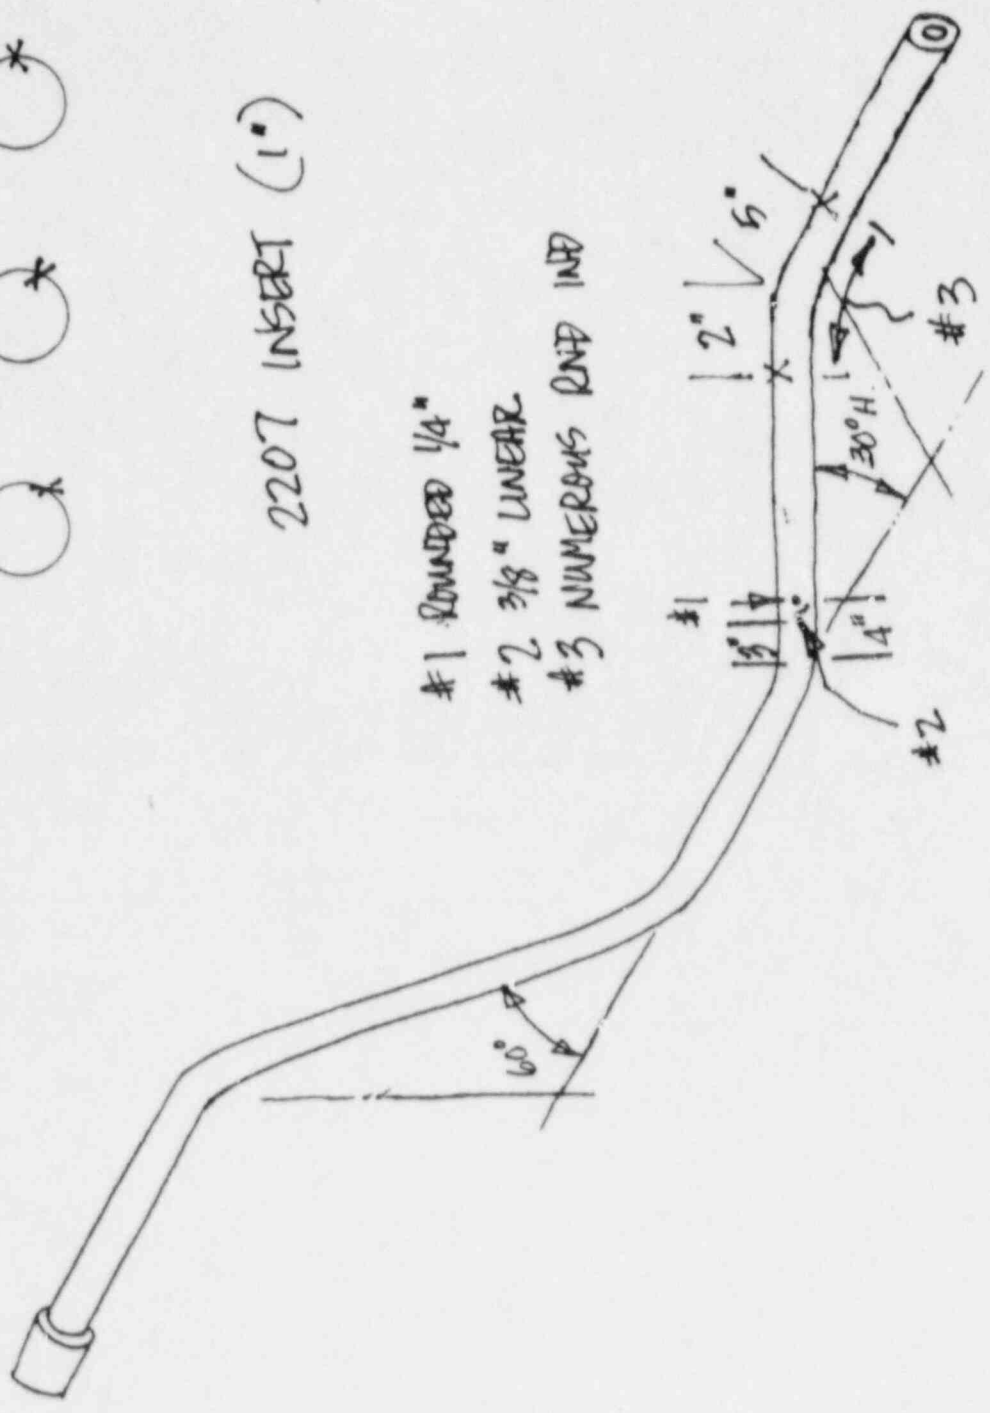
2207 INSERT (1°)

- #1 ROUNDED 1/4"
- #2 3/8" LINEAR
- #3 NUMEROUS RND IND

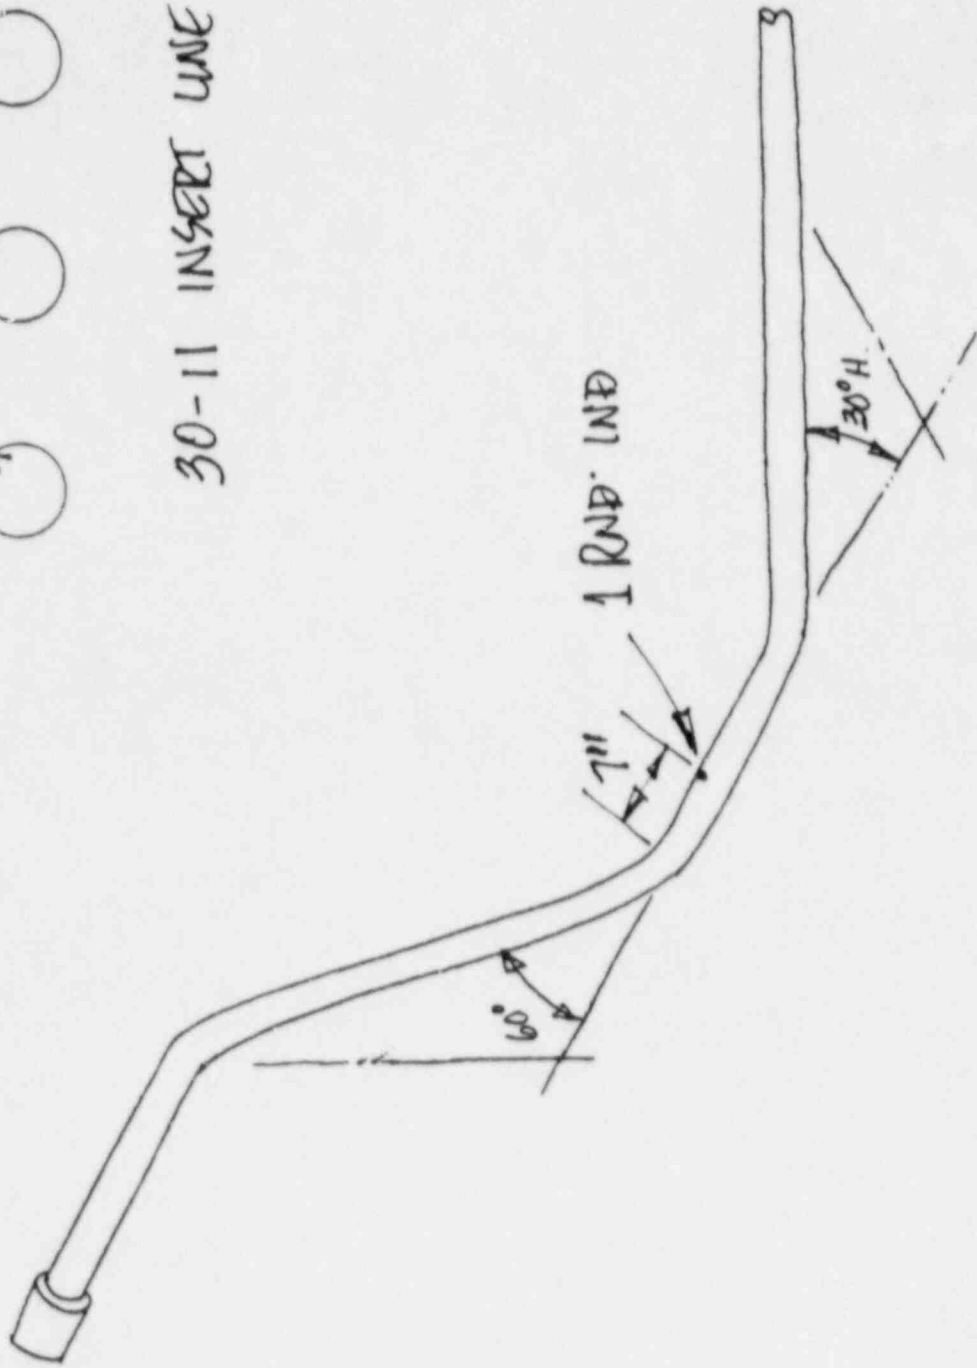
30-11 INSERT LINE (1")

- QC COMPLETED LP EXAM OF ALL TUBES @ 115° - ONLY 3 CONFIRMED THRU-WALL INDICATIONS - THE WITHDRAWAL LINES FOR HCU'S 46-19, 42-15 & 46-15. ONLY ONE ADDITIONAL REJECTABLE INDICATION WAS DISCOVERED ON THE INSERT LINE FOR HCU 30-11 *
- ISSUED FR #40 TO ALLOW WORK ON 115° AZ TO PROCEED WHEN READY.
- COMPLETED REPLACEMENT OF TUBES @ 245° (LATE NIGHTSHIFT)
