Public Service Electric and Gas Company P.O. Box L Hancocks Bridge, New Jersey 08038
Hope Creek Operations

Enclosed is the report which you requested on the General Electric findings regarding the damaged solenoids from the Hope Creek MSIV which failed to close on February 24, 1987. This event was reported in LER 87-018-00 and LER 87-018-01.

HOPE CREEK, MALFUNCTION OF MSIV FO22A

This document describes the evaluations performed to determine the cause of events on October 29 and November 3, 1987 when Perry I Main Steam Isolation Valves (MSIVs) failed to fast close on command. The most probable root cause, based on data currently available, is failure of an Automatic Switch Company (ASCO) Model 8323 3-way dual solenoid valve. The primary suspected cause is hardening and dimpling of the EPDM rubber disc seat material and other EPDM seals, causing the disc holder assembly to wedge in place when the solenoid was de-energized. Several mechanisms have been proposed that might lead to EPDM degradation, the most probable of which is a local high temperature environment.

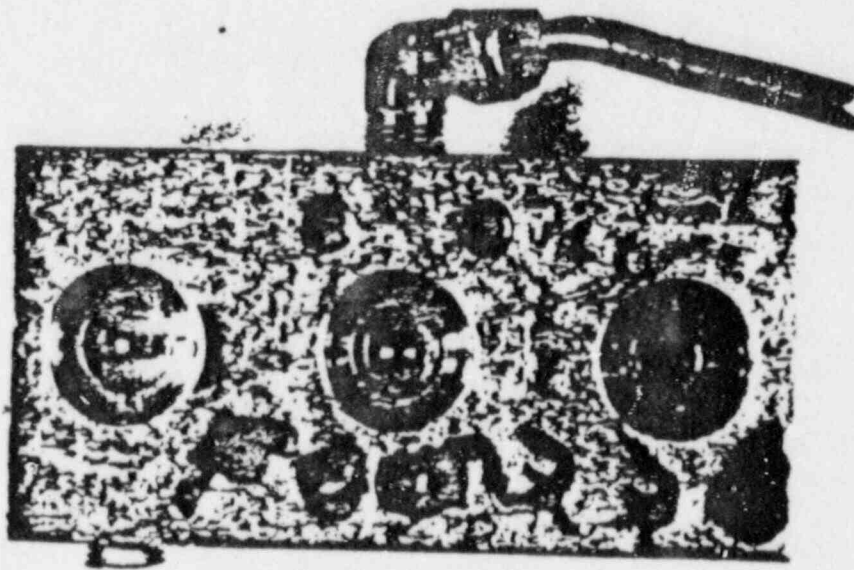
Figure 1. Solenoid Valve Base Showing Some Dark Deposits in the Hole on the Right.

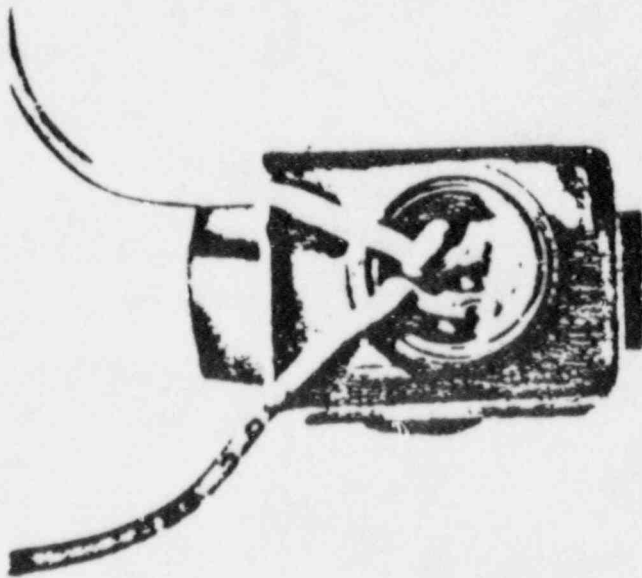
It was noted that the wiring insulation for all three solenoids of FO22A valve was broken where the wire joined the solenoid, Figure 3. It appeared that the process of potting the coil could have caused the insulation to fracture and peel. There was no evidence of shorting but the wires were bare for approximately 3/4 inch.

Figure 3. Solenoid Showing Damaged insulation

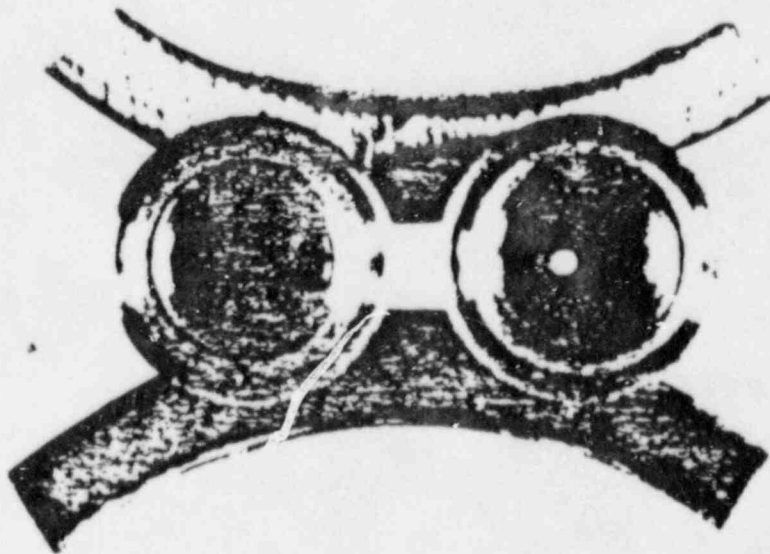
Figure 7. View of Plunger Housings Looking into the Plunger End.
The Plugged Housing is on the Left. FO22A, SV #1

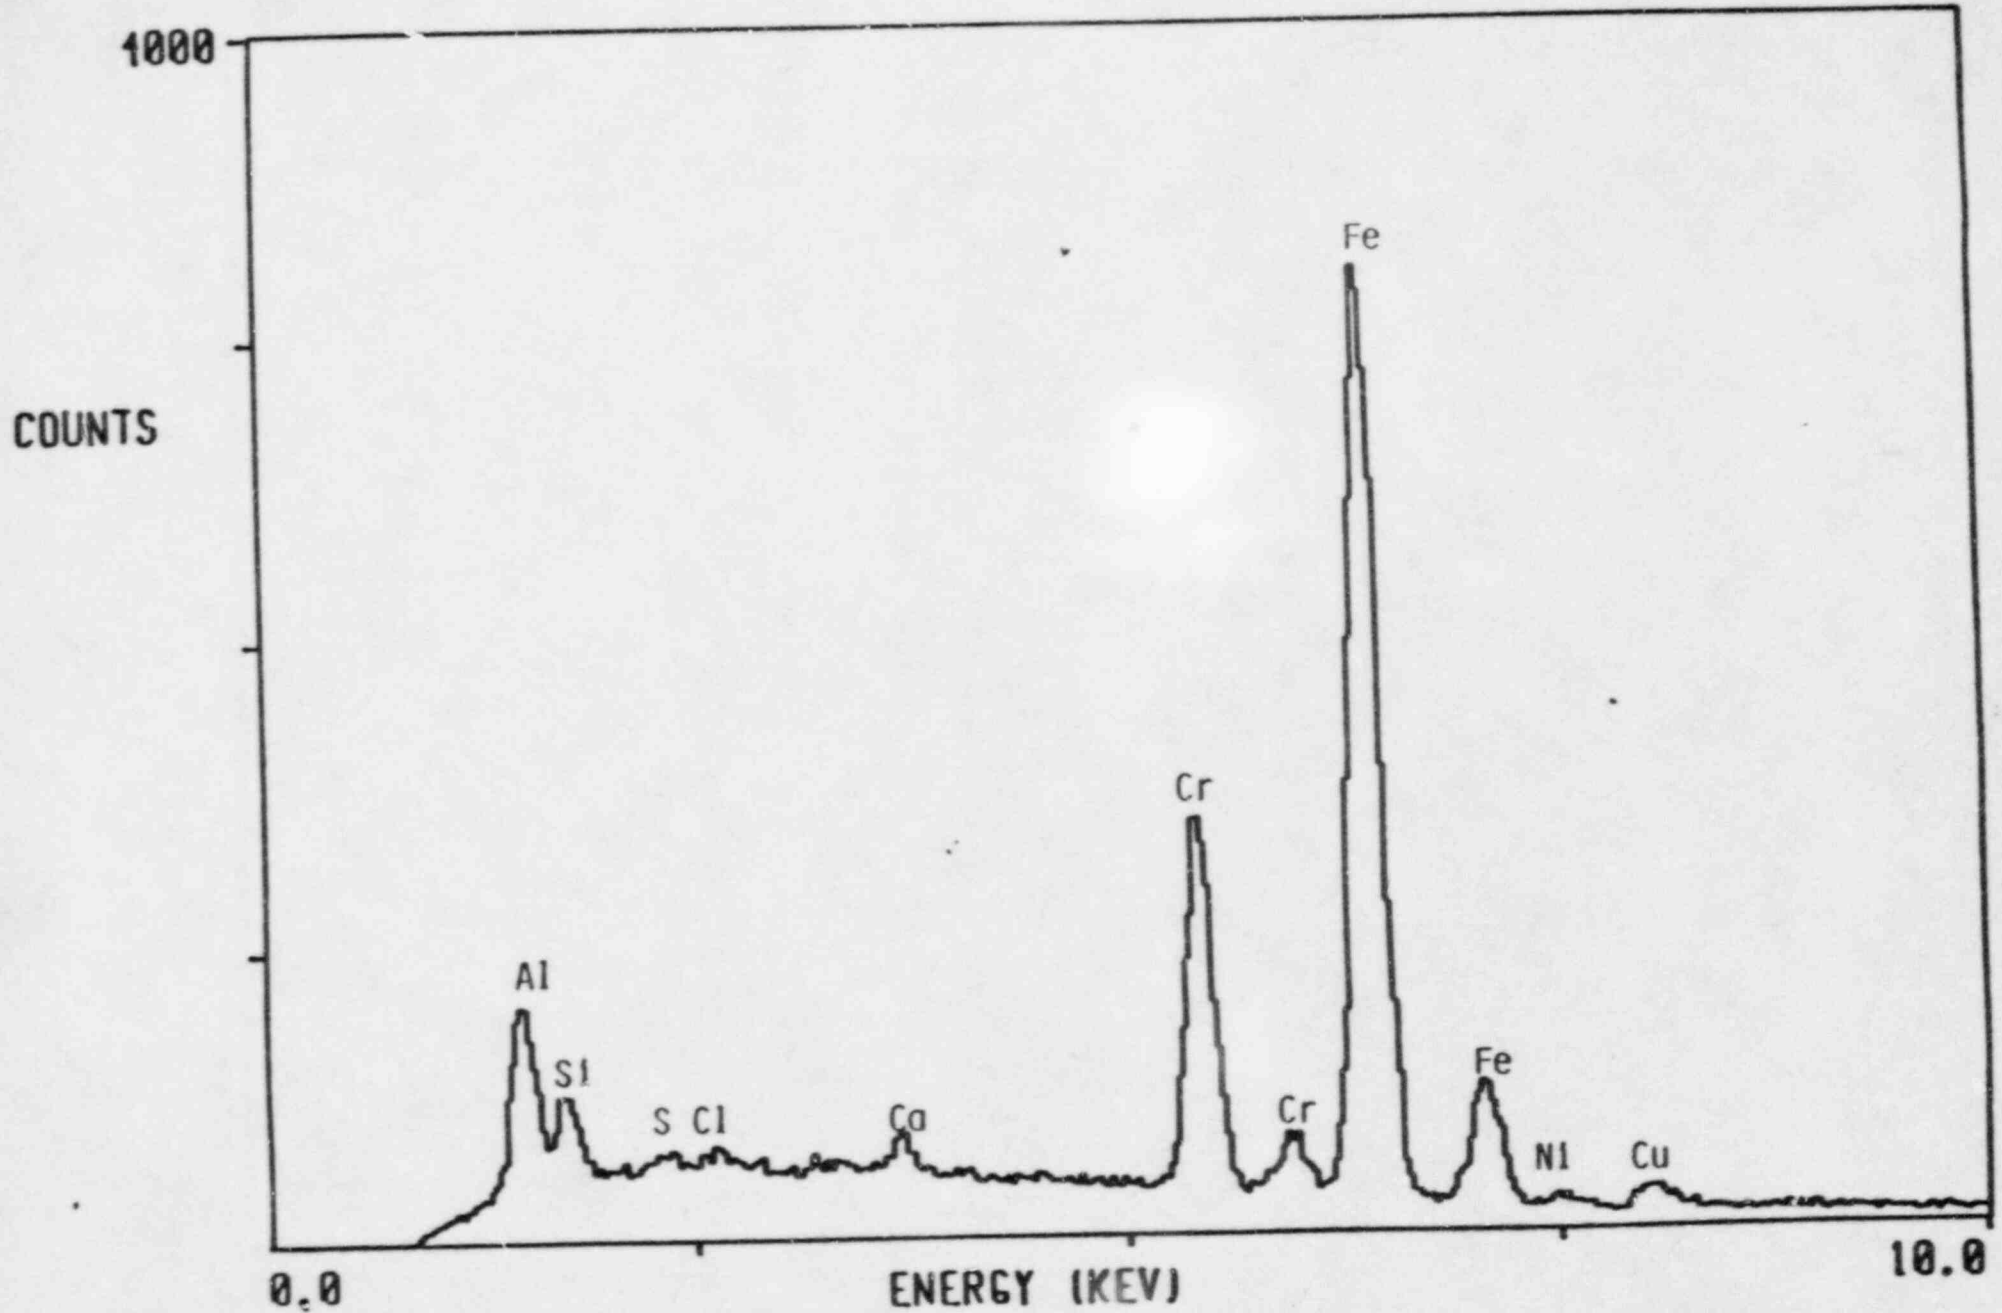
Scanning electron microscope (SEM) revealed a typical wear pattern for a soft material, Figure 6. EDX analyses showed the plunger material to be an iron-chrome alloy. The analyses also showed some contaminants of aluminum, sulfur, chlorine, and calcium present, Figure 9.

FIGURE 9. EDX ANALYSIS OF WORN SURFACE OF PLUNGER

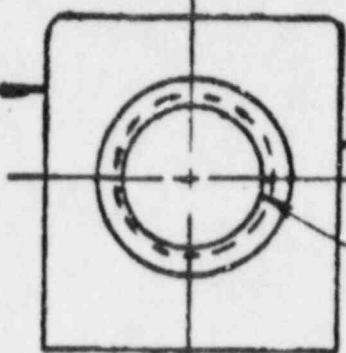
I have attached a copy of Hope Creek's C6930-070 solenoid manifold with pencil notes, identifying the damaged adaptor, solenoid, lead wires, copper shading ring, plunger tube and black residue for your reference.

THREADS CROSS THREADED

LEAD WIRES STRIPPED AT HUBS

TUBE DAMAGED BY VISE GRIP PLIERS

BLACK RESIDUE

Spanner wrenches must be used to prevent damage to solenoid tube guides.

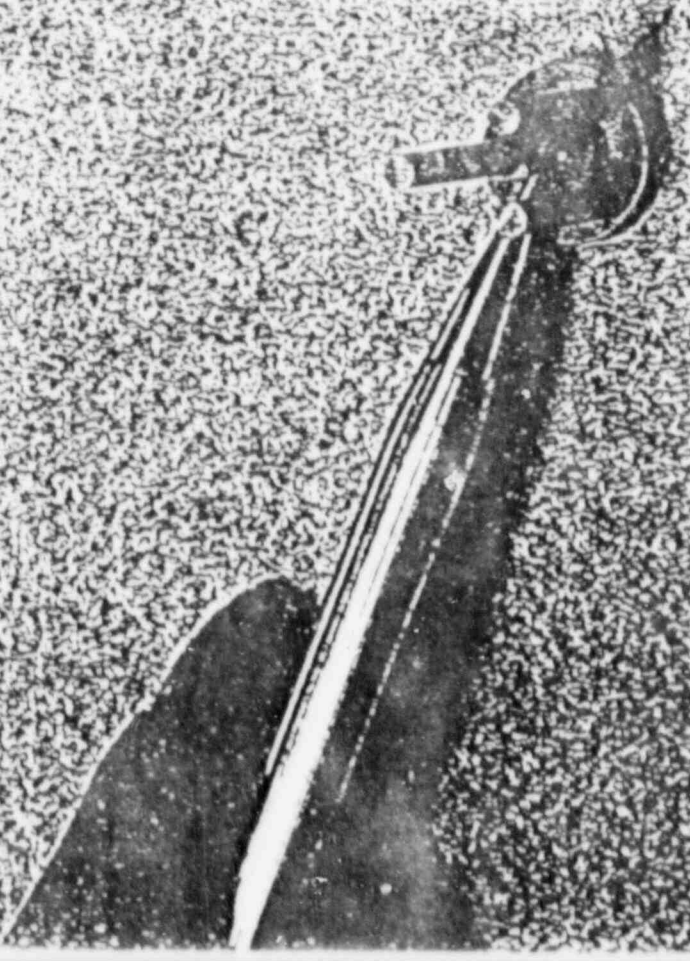
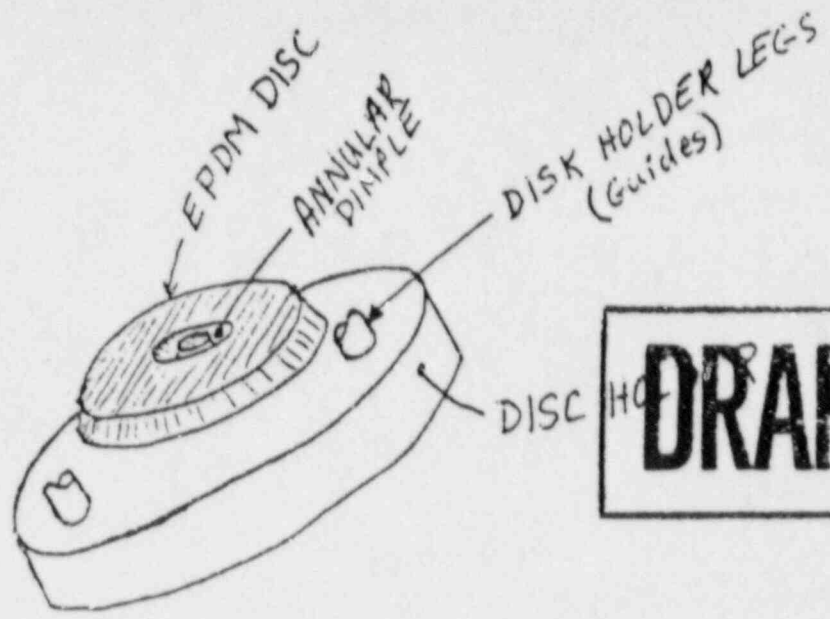
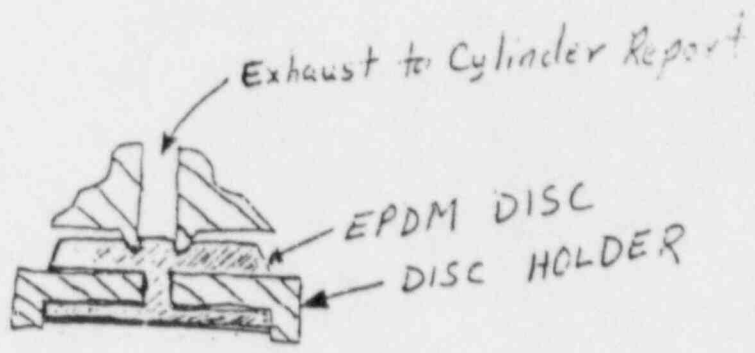
Disc Holder
Assembled
Figure 1

This failure mode is the most likely candidate for root component failure of the problem. The post-disassembly inspection has found dimpling of the EPDM rubber disc seat material. This could cause the disc holder assembly to wedge in place when the solenoid is de-energized. This would in turn not allow air pressure to relieve through the #3 air port, and preclude MSIV closure.
