PRELIMINARY NOTIFICATION OF EVENT OR UNUSUAL OCCURRENCE--PNO-III-87-138 Date November 3, 1987

Subject: SHUTDOWN BECAUSE OF EXCESSIVE MSIV CLOSURE TIMES

This letter confirms the telephone conversation on November 3, 1987, between Mr. Greenman and others of this office and Mr. A. Kaplan of your staff regarding the Main Steam Isolation Valve (MSIV) failures occurring at the Perry Nuclear Power Plant Unit 1 on November 3, 1987. With regard to the matters discussed, we understand that you will:

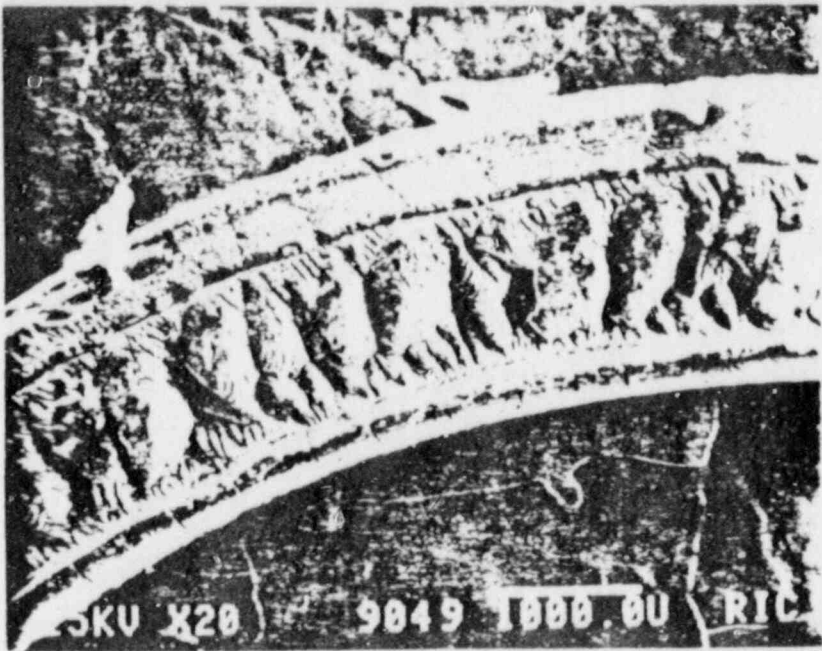
Figure 3.

MSIV24
O-ring Surface
Failed

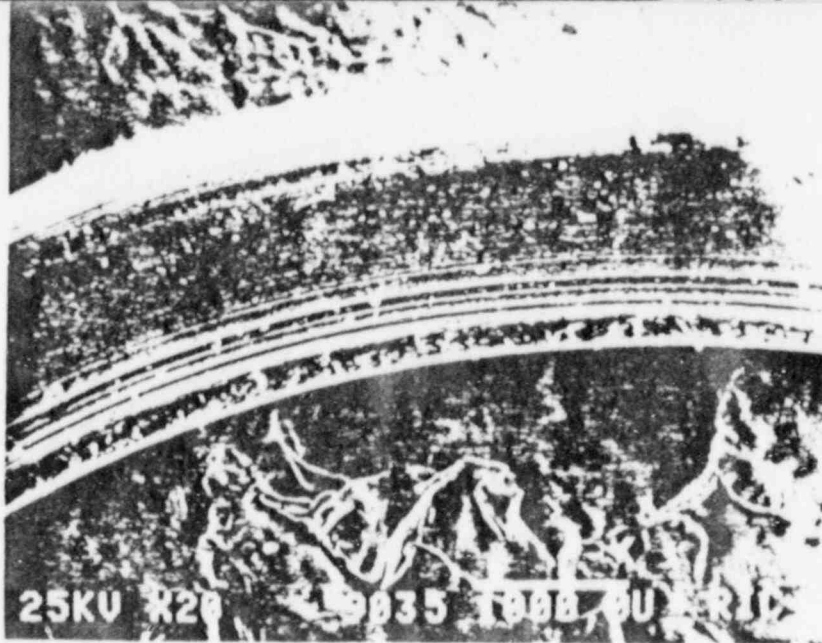
Figure 5.

MSIV26
O-ring Surface
Not Failed

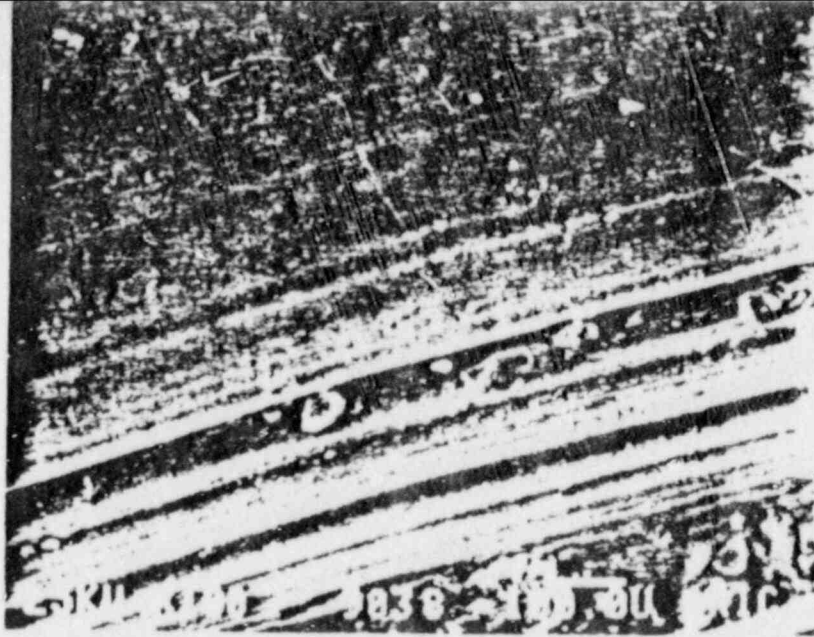
Figure 6.

MSIV26
O-ring Surface
Not Failed

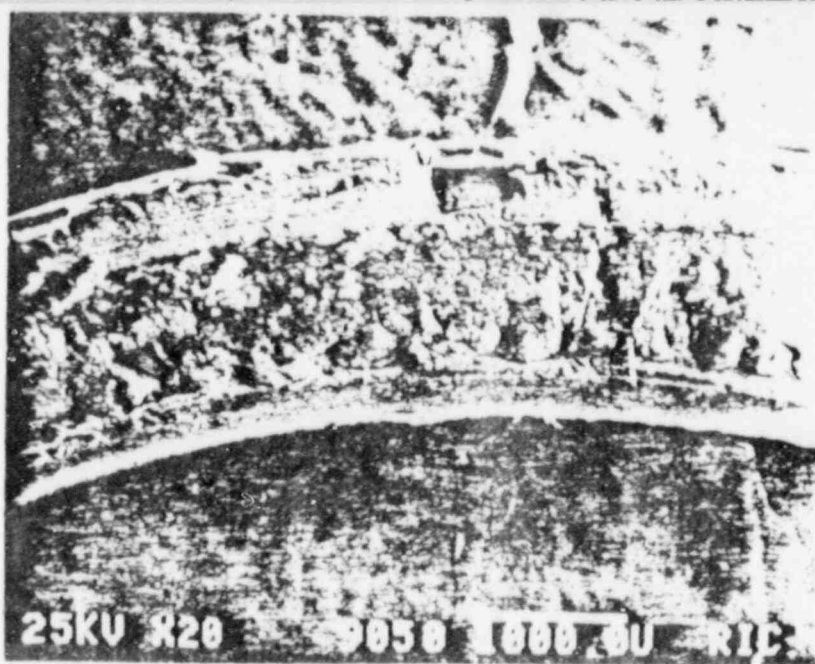
Figure 7.

MSIV27
O-ring Surface
Failed

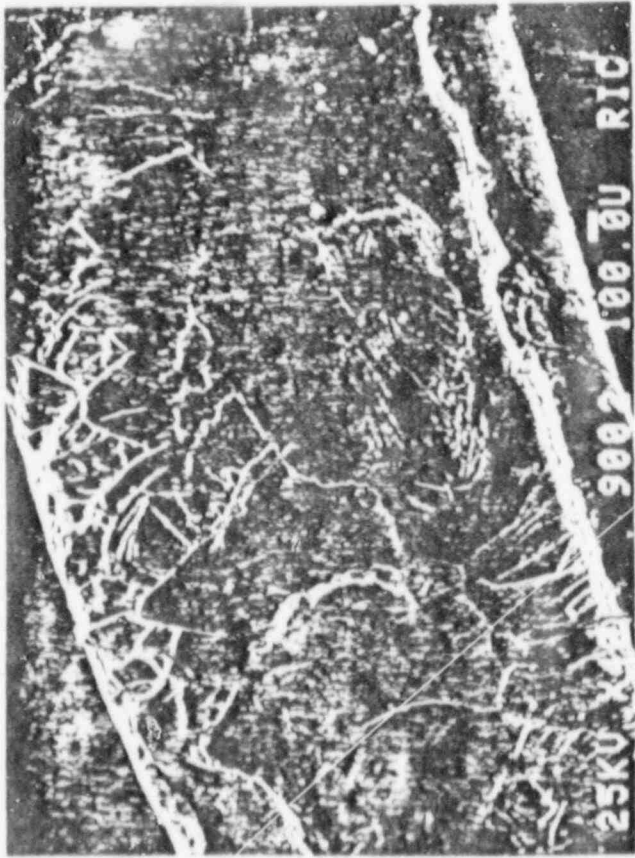
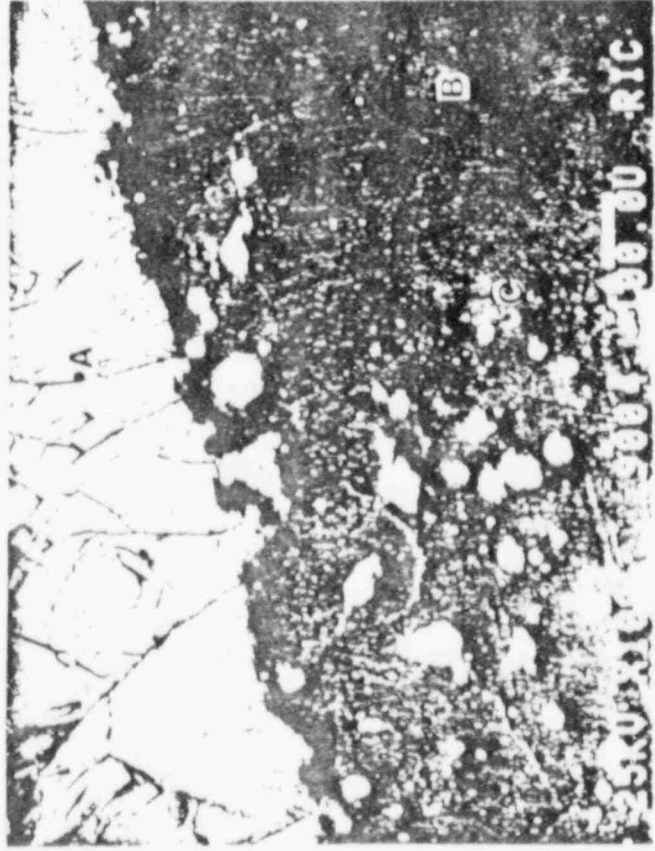
Figure 9. MSIV28
O-ring Surface Failed

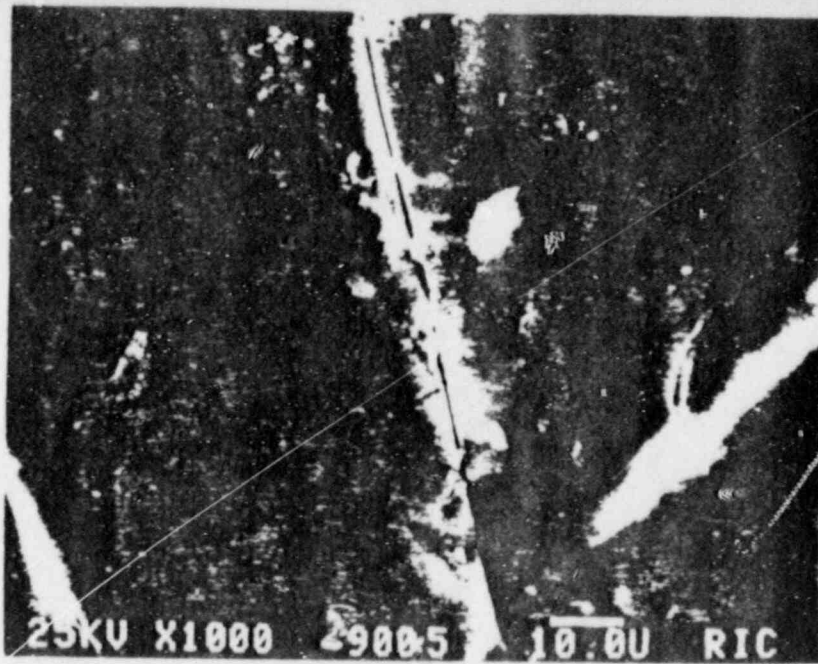
Figure 10.

MSIV28
O-ring Surface
Failed

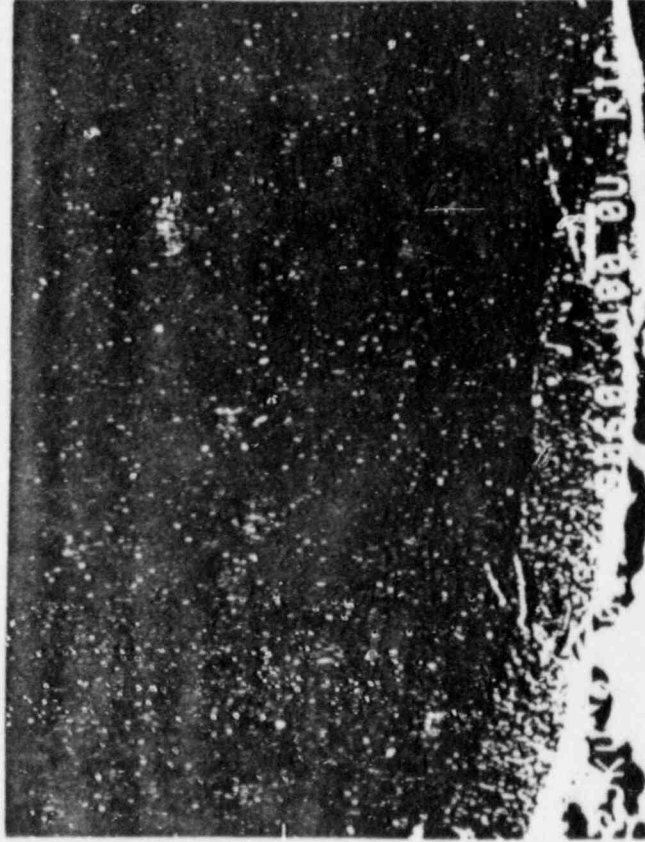
Figure 13. MSIV24
O-ring Cross-section Failed

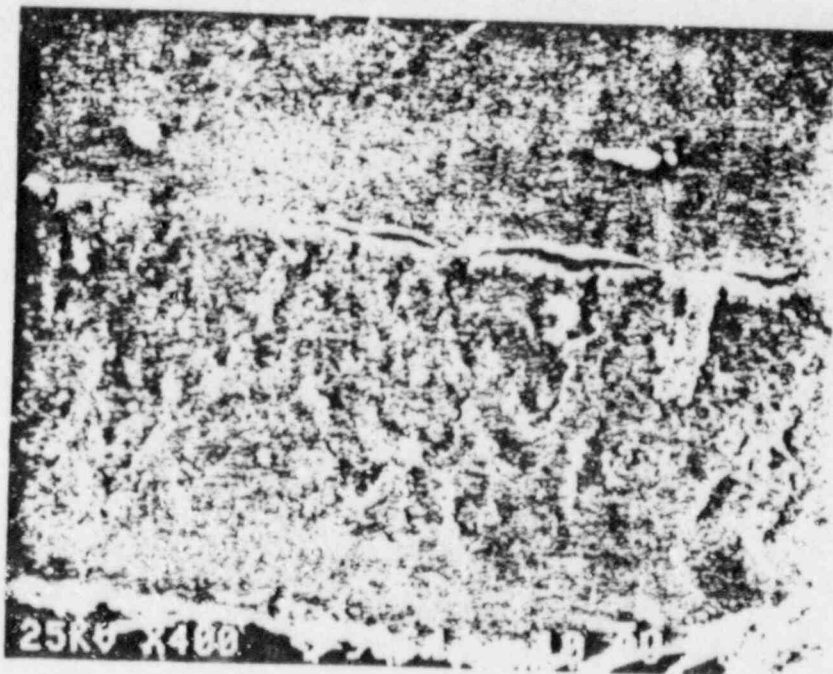
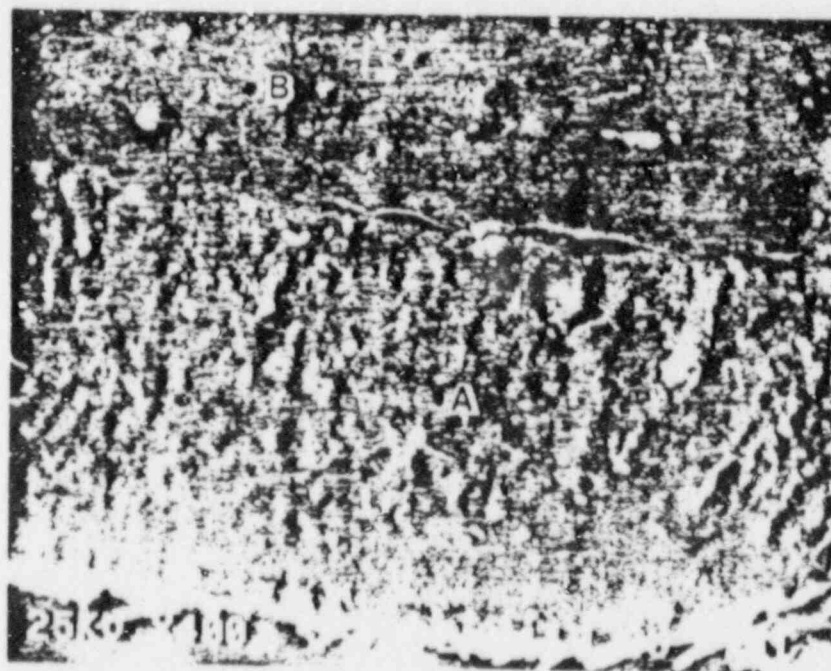
Figure 14. MSIV24
O-ring Cross-section; Failed

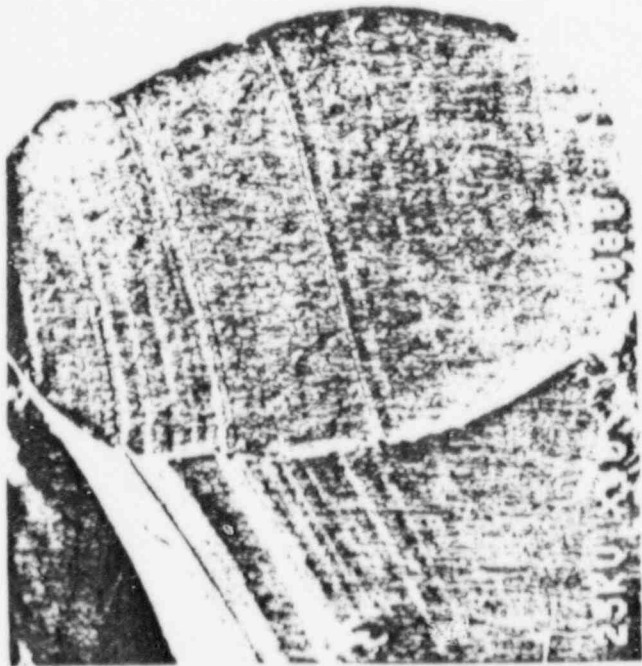
Figure 15. MSIV26
O-ring Cross-section; Not Failed

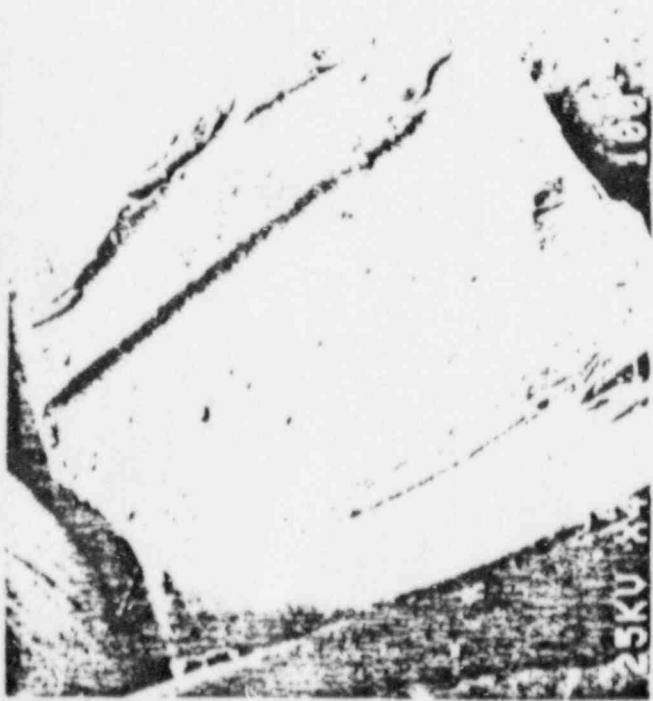
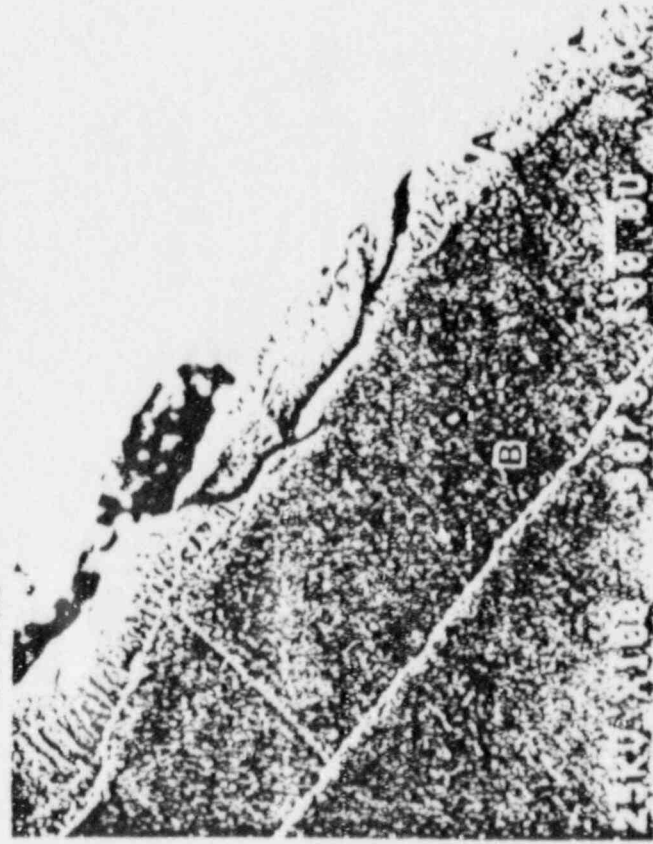
Figure 17. MSIV27
O-ring Cross-section; Failed

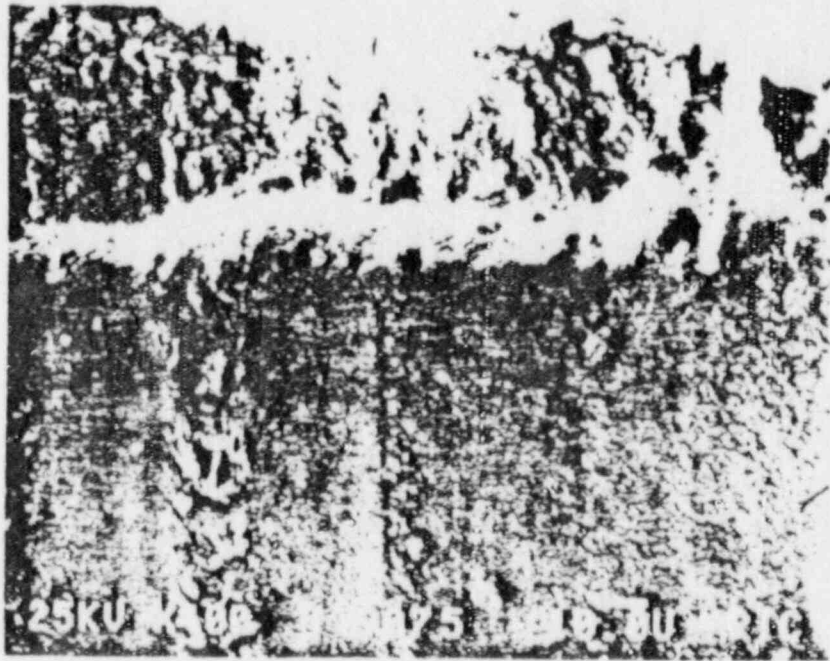
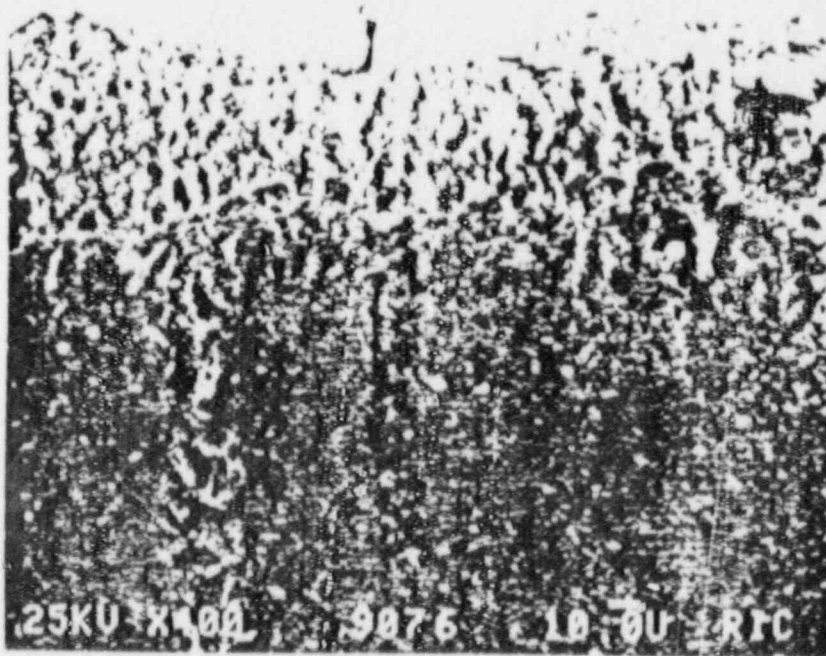
Figure 18. MSIV27
O-ring Cross-section; Failed

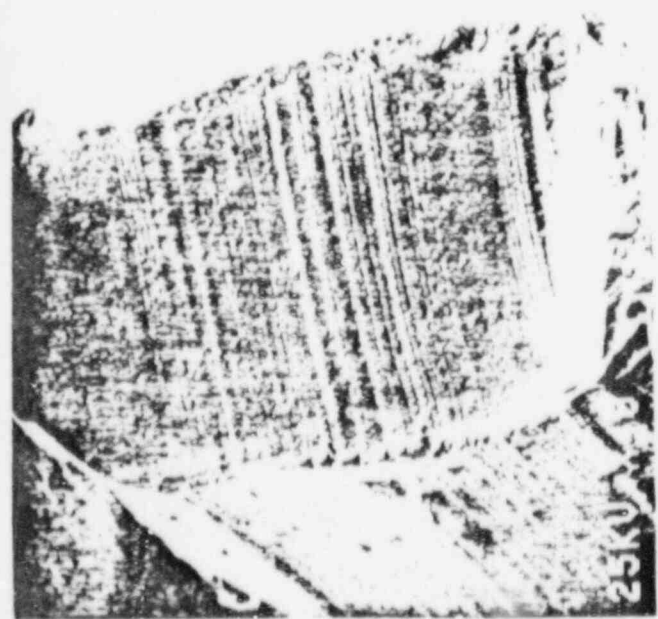
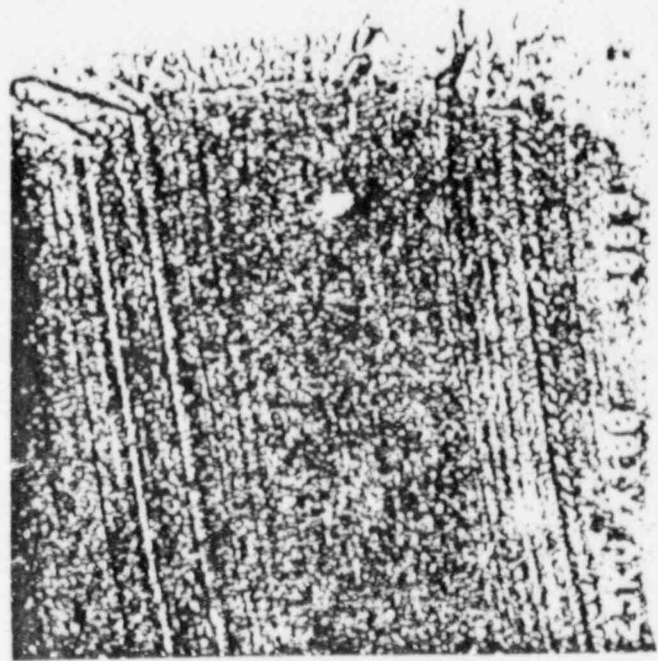
Figure 19. MSIV28 O-ring Cross-section; Failed

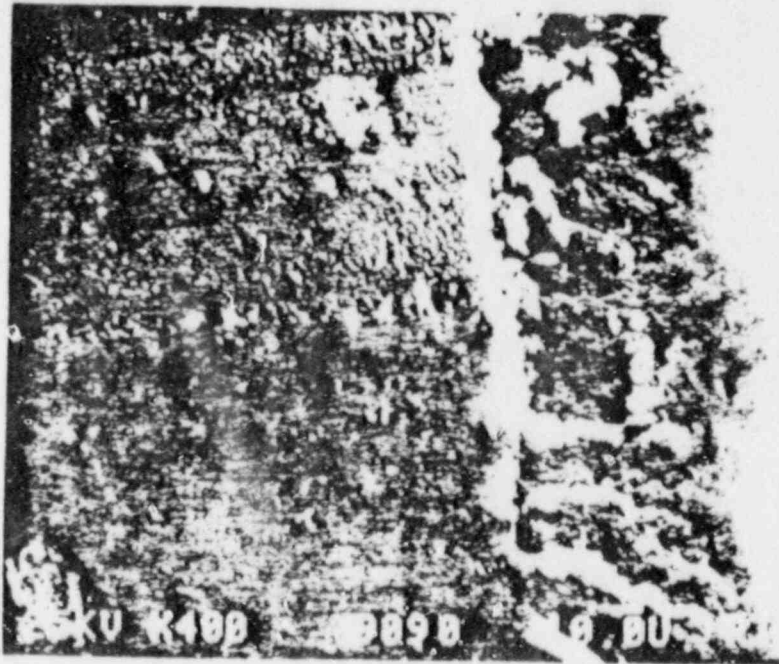
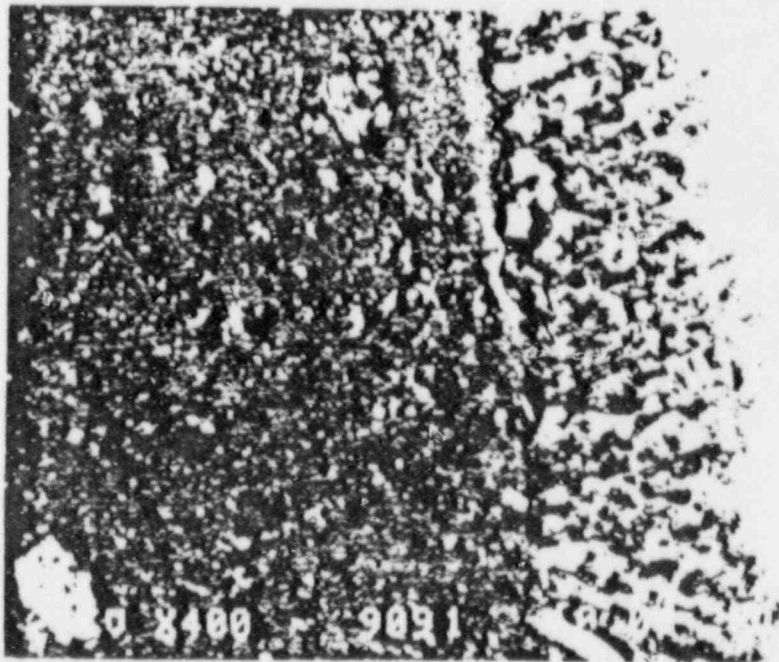
Figure 20. MSIV28
O-ring Cross-section; Failed

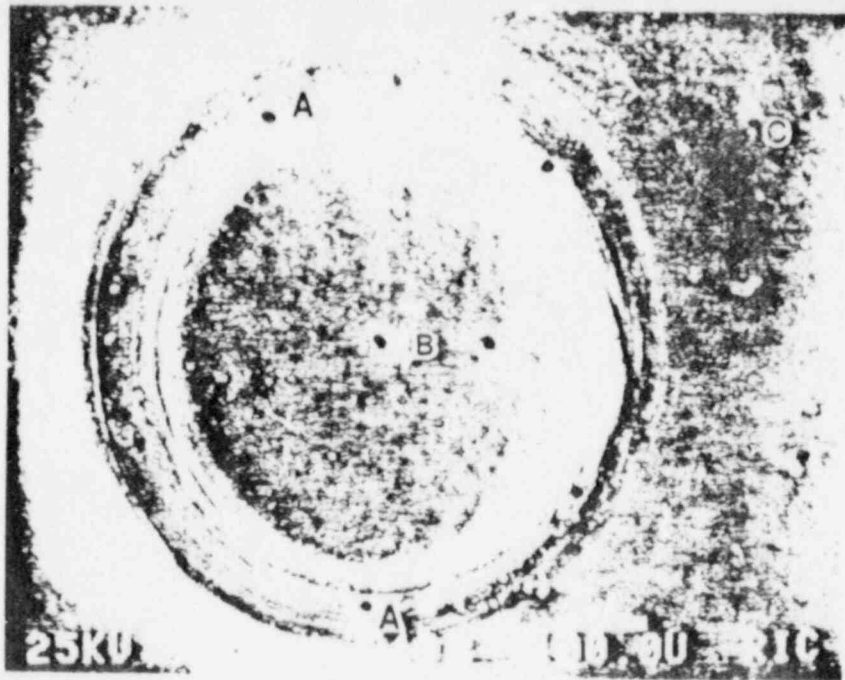
Figure 2.

MSIV24
Energized Elastomer Seats
Failed
Surface

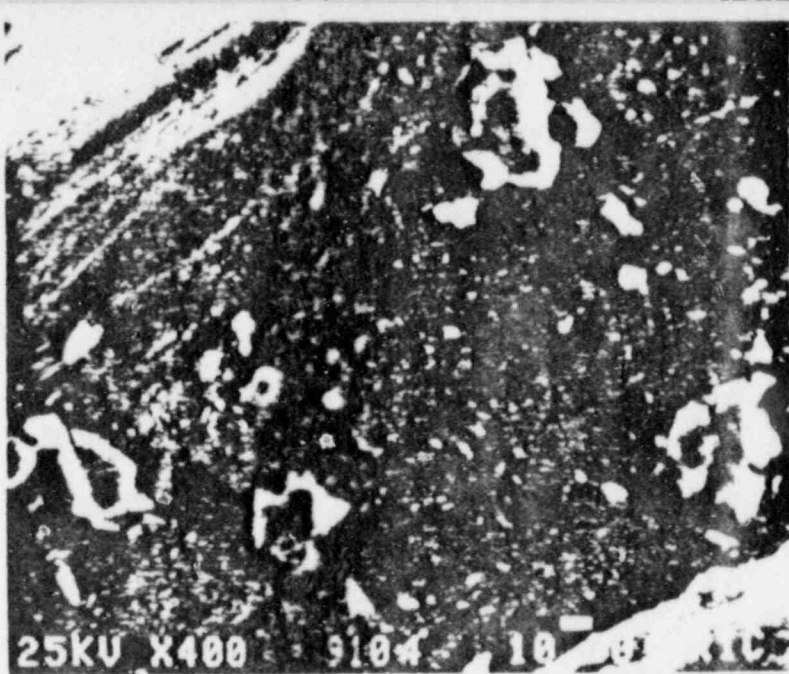
Figure 3.

MSIV24
Energized Elastomer Seats
Failed
Surface

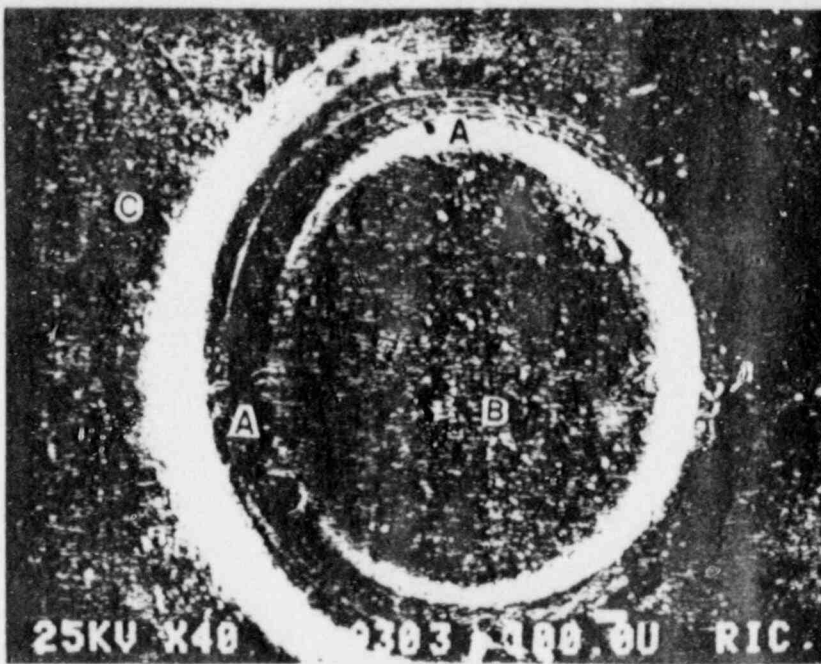
Figure 4.

MSIV26
Energized Elastomer Seats
Not Failed
Surface

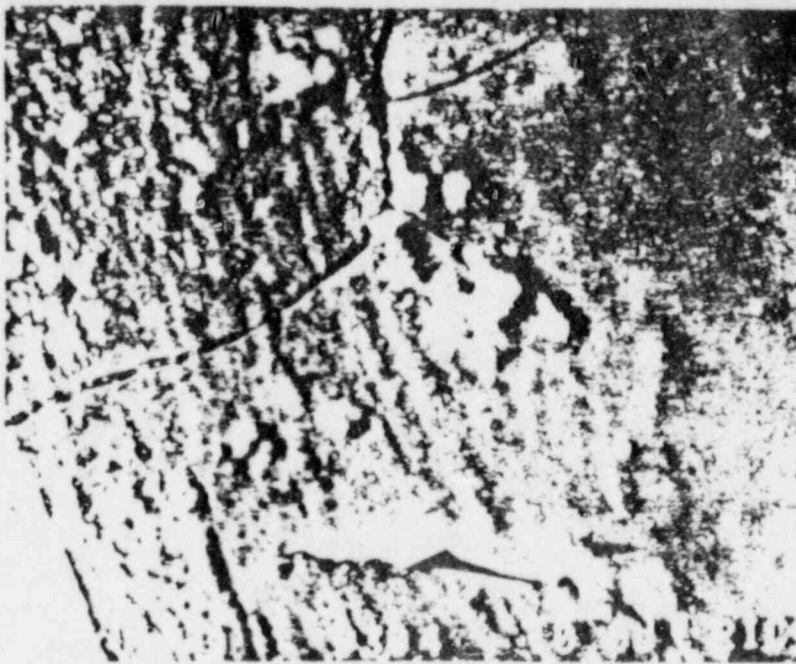
Figure 5.

MSIV26
Energized Elastomer Seat
Not Failed
Surface

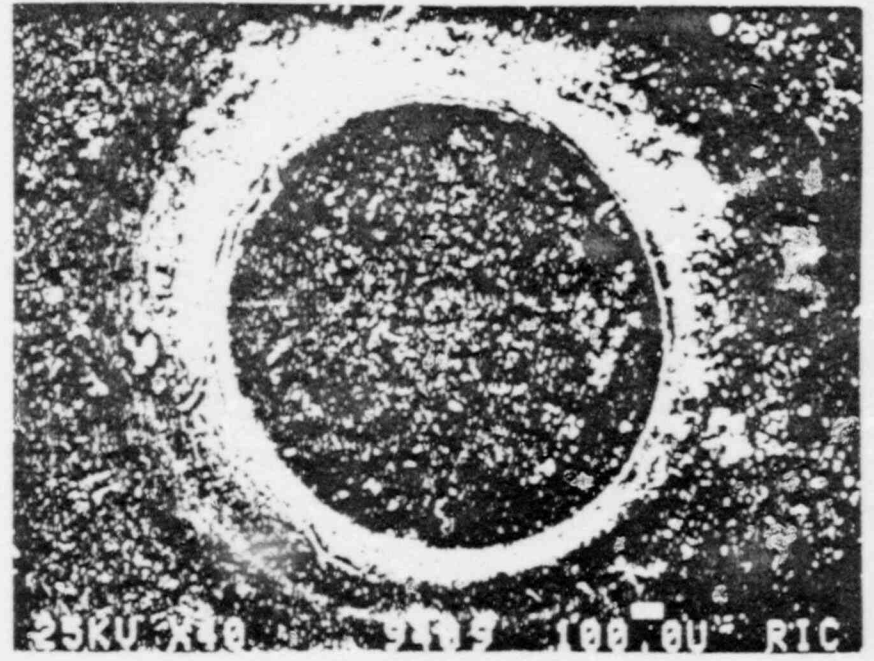
Figure 6. MSIV27; Energized Elastomer Seat; Failed; Surface

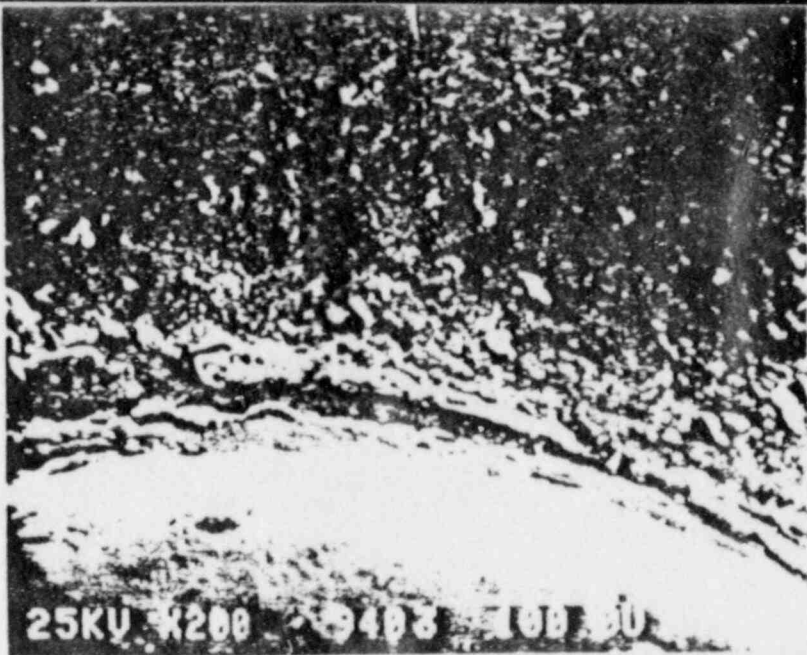
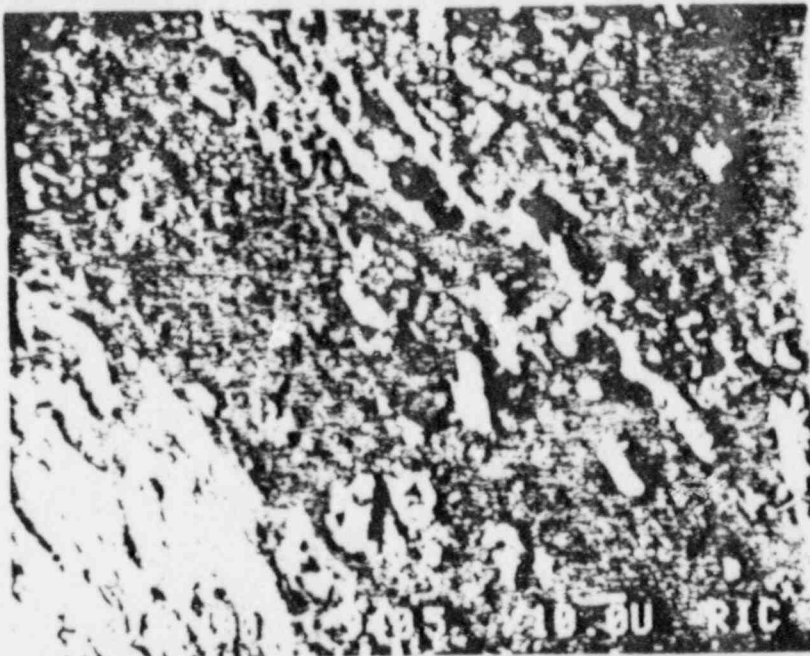
Figure 7.

MSIV27
Energized Elastomer Seat
Failed
Surface

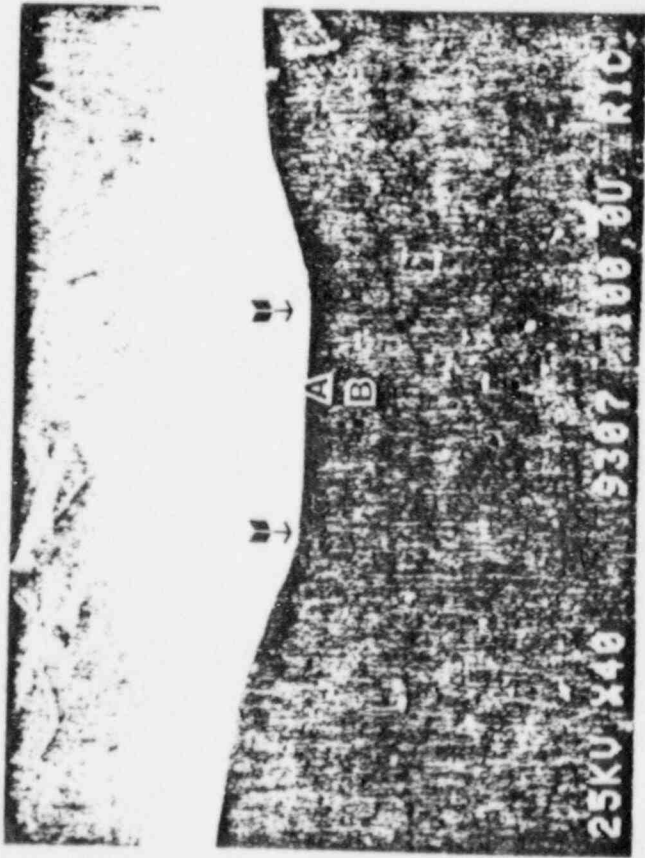
Figure 12. MSIV26; Energized Elastomer Seat; Not Failed; Cross-section

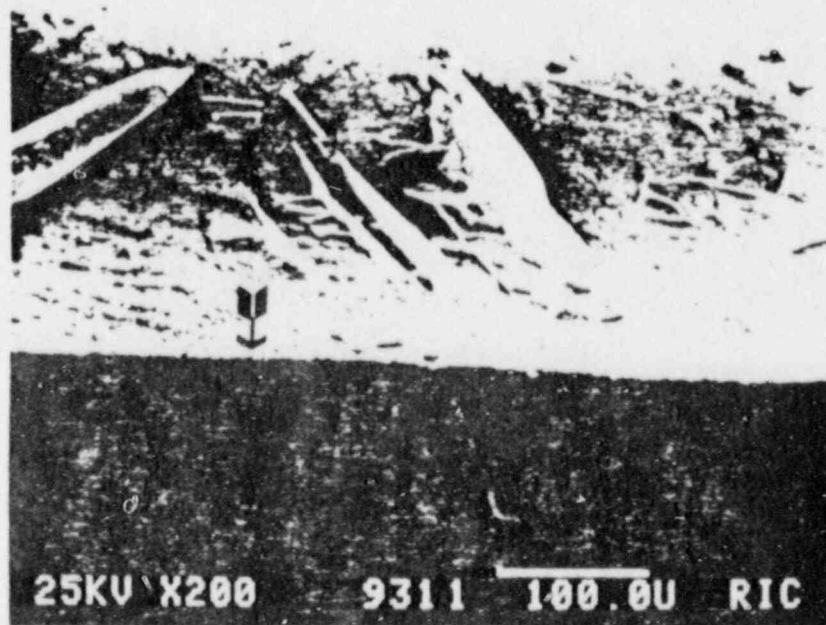
Figure 13. MSIV26; Energized Elastomer Seat
Not Failed; Cross-section

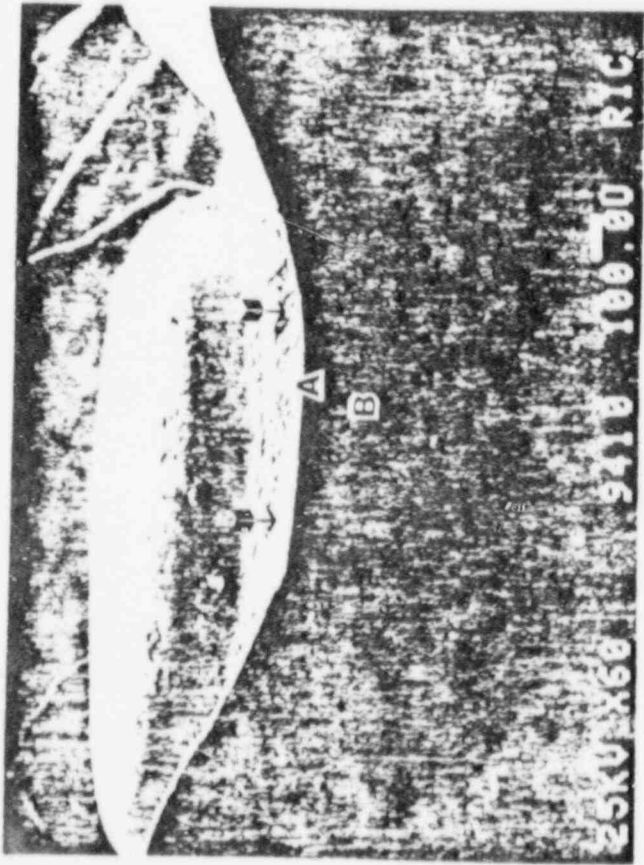
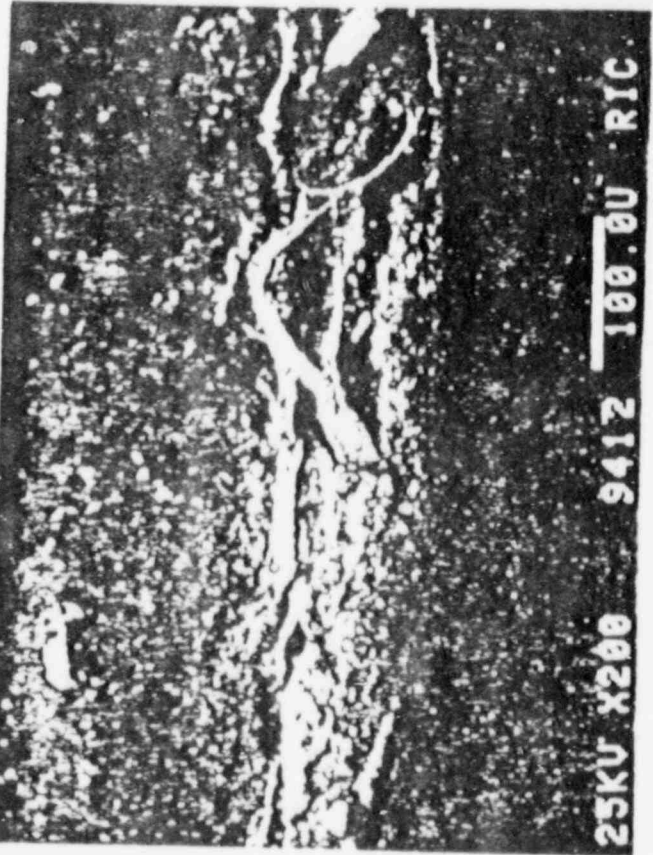
Figure 14. MSIV27; Energized Elastomer Seat; Failed; Cross-section
