EE-12-0013-REV. B

INTEGRATED SYSTEMS STUDY OF THE CONTROL ROD DRIVE MECHANISM
ROD POSITION INSTRUMENTATION

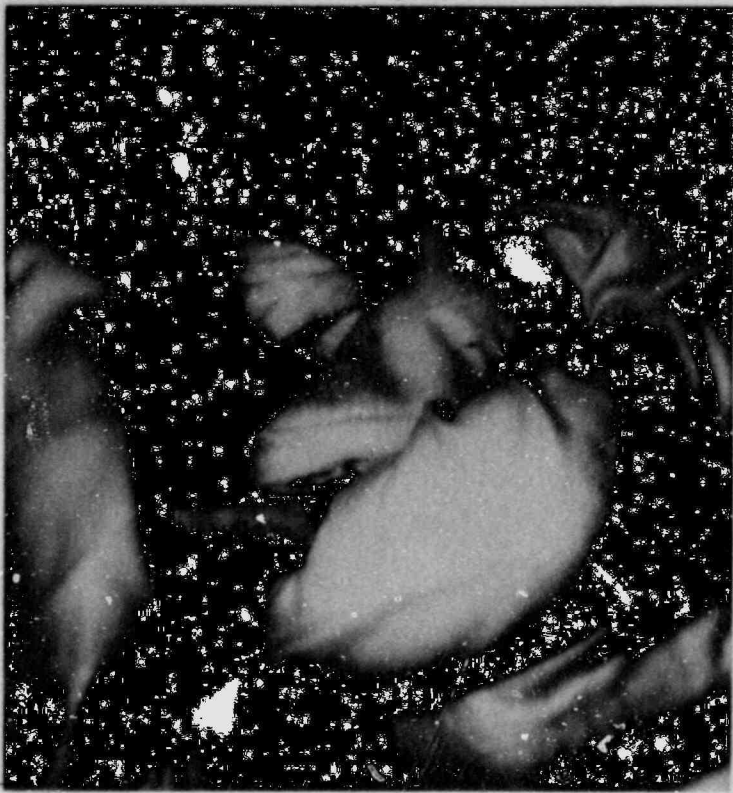
PHOTO OF FULL IN SWITCH SHAFT OF A PARTIALLY FAILED (STICKING) UNIT

Conclusions: Shaft fails due to high lateral forces caused by Cam angle $>15^\circ$ (recommended max per Mfr). Failure is by erosion, deposition of eroded metal, corrosion until space between shaft and housing is filled and will not allow free movement. To verify: (1) Contact manufacturer for concurrence; (2) Check for corrosion/erosion/deposition on only 1 side of shaft (side opposite Cam approach)
Verify as required.

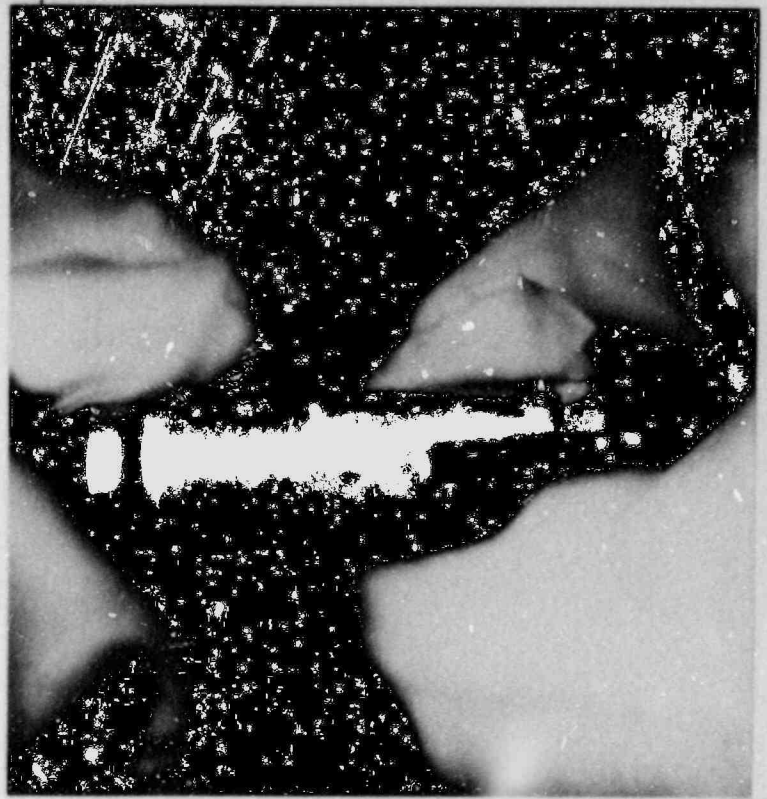
CLOSE-UP OF SAME SWITCH SHAFT SHOWING DEGRADATION OF SHAFT ON SIDE OPPOSITE CAM APPROACH

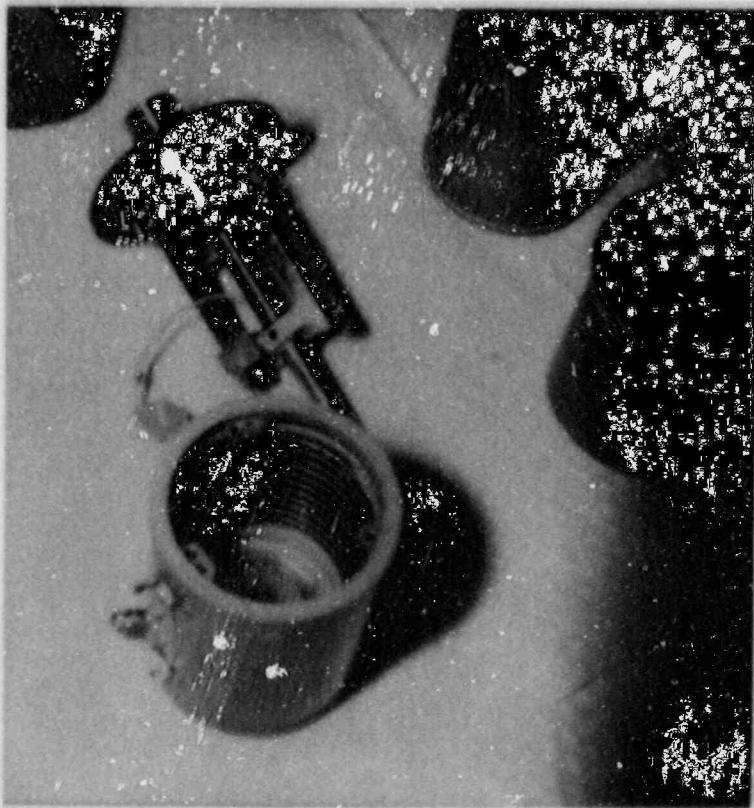
DISASSEMBLED POT WITH SLIDER, SHAFT ETC. VISIBLE*NEW*

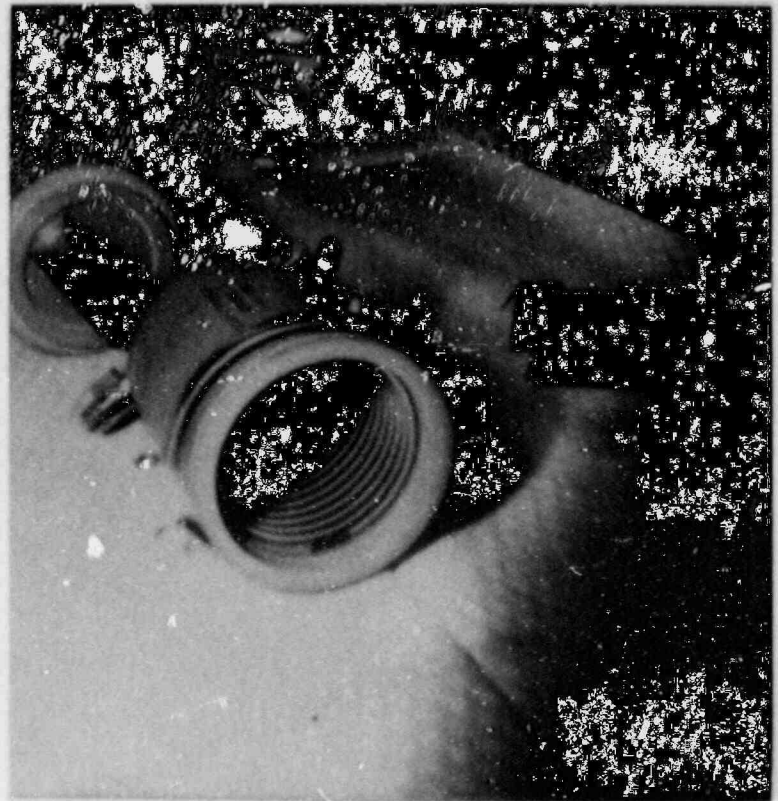
AN OLDER POT RESISTIVE ELEMENT VISIBLE FROM A SIMILAR ANGLE*AGE UNKNOWN*

Pg. 3 - C - Control Rod Position Potentiometer fails electrically by producing copper oxide and thus changing the resistance of the potentiometer. This results in erroneous indication in the Control Room.

Cause - Electrolysis induced by bare copper and other metals in a moist environment. Apparently, the added current of the circuit aid in the electrolysis.

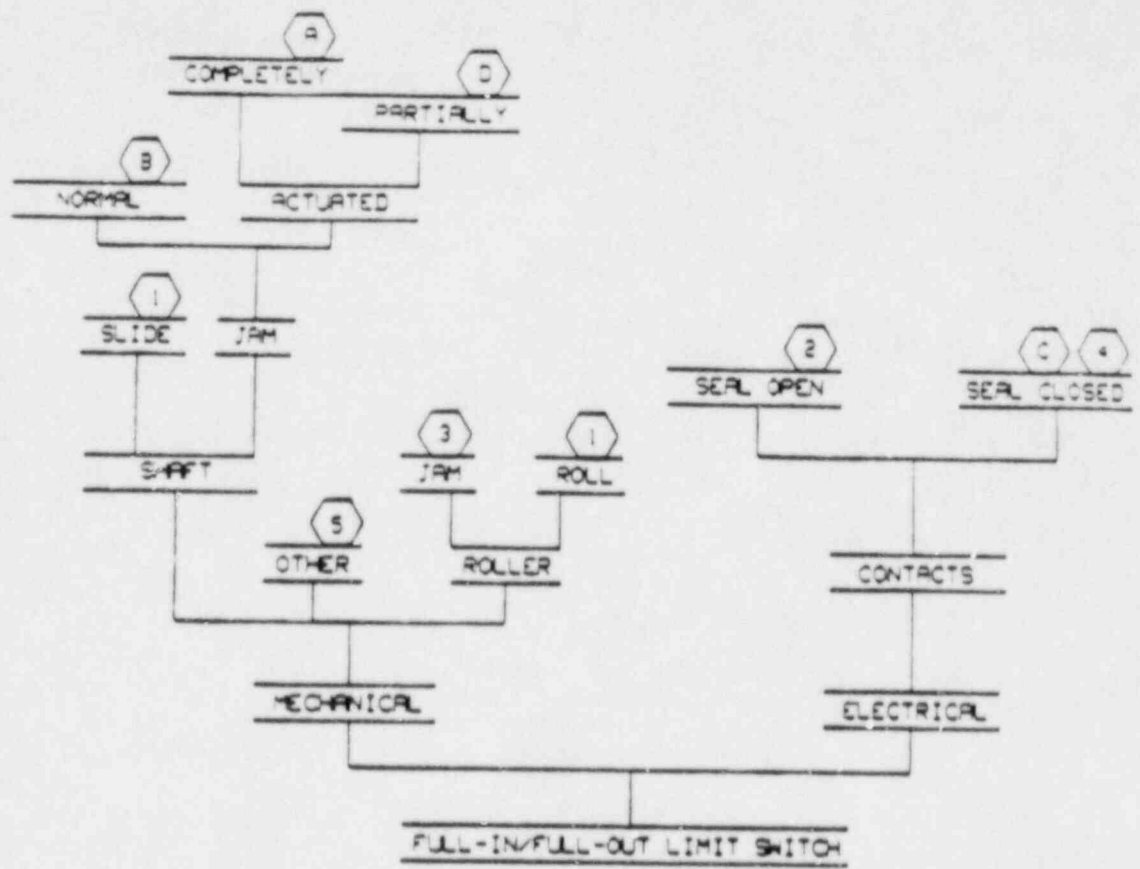
FAILURE ANALYSIS TREE

Pg. 1 - A - Full-In/Full-Out Switch fails mechanically by jamming the shaft in the completely actuated position.

Cause - Shaft Failure
Investigate cause of shaft failure.

Pg. 1 - B - Same as "A" above, except position at which final failure occurs.* Cam may fail.*

Pg. 1 - D - Same as "A" above, except position at which final failure occurs.

Pg. 1 - C - Full-In/Full-Out Switch fails electrically by sealing the contacts in the closed position. Not credible.

Cause - High inductance discharge from relay coil.

A commitment for testing of surge suppressors is in place.

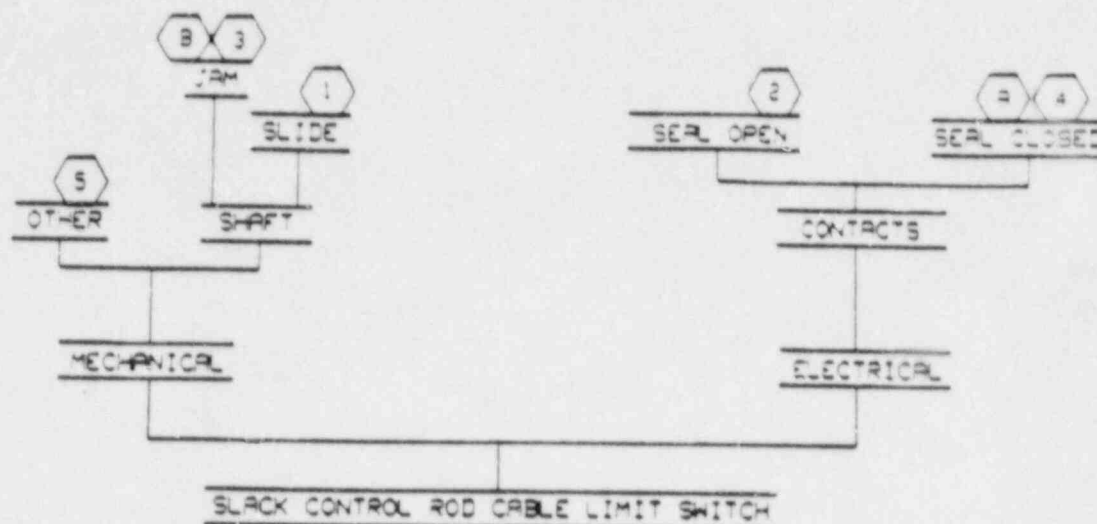
FAILURE ANALYSIS TREE

Pg. 2 - A - Slack cable Limit Switch fails electrically by sealing the contacts in the closed position. Not judged a credible failure.

Cause - High inductive discharge from relay coil.

Pg. 2 - B - Slack cable Limit Switch fails mechanically by jamming the shaft in the completely actuated position. Not a credible failure.

Cause - None known.

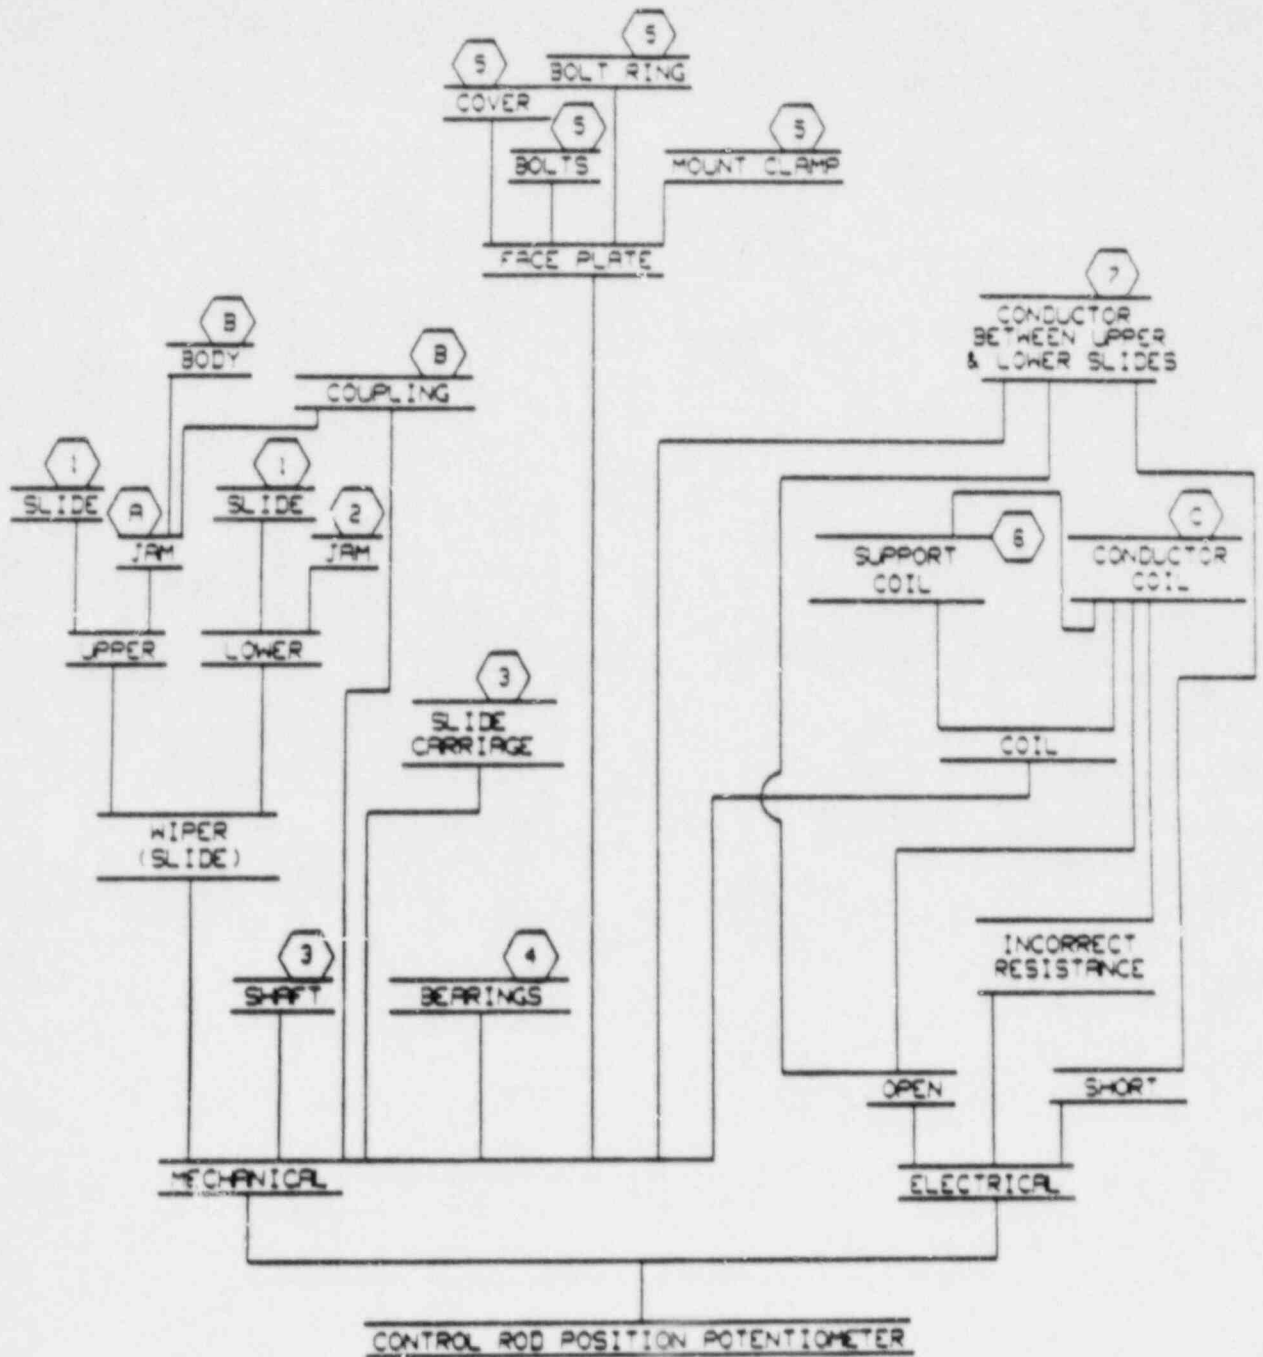
FAILURE ANALYSIS TREE

Pg. 3 - A - Control Rod Position Potentiometer fails mechanically by jamming the upper wiper resulting in wiper damage.

Cause - Control Rod Drive Mechanism (CRDM) is overdriven (forced beyond the intended design limit) in an attempt to actuate non-working Limit switches.

Pg. 3 - B - Control Rod Position Potentiometer fails mechanically by jamming the upper wiper resulting in body or coupling damage.

Cause - Same as "A" above.

An administrative procedure now controls this action to limit this type of damage.
