Millstone Nuclear Power Station, Unit No. 2
Independent Corrective Action Verification Program
Unresolved Discrepancy Reports

Millstone Nuclear Power Station, Unit No. 2

DR-0027

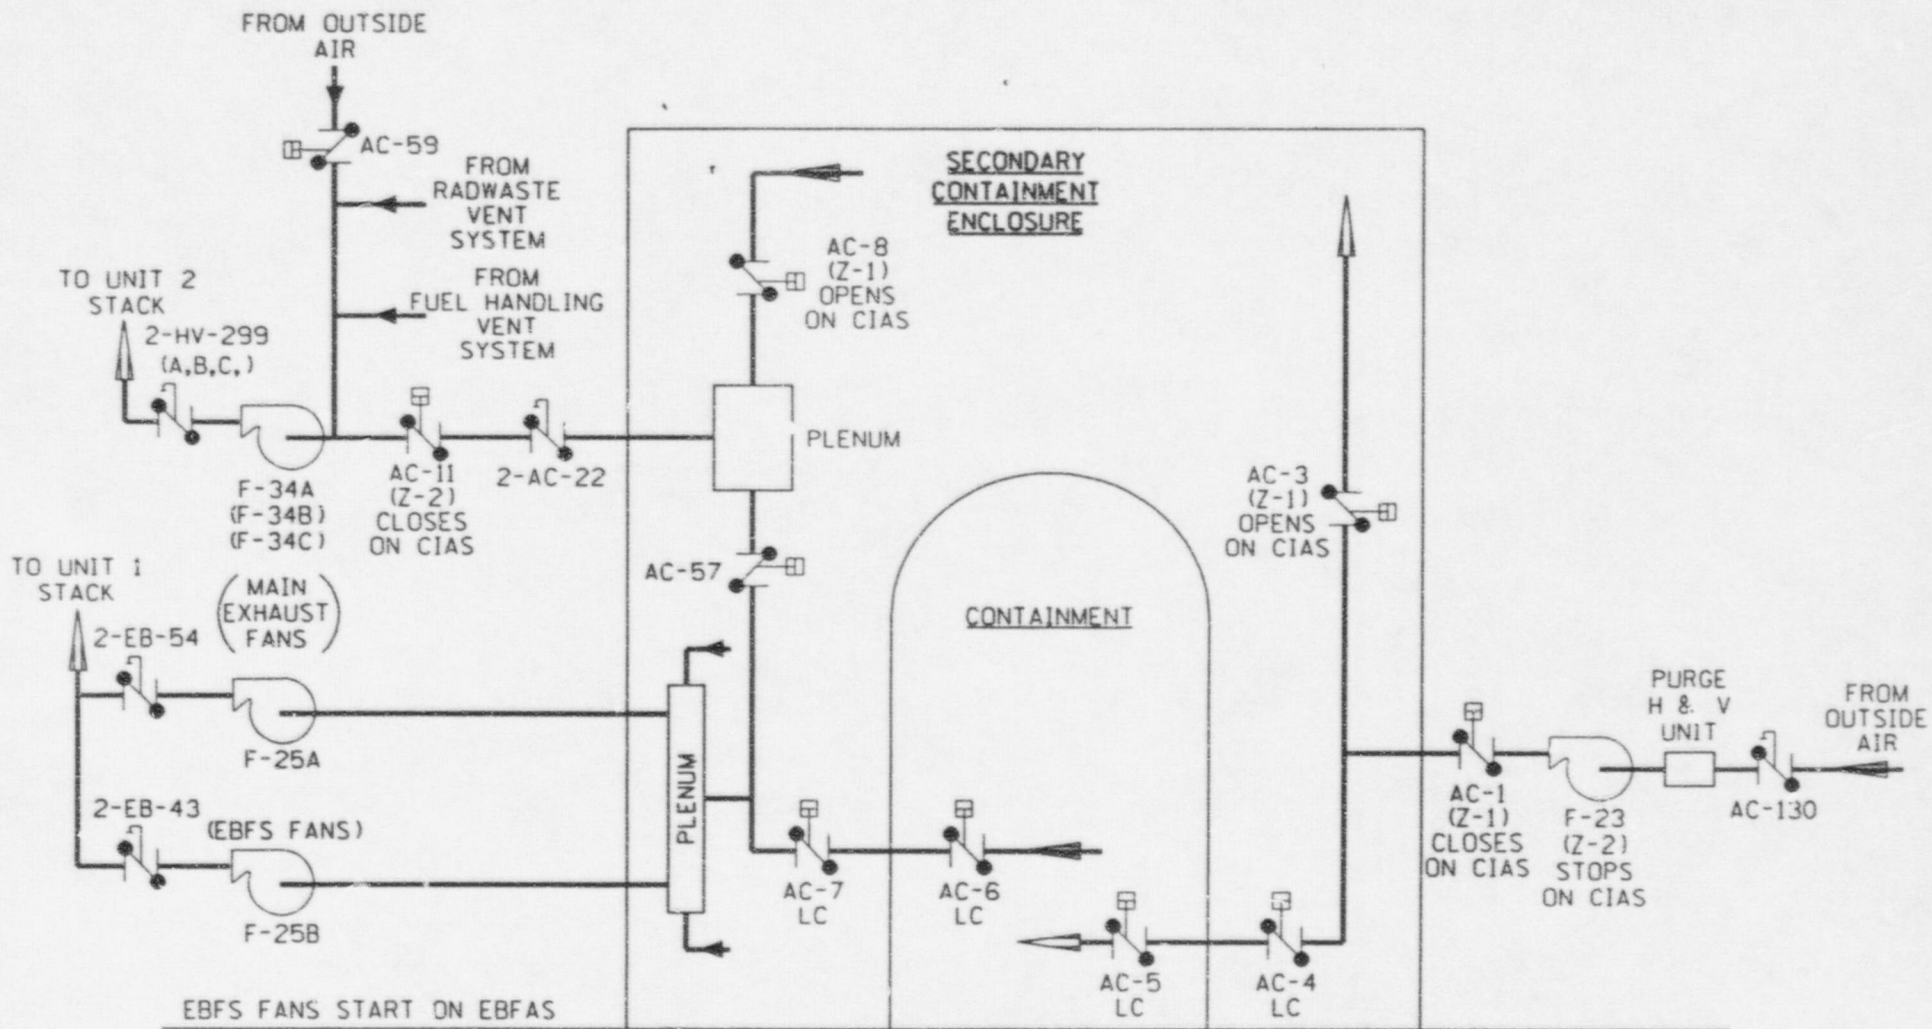
EBFS AND CONTAINMENT & ENCLOSURE BUILDING PURGE SYSTEM

- Millstone 2 Enclosure Building Ventilation Layout
- Scenario
 - Infrequent Purge Operation, research of a sample year concluded Enclosure Building purge occurs less than 7% of the time
 - LOCA Coincident with Single Failure of 1-AC-11 to close
 - Results in Main Exhaust Fans and EBFS Fans Pulling on Enclosure Building
