SUBJECT: THE OPERATING REACTORS EVENTS MEETING
May 3, 1988 - MEETING 88-18

OPERATING REACTORS EVENTS BRIEFING (88-18)

OCONEE UNIT 2
POWER CIRCUIT BREAKER PROBLEMS
APRIL 26, 1988

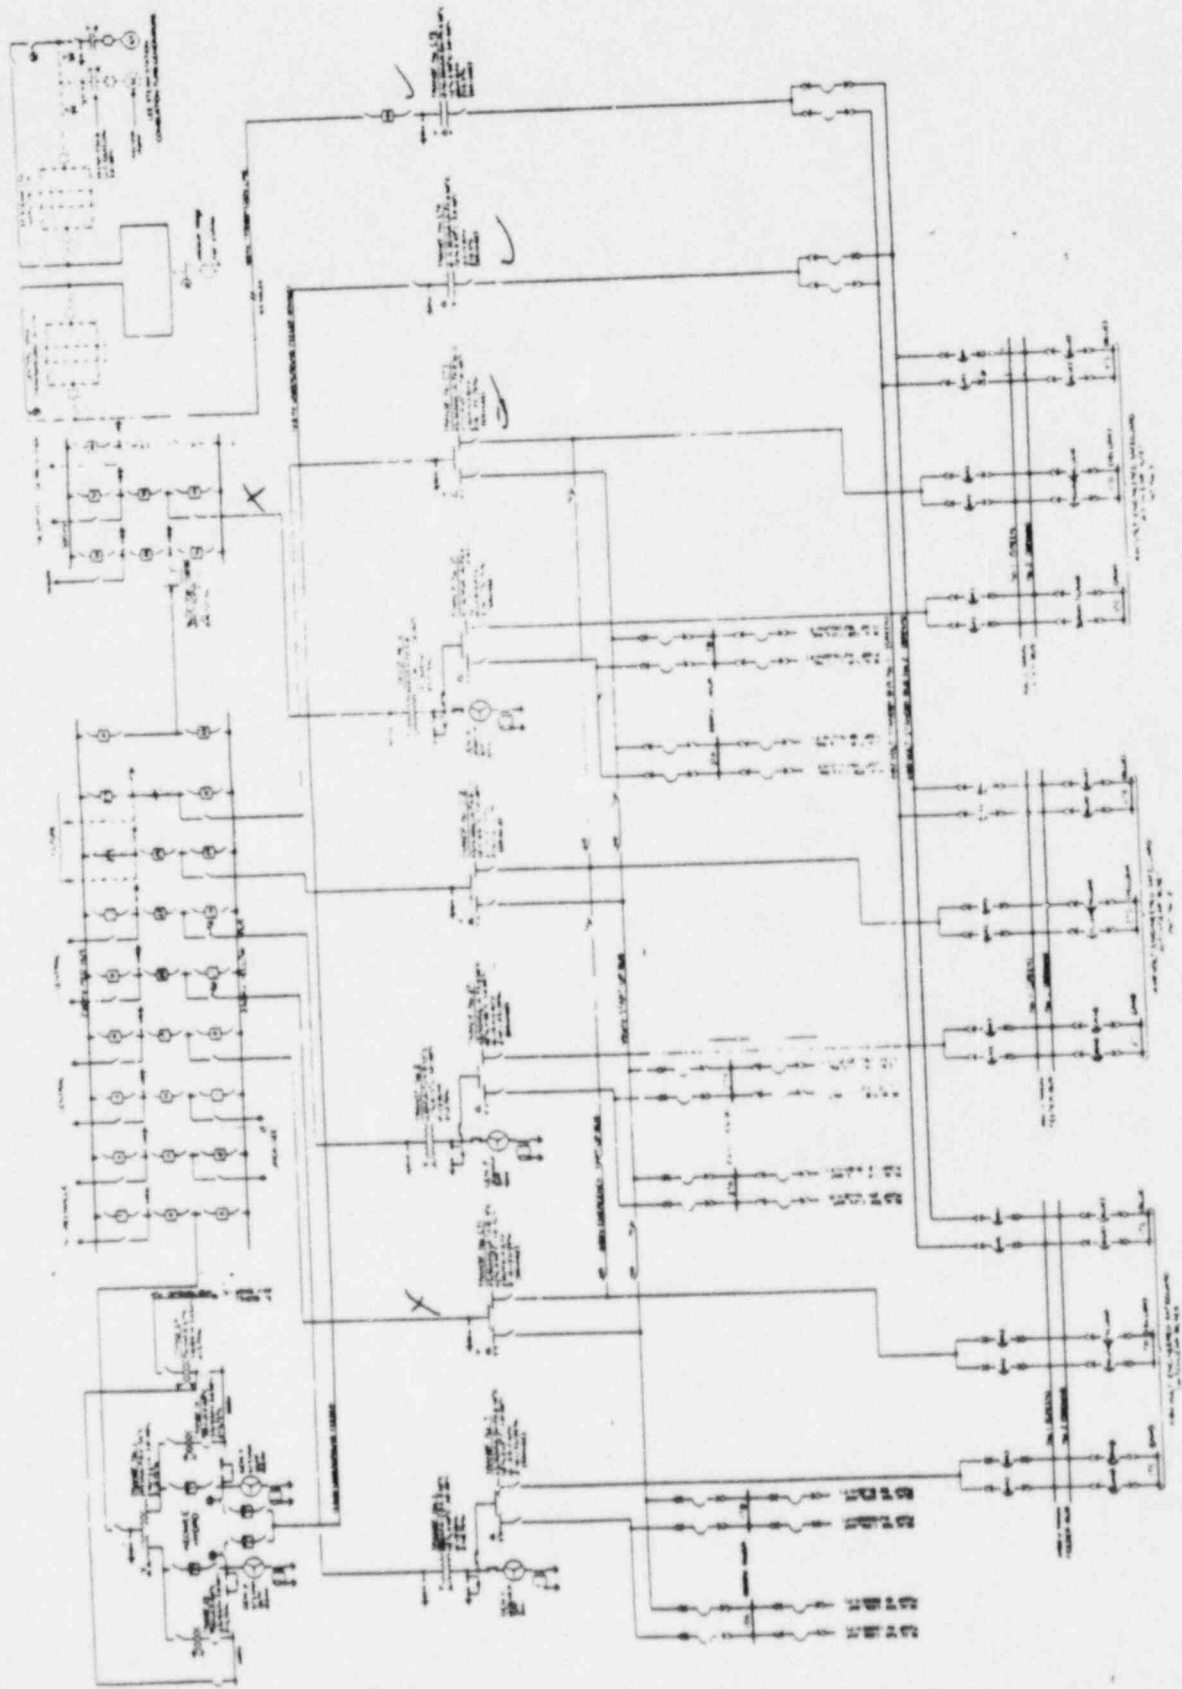
STATION MAIN BUSES
 SINGLE LINE DIAGRAM
 OCONEE NUCLEAR S
 Figure 8.1-1

NEW SWITCHYARD POWER CIRCUIT BREAKERS ENABLED THE EMERGENCY POWER SWITCHING LOGIC TO BE DEFEATED

OVERSIZED CIRCUIT BREAKER (COGENEL) CAPACITORS SET UP INDUCTIVE AND CAPACITIVE RESONANCE RESULTING IN A HIGH VOLTAGE ON THE SECONDARY SIDE OF THE STARTUP TRANSFORMER

A FALSE FAULT INDICATION IN THE STARTUP TRANSFORMER COINCIDENT WITH A REACTOR TRIP WILL PREVENT THE EMERGENCY POWER SWITCHING LOGIC (EPSL) FROM PICKING UP ITS EMERGENCY POWER SOURCES.

- o OCONEE SYSTEM PLANNING DEPARTMENT CHANGED OUT A NUMBER OF POWER CIRCUIT BREAKERS (PCB) IN FAVOR OF PCB'S WITH HIGHER FAULT INTERRUPTING DUTIES IN ANTICIPATION OF INCREASED GRID GENERATION CAPABILITY.
- o APRIL 4, 1988 UNIT 2 STARTUP WITH COGENEL PCB'S. UNIT 3 IN SHUTDOWN, ITS" PCB"S ARE ITE PCBs. UNIT 1 IS OPERATING, HALF ITS' PCB'S ARE COGENEL'S.
- o APRIL 26, 1988 WORKERS IN THE SWITCHYARD QUESTION THE LOUD HUMMING NOISE COMING FROM THE UNIT 2 (CT2) STARTUP TRANSFORMER WHEN THEY KNOW IT'S POWER CIRCUIT BREAKERS ARE LOCKED OUT.
- o OCONEE DETERMINES THAT A HIGH VOLTAGE EXIST ON THE SECONDARY SIDE OF THE STARTUP TRANSFORMER.
- o ENGINEERING EVALUATION DETERMINES THAT THE CAPACITOR ACROSS THE COGENEL PCB ARE PASSING ENOUGH CURRENT TO SET UP A C & L RESONANCE WITH THE STARTUP TRANSFORMER WHICH ESTABLISH A LARGE VOLTAGE ON THE SECONDARY SIDE OF THE TRANSFORMER.

- o IMMEDIATE CORRECTIVE ACTION TAKEN BY LICENSEE TO LINE UP THE UNIT 3 STARTUP TRANSFORMER TO UNIT 2.
- o LICENSEE STATED THAT UNIT 3 WILL NOT BE RESTARTED UNTIL THE UNIT 2 PCB ARE AVAILABLE TO BE RETURNED TO SERVICE.
- o POST-INSTALLATION SYSTEM TESTING DID NOT IDENTIFY THE DESIGN PROBLEM.

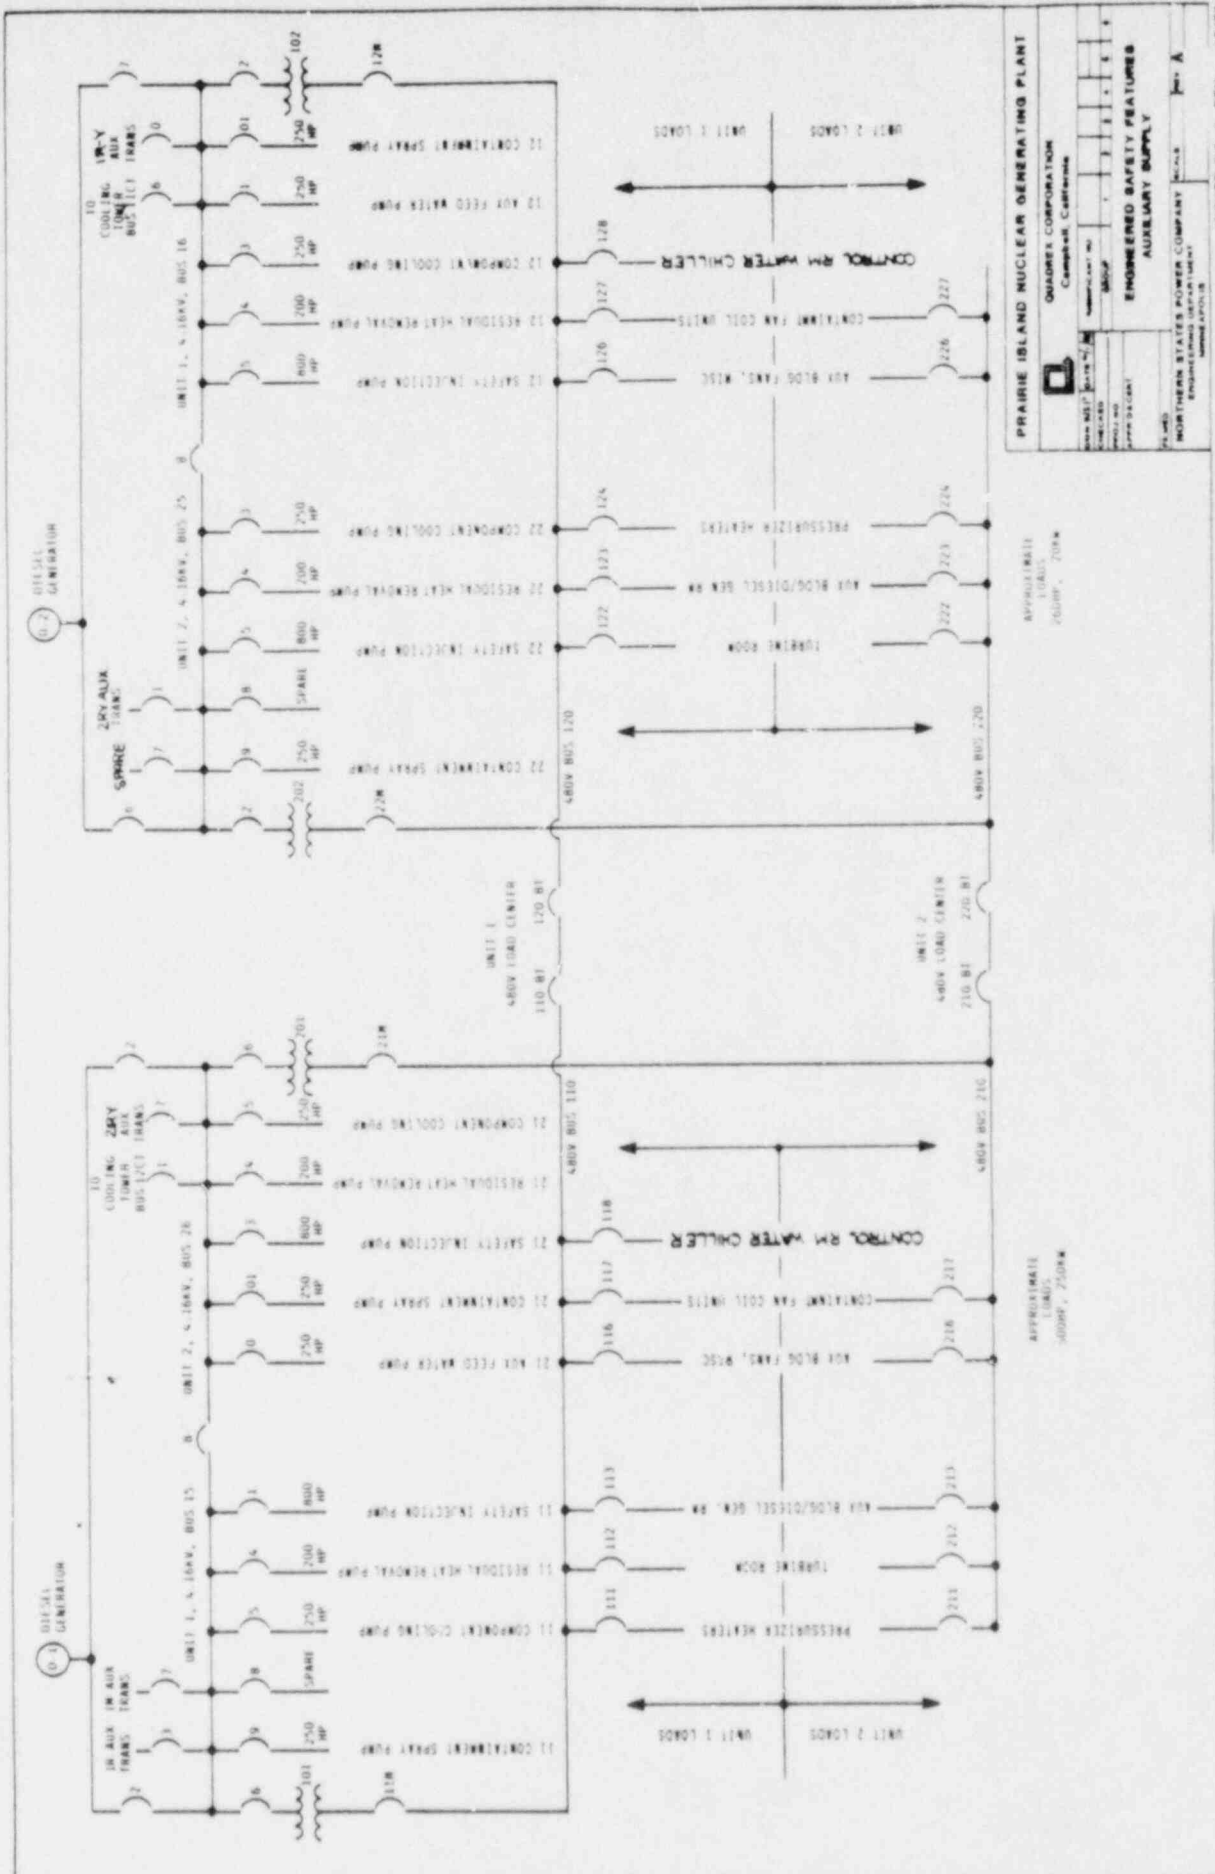
**ENGINEERED SAFETY FEATURES
AUXILIARY SUPPLY**

SINGLE FAILURE (FUSE) RENDERS ONE ESF BUS INOPERABLE.

IMPROPER MAINTENANCE ACTION BLOWS D.C. CONTROL POWER FUSE.

THE AFFECTED BUS COULD NOT BE ENERGIZED BY EITHER THE EMERGENCY DIESEL OR OFFSITE POWER.

- o TECHNICIAN BLEW A D.C. CONTROL CIRCUIT FUSE RENDERING AUTO SEQUENCING OF DIESEL #2'S LOADS TO THE ESF BUS OR AN ALTERNATE BUS INOPERABLE.
- o THIS FAILURE COULD ALSO DISABLE FAST TRANSFER OF THE ESF BUS TO OFFSITE POWER. MANUAL CONTROL WAS STILL AVAILABLE.

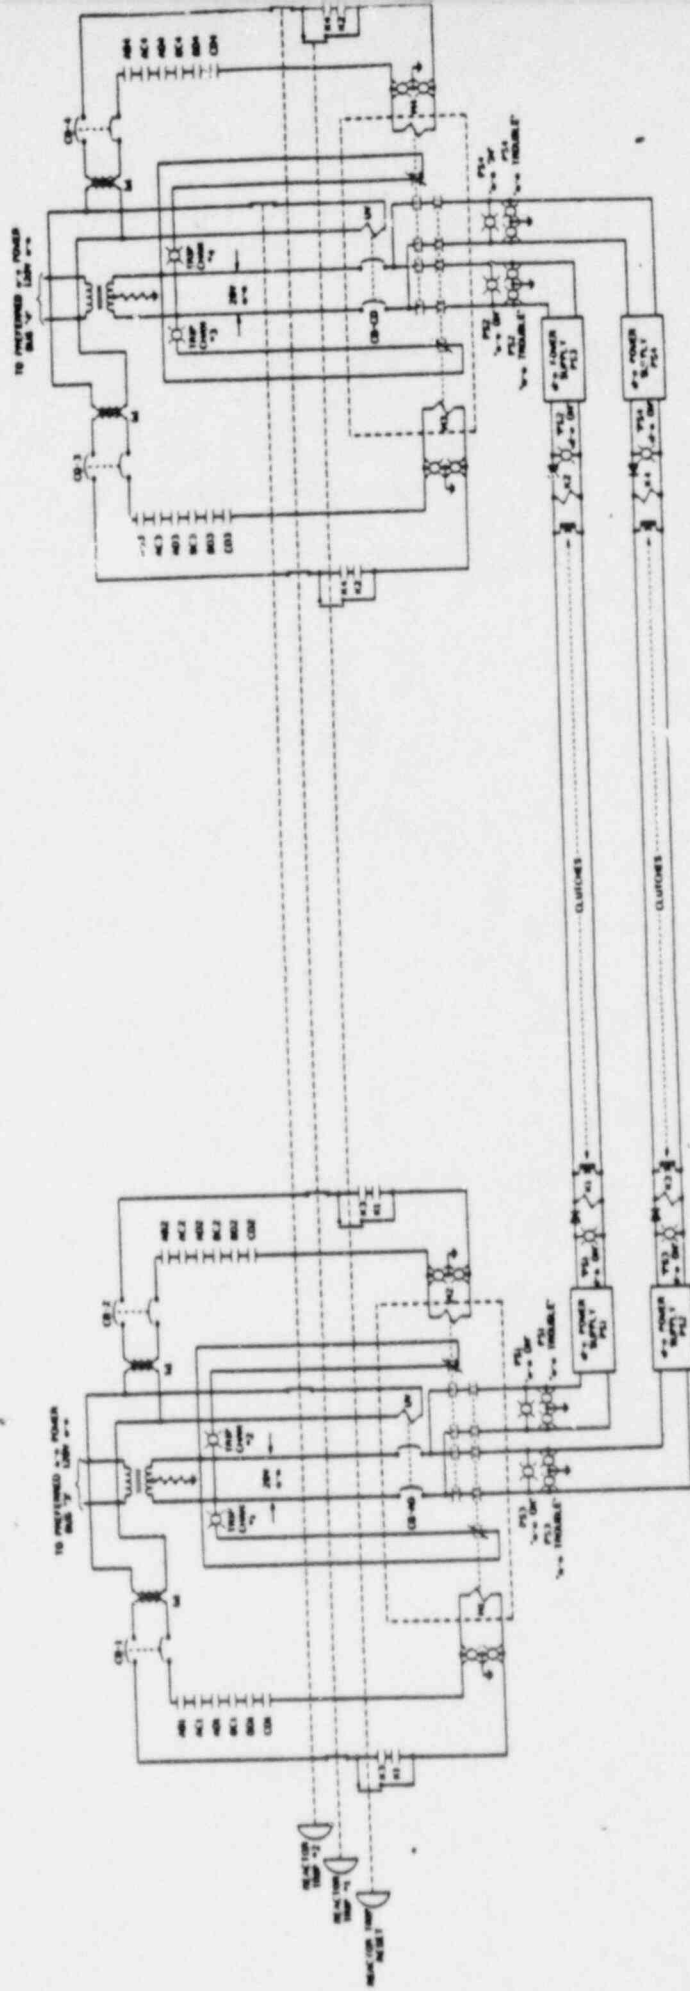
PALISADES 1

- o AN UNRECOVERABLE DROPPED ROD FORCED A PLANT SHUTDOWN FROM 100% POWER.
- o DURING PLANT SHUTDOWN, EQUIPMENT FAILURE ERROR RESULTED IN THE OPENING OF THE #6 HP FEEDWATER HEATER SAFETY RELIEF AND OPERATOR ERROR RESULTED IN THE OVER FLOWING OF COOLING TOWER BASIN.
- o IN PREPARATION FOR STARTUP, A TEST OF ONE OF THE MANUAL RX TRIP PUSH BUTTONS FAILED TO OPEN THE UNDERVOLTAGE TRIP BREAKER.

- o CAUSE OF THE DROPPED ROD HAS NOT BEEN DETERMINED.
- o ROOT CAUSE FAILURE OF THE UNDERVOLTAGE TRIP ATTACHMENT IS STILL UNDER INVESTIGATION.

- o DROPPED ROD IS AN ANALYZED EVENT WITH MINIMAL SAFETY SIGNIFICANCE.
- o THE OPERATOR ERRORS, ALTHOUGH DISCONCERTING, DID NOT RESULT IN ANY PERSONAL INJURIES OR CONTAMINATION.
- o THE FAILURE OF THE UNDERVOLTAGE RELAY IS A FAILURE OF THE BACKUP REACTOR TRIP SYSTEM.

- o LICENSEE REPLACED BOTH UV BREAKERS.
- o UV BREAKER FAILED DUE TO THE UV COIL BEING IMPROPERLY MOUNTED ALLOWING COIL TO ROTATE RATHER THAN TO GENERATE A TRIP. ROOT CAUSE UNDETERMINED.
- o SECOND UV BREAKER ANALYZED AND NO DEFICIENCIES WERE IDENTIFIED.
- o LICENSEE REPLACED THE CRD PACKAGE AND ALL CRD CABLING/CONNECTIONS WITHIN CONTAINMENT.
- o LICENSEE INITIATED CLEANUP OF RADWASTE BLDG AND FW HEATER AREA.
