Subject: SEQUOYAH NUCLEAR PLANT - UNIT 1 - INCORE THIMBLE EJECTION -
INVESTIGATION AND REVIEW OF EVENTS FOR INDUSTRIAL SAFETY
IMPLICATIONS

INCORE THIMBLE EJECTION - SEQUOYAH NUCLEAR PLANT, UNIT 1

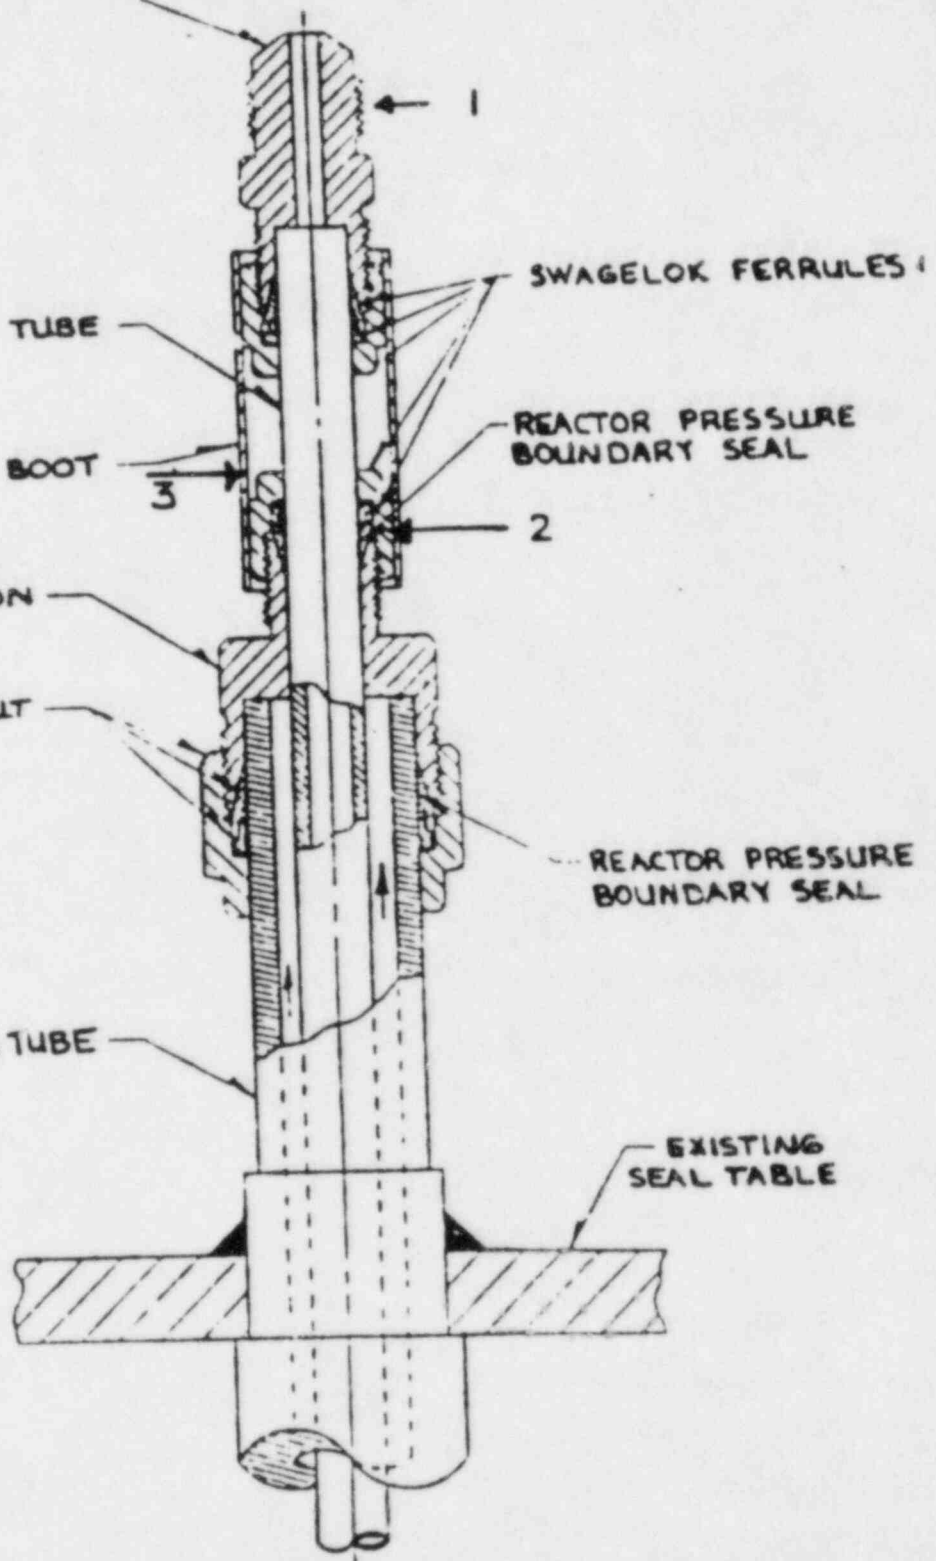
ATTACHMENT 3

The specially designed brushing mechanism is composed of several feet of heliflex cable fed through a stabilizing tube and forced through the thimble tube by a hand crank. Attachment 3 shows a cut-away detail of the thimble tube connection. The hand crank is attached to the thimble tube at point 1, with the brush entering the connection at that point.

The failure occurred at the reactor pressure boundary seal, point #2 (attachment 3). This seal is obtained by a 5/16-inch swagelok nut and ferrules crimped onto a smaller stainless steel heavy wall tube expanded to 5/16 inch. This union is protected from external tampering by a plastic boot (point 3).

The reason for the failure is not evident. Existing possibilities are (1) the tube was not expanded sufficiently or to a sufficient depth (specifications require a minimum of 1.5 inches), (2) the swagelok was not tightened sufficiently (hand tight and 1.25 additional turns) to set the ferrule, (3) the nut had inadvertently been loosened since the union was made, allowing the ferrule to relax, or (4) the partial crack in the ferrule allowed the tube to be released. The flexing activity of the brushing would have aggravated any of the above conditions leading to the failure. Following this failure all fittings were checked and some were tightened. SMI-0-94-1 states that this procedure is not to be used at power. Since the unit was in Mode 1, this procedure was violated.

1. All cleaning and brushing of these tubes should be done with the reactor at Mode 5.
2. If for some reason the brushing iteration is required past Mode 5, a thorough prejob safety analysis should be performed and the procedure approved by PORC. As a minimum, a mechanism should be installed to preclude tube ejection and leakage and a clear path of egress should be established.

3. A rigidly mounted attachment should be fabricated on which the brushing mechanism and crank would mount which will eliminate any stress or flex on the thimble tube connection. An alternative method of cleaning which would mount independently of the thimble tube would be preferred.

6. Ensure that all emergency notification systems are in constant operation. The air lock telephone was out of service during this event.
7. Reinstall the plastic boots or install other means around all reactor pressure boundary seal unions to prevent tampering.
