LICENSEE EVENT REPORT (LER)

FACILITY NAME (1) Catawba Nuclear Station, Unit	DOCKET NUMBER (2) 0 5 0 0 0 4 1 3	PAGE (3) 1 OF 1 4
---	---	-----------------------------

TITLE (4) **Degraded Performance of Unit 1 Auxiliary Feedwater System and Required Hot Shutdown of both Units Due to Asiatic Clam Infestation In The Nuclear Service Water System.**

Subject: Catawba Nuclear Station, Units 1 and 2
Docket Nos. 50-413 and 50-414
LER 413/88-15, Revision 1

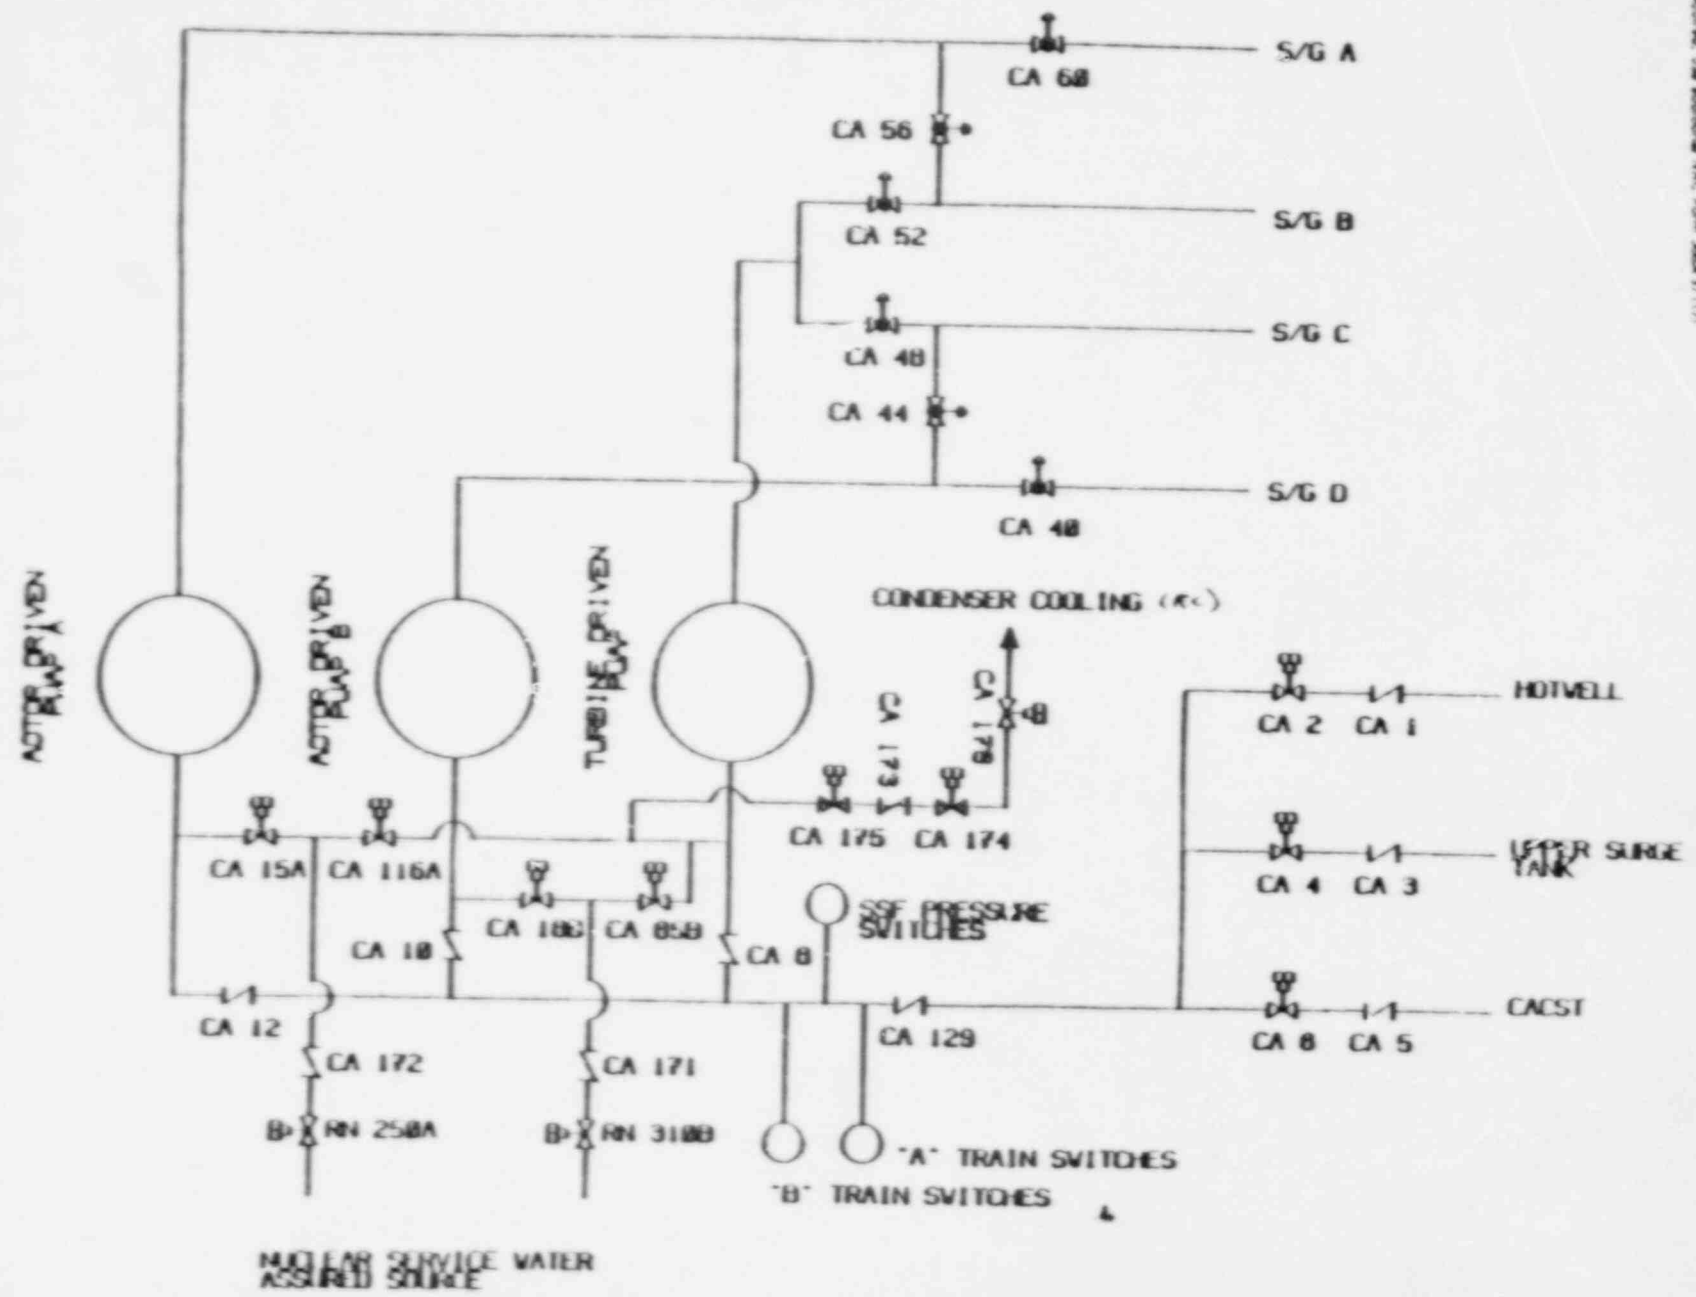
CATAWBA NUCLEAR STATION - (FIGURE 1) AUXILIARY FEEDWATER SYSTEM

The Auxiliary Feedwater (EIIS:BA) (CA) System ensures a sufficient feedwater supply to the Steam Generators (EIIS:SG) (S/Gs) in the event of loss of Main Feedwater (EIIS:SJ) (CF) System, to remove stored and residual core energy from the Reactor Coolant (EIIS:AB) (NC) System. Each Unit is provided with a separate CA System which is designed to be capable of cooling down the NC System to the temperature at which the Residual Heat Removal (EIIS:BP) (ND) System may be operated. There are two motor (EIIS:MO) driven CA pumps (EIIS:P) (MDCAPs) and one steam turbine (EIIS:TRB) driven CA pump (TDCAP) per Unit. Each MDCAP is capable of supplying two S/Gs while the TDCAP is capable of supplying all four S/Gs. Figure 1 shows a simplified flow diagram for the CA System.

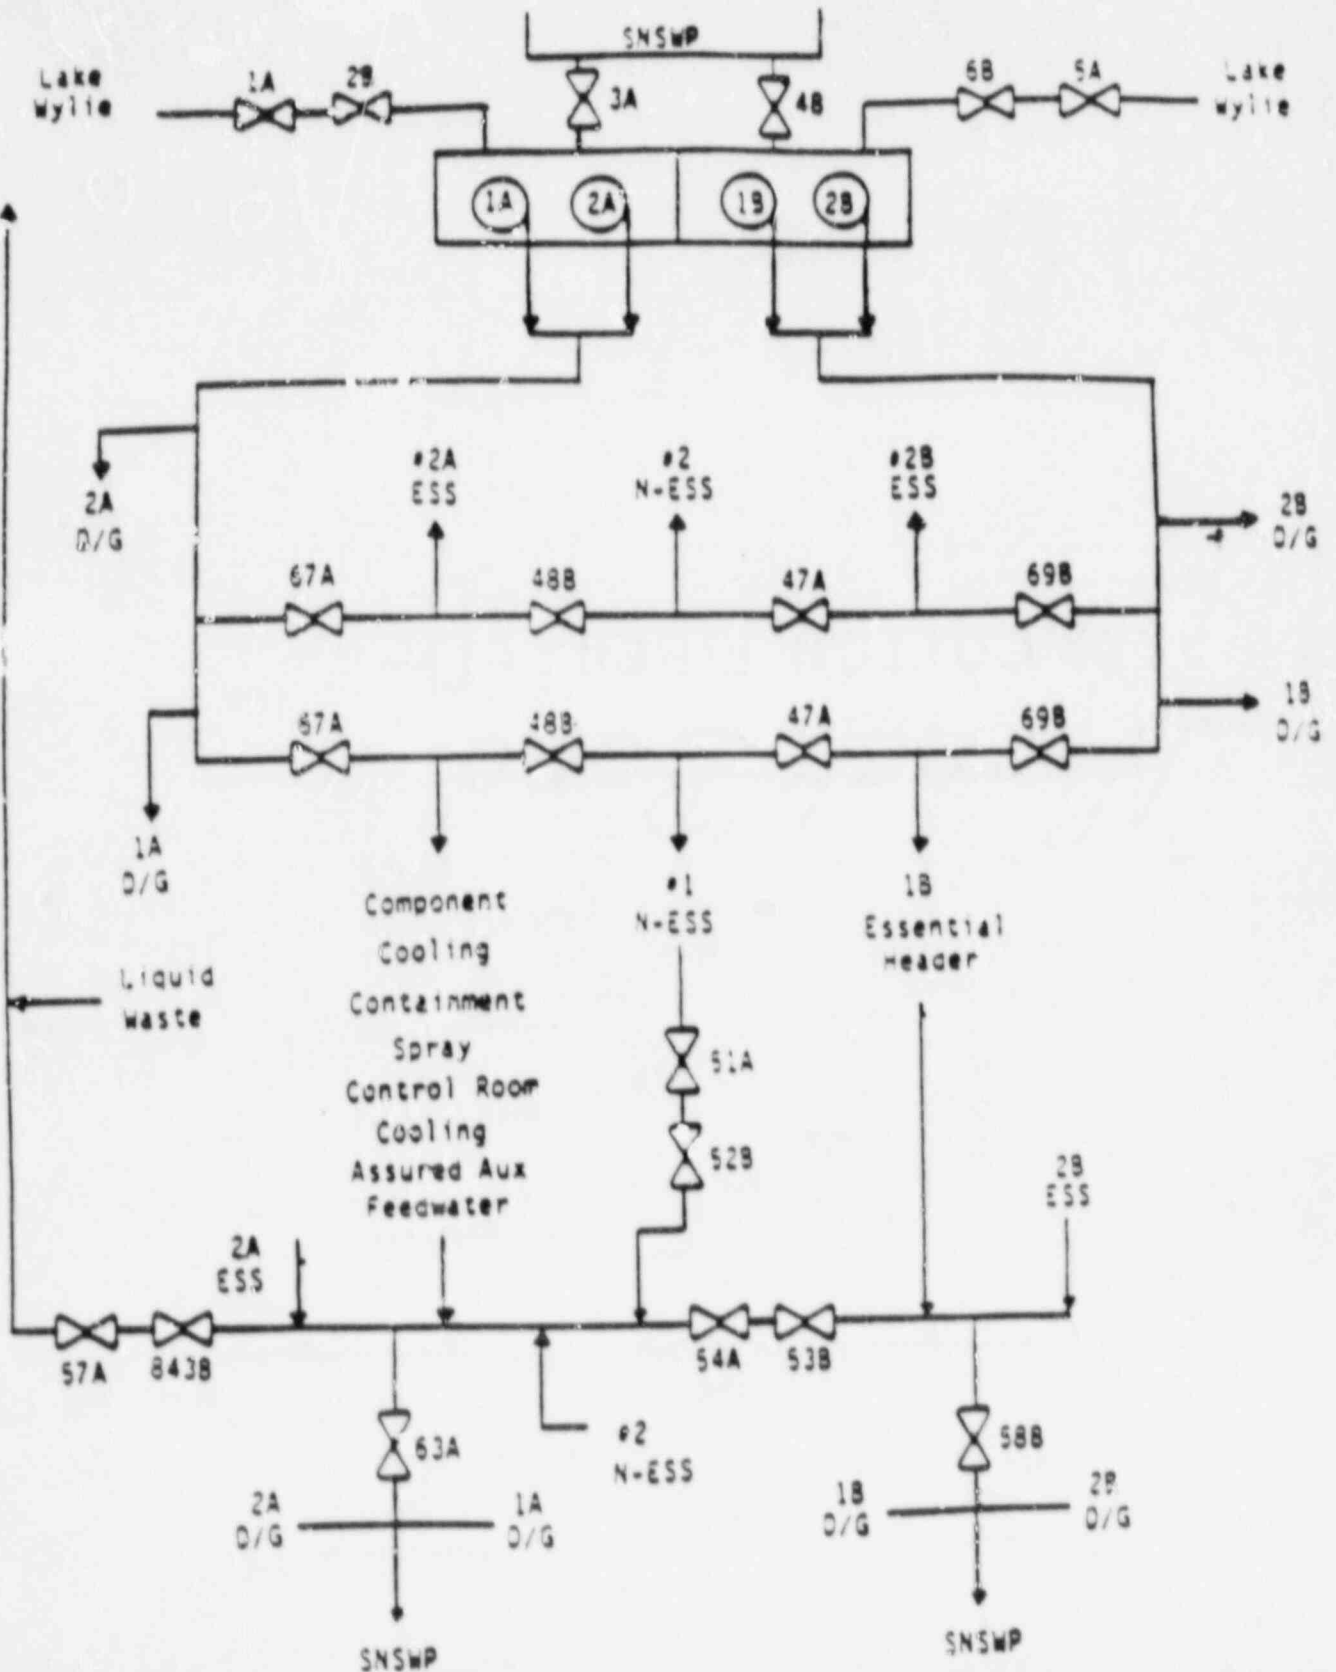
CATAWBA NUCLEAR STATION - (FIGURE 2)
NUCLEAR SERVICE WATER SYSTEM

Wylie. Should Lake Wylie be lost for any reason, suction will automatically be swapped to the Standby Nuclear Service Water Pond. The outlets of each R₁ pump utilize strainers with a 1/32 inch mesh to prevent debris and aquatic wildlife from entering the system. Figure 2 shows a simplified diagram of the RN System.

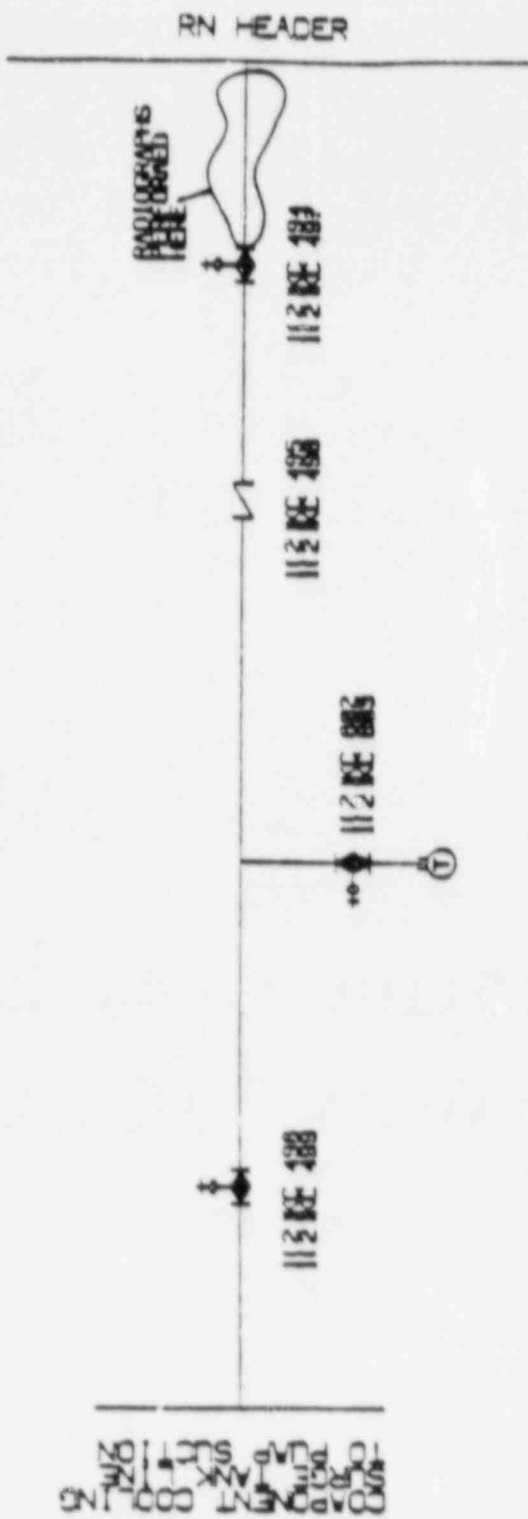
CATAWBA NUCLEAR STATION - (FIGURE 3)
RN TO KC
FLOW DIAGRAM

On March 12, 1988, a heat-up of Unit 1 was begun and the Unit entered Mode 3 at 0120 hours. The RN lines providing an assured source of makeup water to both Units' KC Systems were radiographed to determine if clams were present (see Figure 3). No clams were indicated in the Train 1A RN line leading to the KC System. This is probably because the line begins with a vertical run upward from the RN header. The 1B supply line begins with a horizontal run off the RN header. Radiography indicated that either clams or pipe corrosion were present in this line. Therefore, the line was flushed by removing the internals of check valve 1KC498 and directing the flow into the "C" Groundwater Drainage Sump via a four inch hose. Following the flush, the line was re-radiographed, and the results looked no different than the first examination. The line was then declared operable at 2025 hours based on the fact that whatever was in the line was not moving. Radiography of the Train 2A supply line showed the line to be totally blocked with clams. A similar flushing operation was performed, and a second radiographic examination showed the line to be completely clear. The line was declared operable following reassembly of check valve 2KC495.

Radiography and flushing of the KC System confirmed the presence of clams in the stagnant RN line leading to KC Surge Tank 2A. Since the dead leg of the 4 inch RN piping leading to the KC Surge Tanks is at most 2 feet in length, the maximum volume of clams which could have been introduced into any one train of KC was approximately 1.3 gallons. The effect of this amount of clams on overall performance of KC Train 2A would have been negligible in the unlikely event RN had been required to makeup to KC. The clams would enter the system upstream of the one stage KC Pumps and pass into the shell side of the KC Heat Exchangers. The larger significant clam parts would be trapped in the heat exchanger with negligible effect on KC hydraulic performance. Any remaining debris would be small enough that clogging of any particular KC component is unlikely.

- (7) All RN to KC lines for both Units were radiographed to determine if clams were present.
- (8) RN to KC lines for Trains 1B, 2A, and 2B were flushed to remove clams and re-radiographed prior to Unit startup.
