LICENSEE EVENT REPORT (LER)														
Facility Name (1) Zion, Unit 2										Docket Number (2) 0 5 0 0 0 3 0 4			Page (3) 1 of 0 3	
Title (4) Nuclear Station Operator failure to log delta I with Nuclear Instrumentation Channel in Test.														
Event Date (5)			LER Number (6)				Report Date (7)			Other Facilities Involved (8) N/A				
Month	Day	Year	Year	/// Sequential Number	/// Revision Number	Month	Day	Year	Facility Names		Docket Number(s)			
0 1	0 8	8 8	8 8	0 0 1	0 1	0 7	1 5	8 8			0 5 0 0 0			
OPERATING MODE (9)			THIS REPORT IS SUBMITTED PURSUANT TO THE REQUIREMENTS OF 10CFR (Check one or more of the following) (11)											
POWER LEVEL (10) 0 9 9			20.402(b)		20.405(c)		50.73(a)(2)(iv)		73.71(b)		Other (Specify in Abstract below and in Text)

FACILITY NAME (1)	DOCKET NUMBER (2)	LER NUMBER (6)						Page (3)		
		Year	///	Sequential Number	///	Revision Number				
Zion, Unit 2	0 5 0 0 0 3 0 4	8 8	-	0 0 1	-	0 1	0 2	OF	0 3

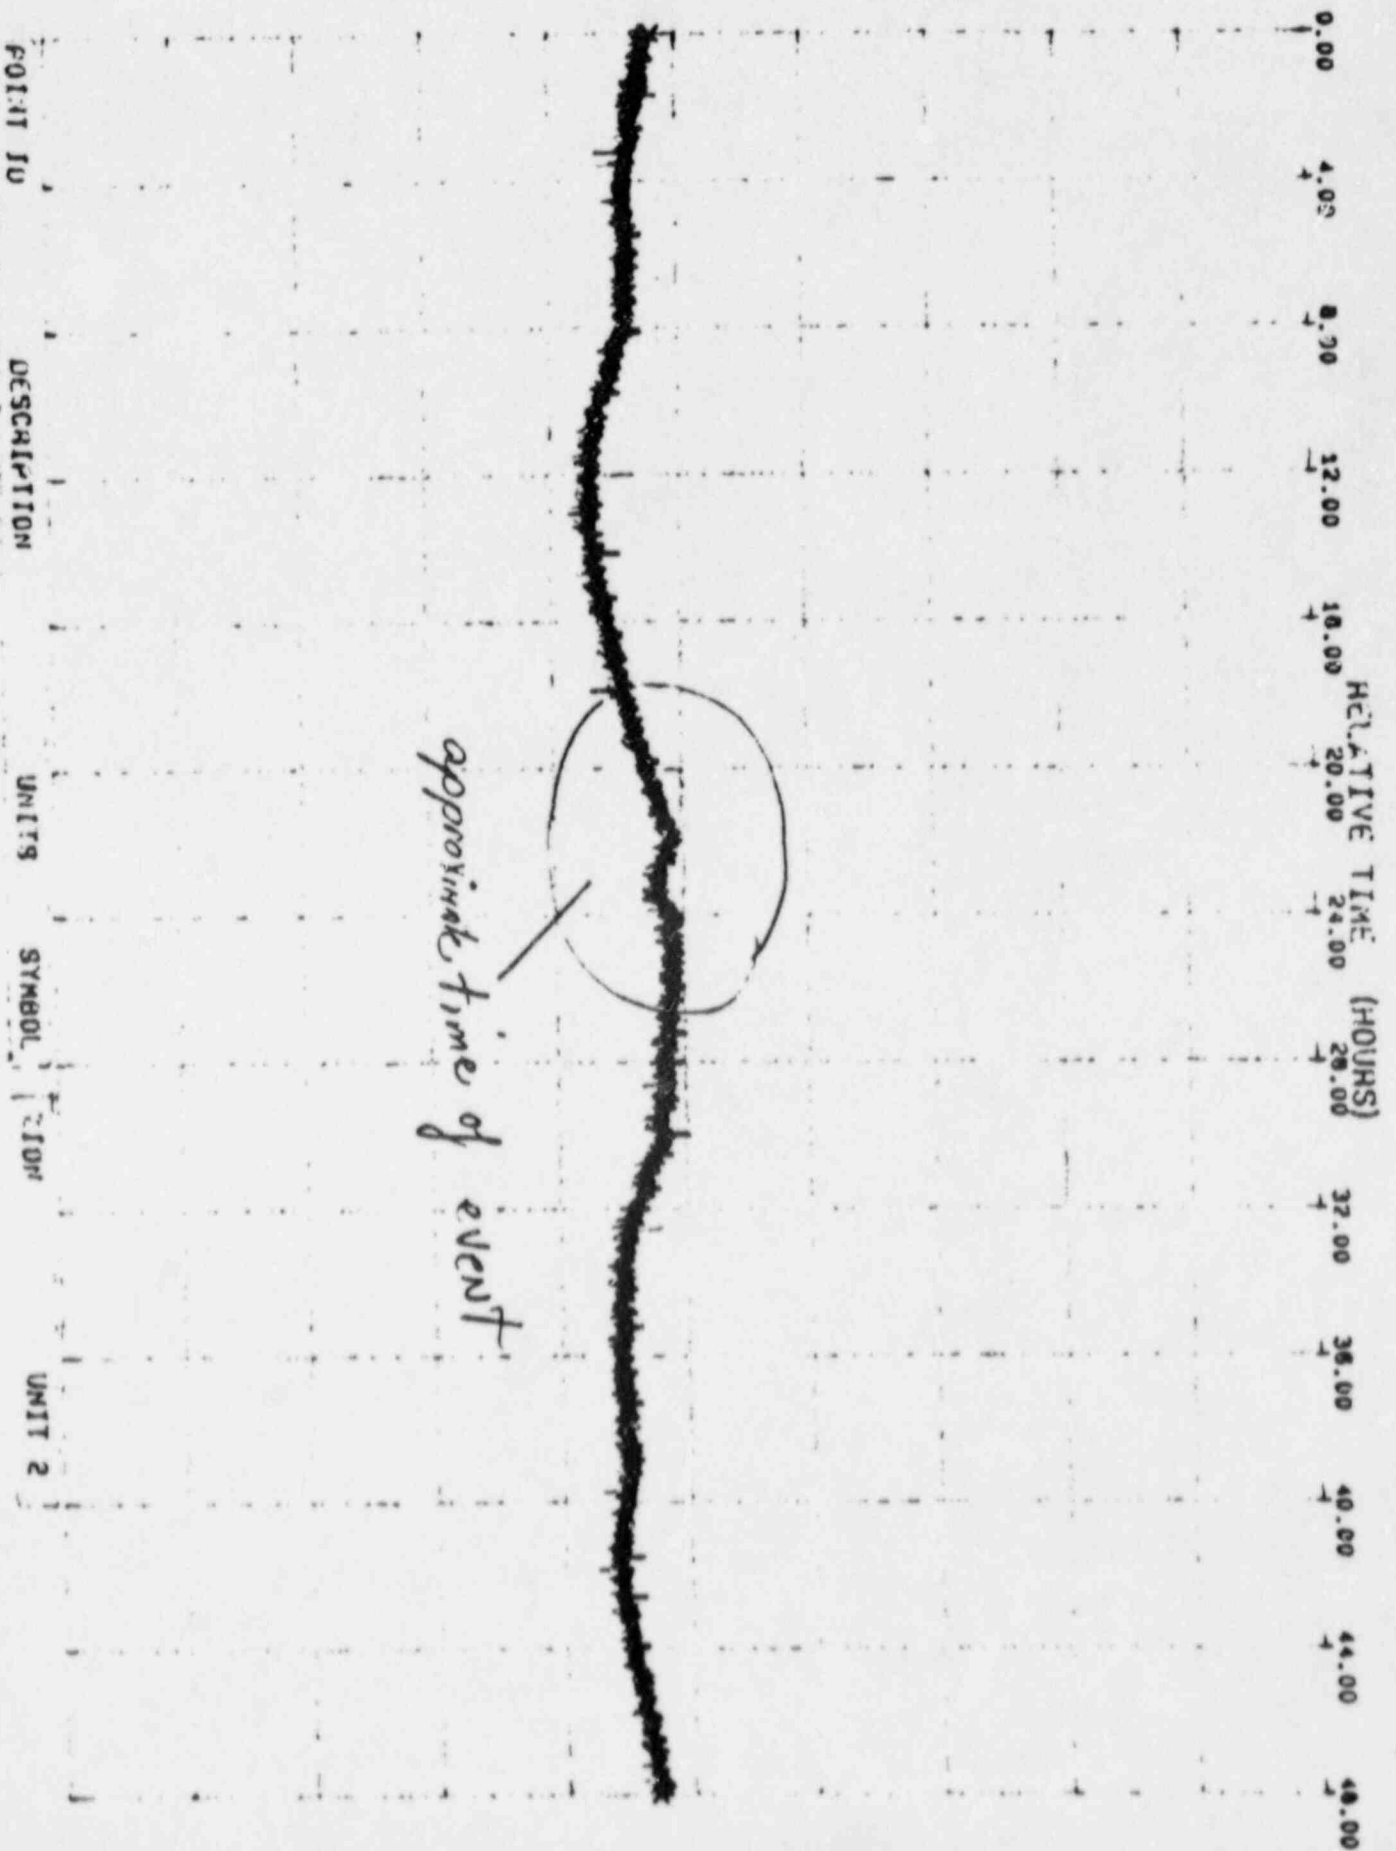
Figure 1: Delta I

Unit Two remained at 99% power throughout the event. Process computer data for delta I was retrieved from this time period, and is shown on figure 1. It shows that delta-I increased slightly from approximately -0.6% to -0.4% from the beginning to the end of the event. The allowable delta-I band for Unit 2 at 99% power is between -7.3% and 5.7%. There is no significant safety impact from this event.
