Houston Lighting & Power

South Texas Project Electric Generating Station
Units 1 and 2
Docket Nos. STN 50-498 and 499
Microbiological Influenced Corrosion in Unit 2
Standby Diesel Generator Jacket Water Cooling System

Evaluation of Unit 2 Diesel Generator MIC

Effects of Corrosion Pits and Cracks
on
Bellows Seal Performance

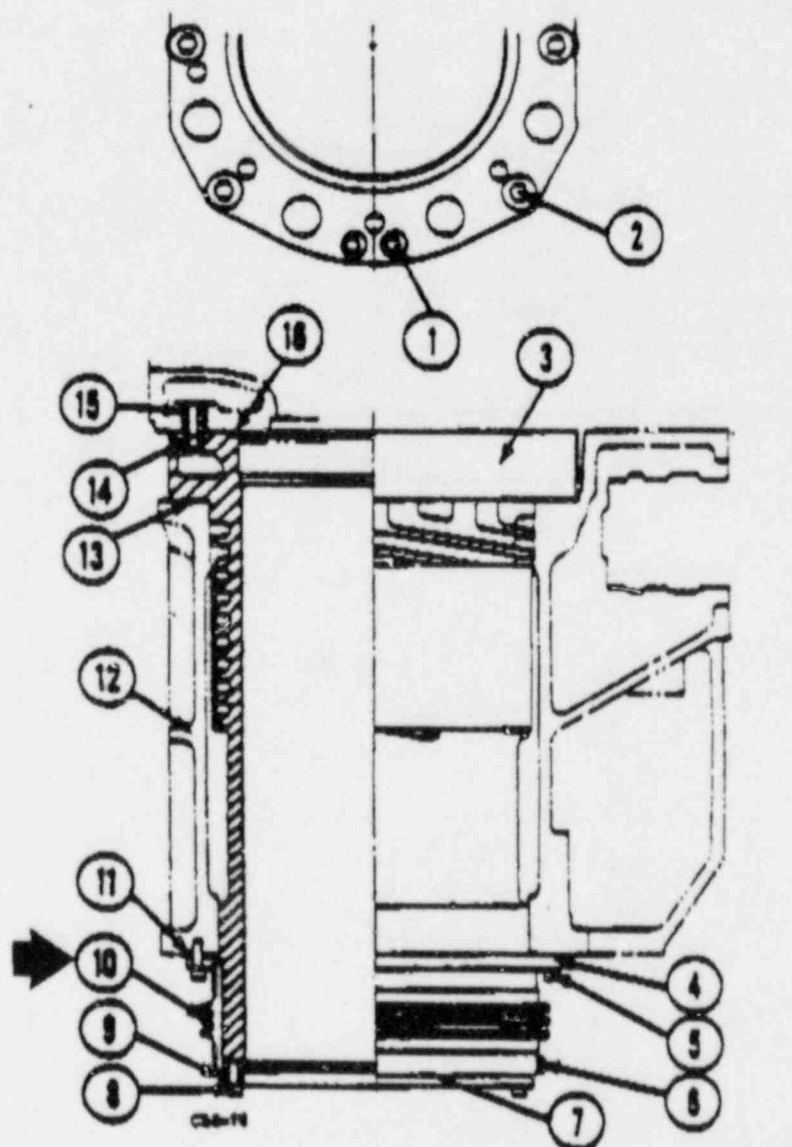
Figure 1 A sectional view of the emergency diesel engine cylinder block. Item 10 (arrow) is the bellows expansion seal.

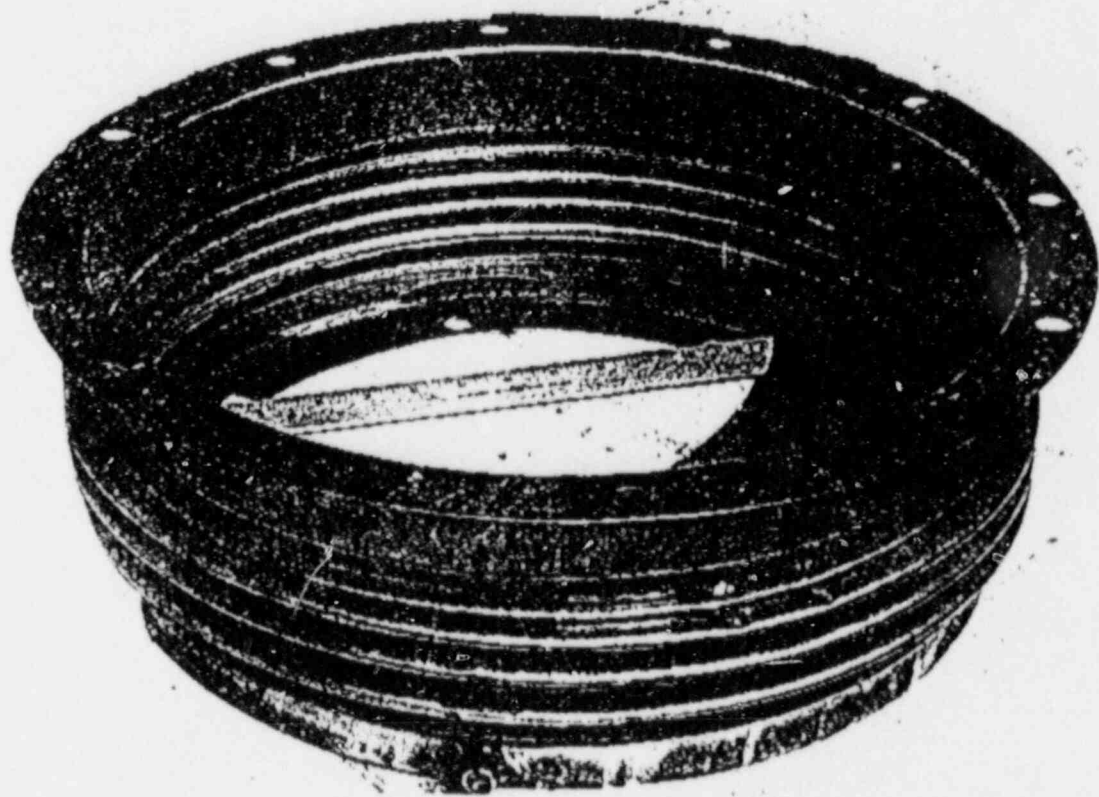
One of the two bellows examined revealed corrosion pits and cracks, creating one hole about 1/2 inch in diameter and another about 1/4 inch in diameter, in and near the longitudinal seam weld. See Figure 5(a) of the failure analysis report. Except for this failure area, most cracks and pits in other areas were small, 1/16 inch or less in the convolution. One exception was a 1/4-inch long crack which straddled a through-wall corrosion pit. See Figure 7(a) of the failure analysis report.

Figure 2 One of the bellows seals examined by M&QS
