FAILURE ANALYSIS OF DIESEL CYLINDER
LINER EXPANSION BELLOWS

Report for
South Texas Project

Tech. Report No. 8803-01 FA
BLN No. 8802-04

March 1988

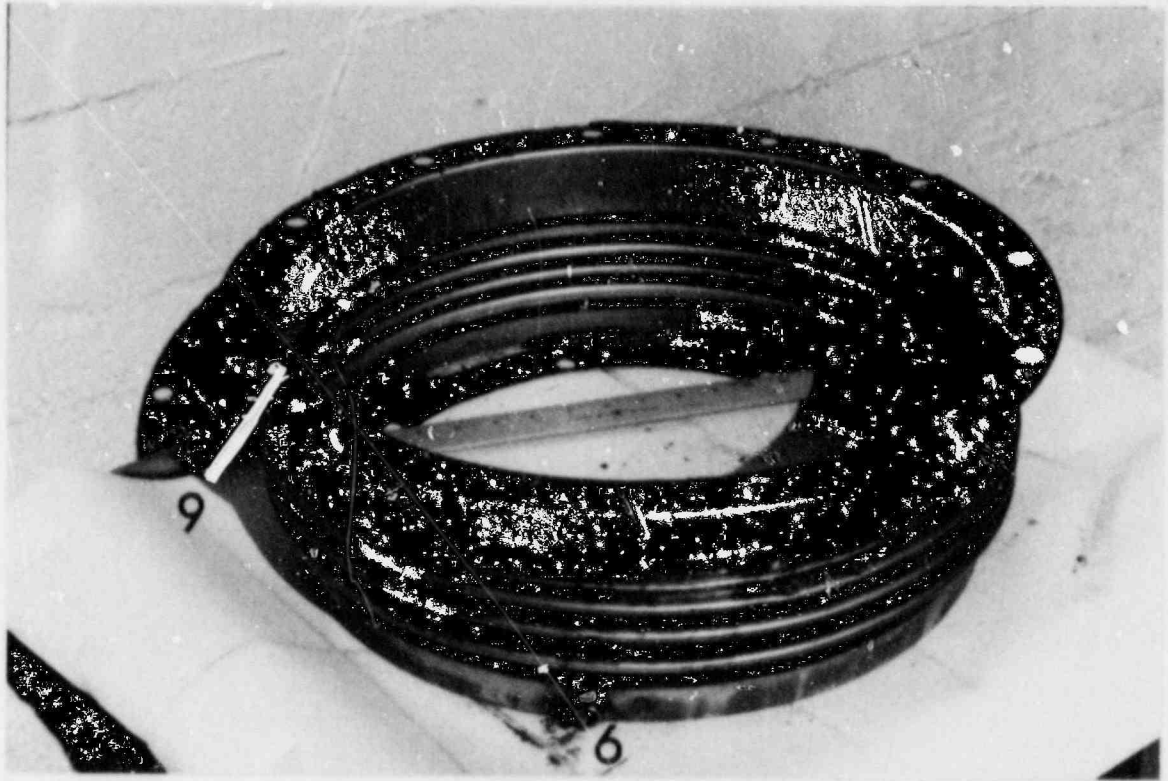
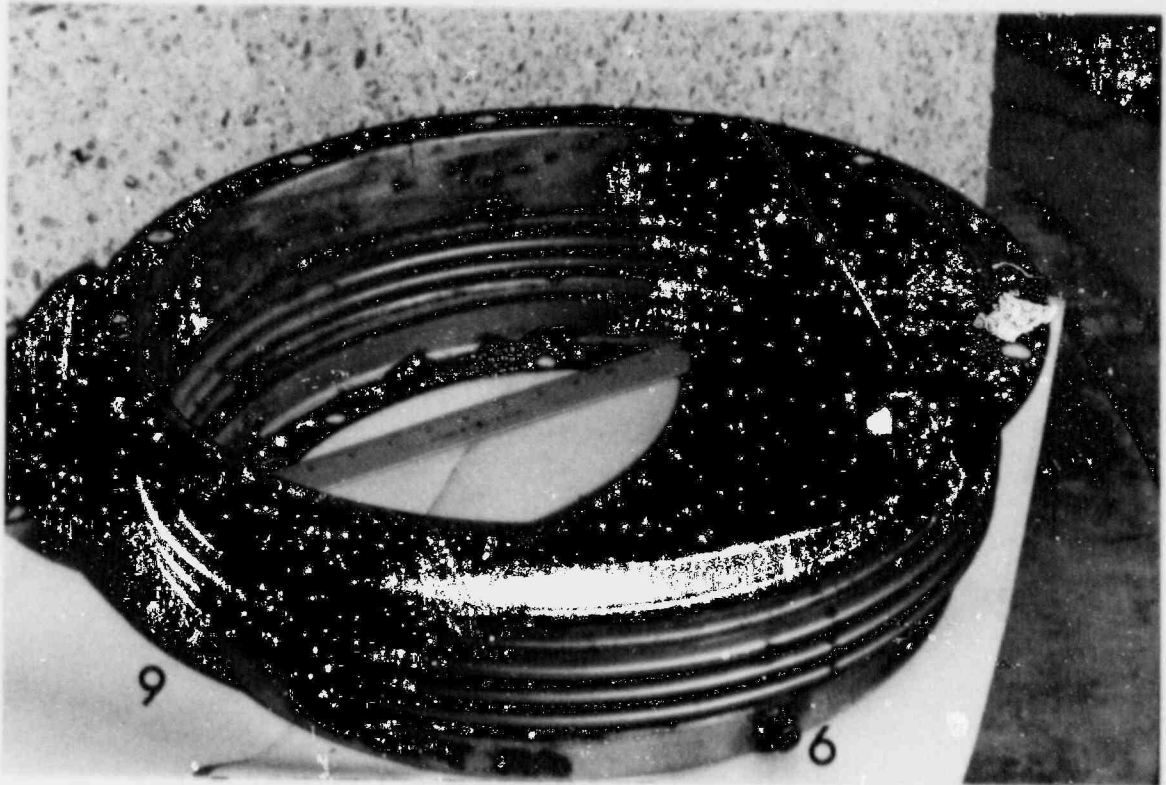
Bellows No. 1 showed holes in the convolutions of the bellows element; Bellows No. 2 appeared to be free from corrosion pits or cracking. Therefore, visual examination focused on Bellows No. 1.

As mentioned before, Bellows No. 2 showed no corrosion pits or cracking. Only a few scattered brown rust spots and some brown film along the bottom inside corner were observed.

Figure 1 Two bellows in the as-received condition, from the cylinder head liner expandable lower seal.

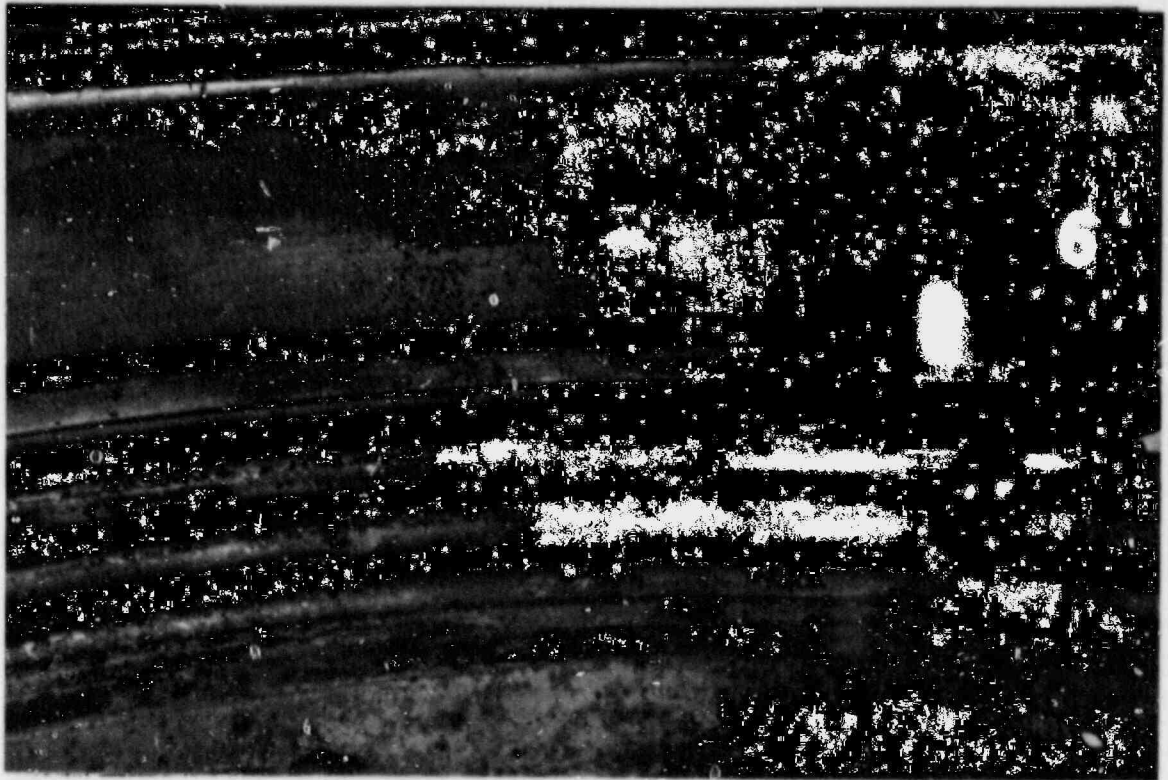
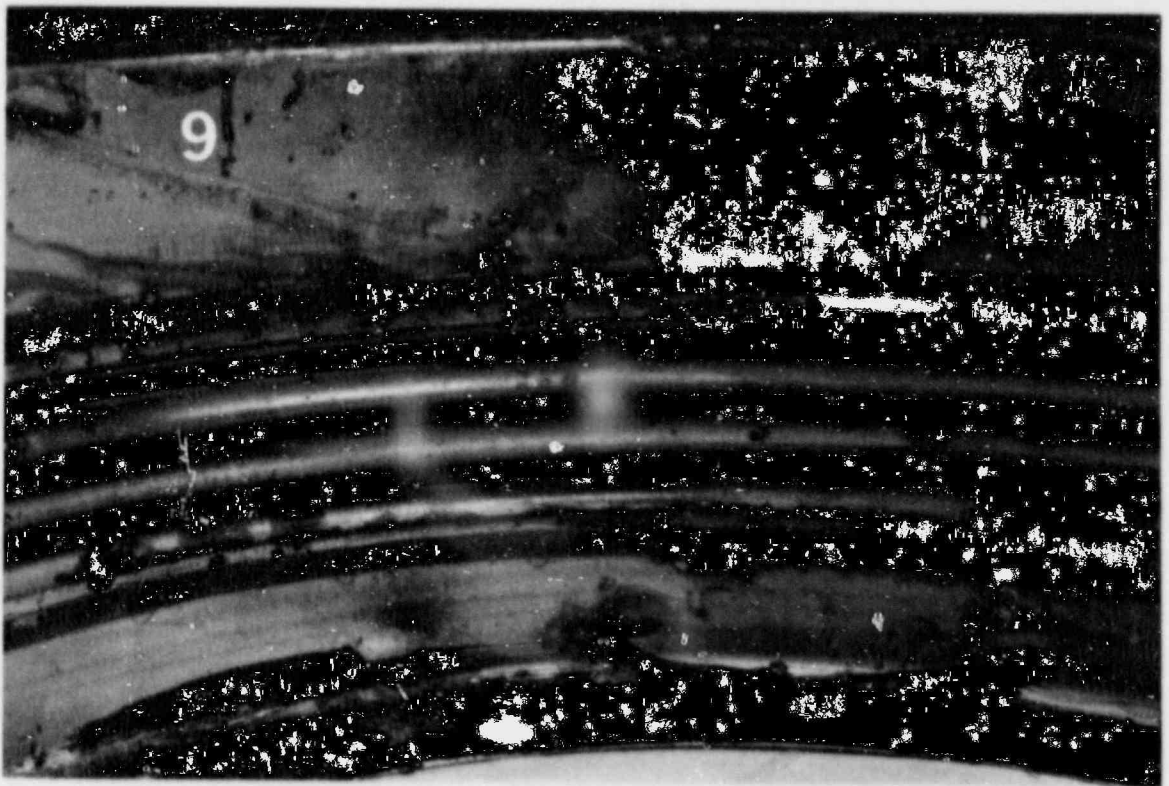
The two bellows have a drain hole near the bottom (Figure 1). Using the drain hole as a reference point (6 o'clock looking down), Figures 2, 3, and 4 show the inside surface of Bellows No. 1. Perforation in the convolution can be seen above the drain hole in Figure 2(a). Brown corrosion products, sometimes with nodules, were found throughout the inside surface. One prominent example of corrosion nodules is shown in Figure 3. The edges of the end pieces which were welded to the bellows element showed numerous cracks (Figure 4).

<u>Specimen No.</u>	<u>Location</u>	<u>Findings</u>
1-1*	Corrosion products with nodules (Figure 3b)	Short Gallionella filaments
1-2	"Dirt" at the bottom corner directly below the drain hole (Figure 2a)	Gallionella filaments
1-3	Corrosion products near the seam weld (Figure 2a)	No positive identification of iron bacteria

Figure 2 Corrosion on the inside of Bellows No. 1 with holes in the bellows convolution above a drain hole in (a).

- (1) One of the two bellows examined failed due to pitting corrosion and cracking which perforated the Type 321 stainless steel convolution. The other bellows showed no pitting or cracking.
- (2) Both bellows were exposed to fluids containing iron bacteria, which influenced the corrosion and cracking in the bellows elements and the end pieces.
- (3) The cooling fluids entering the bellows should be treated with biocide.

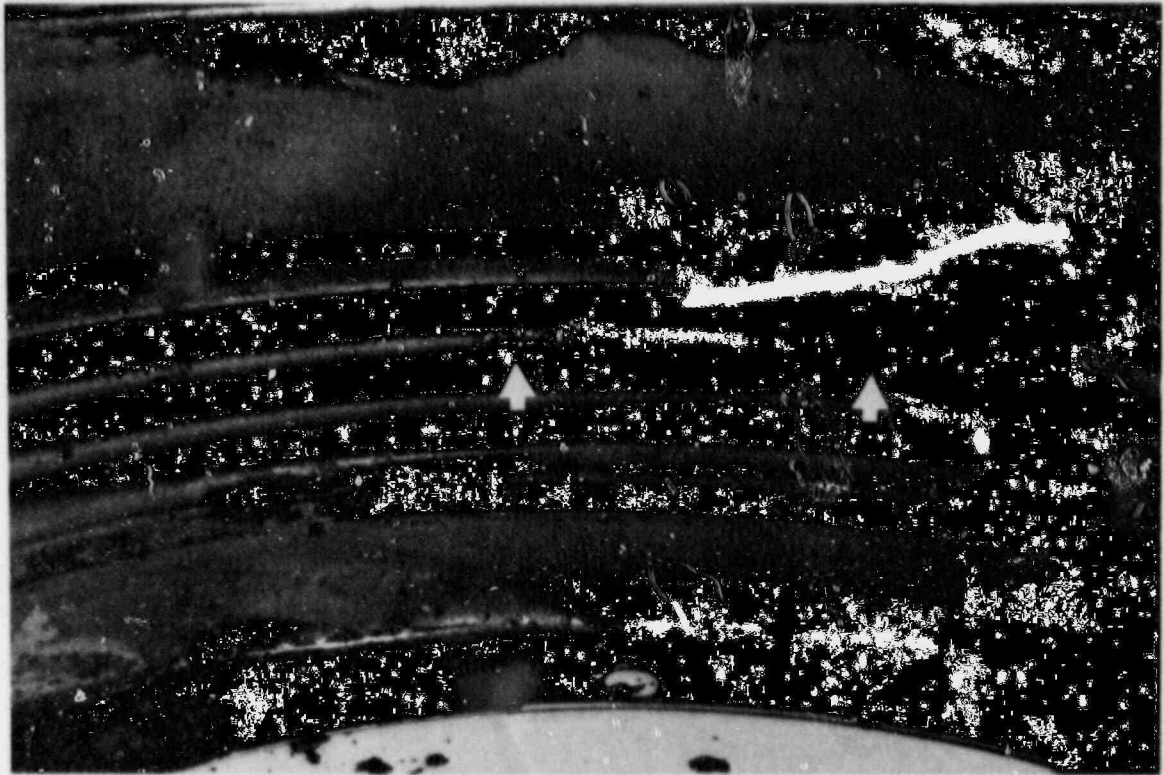
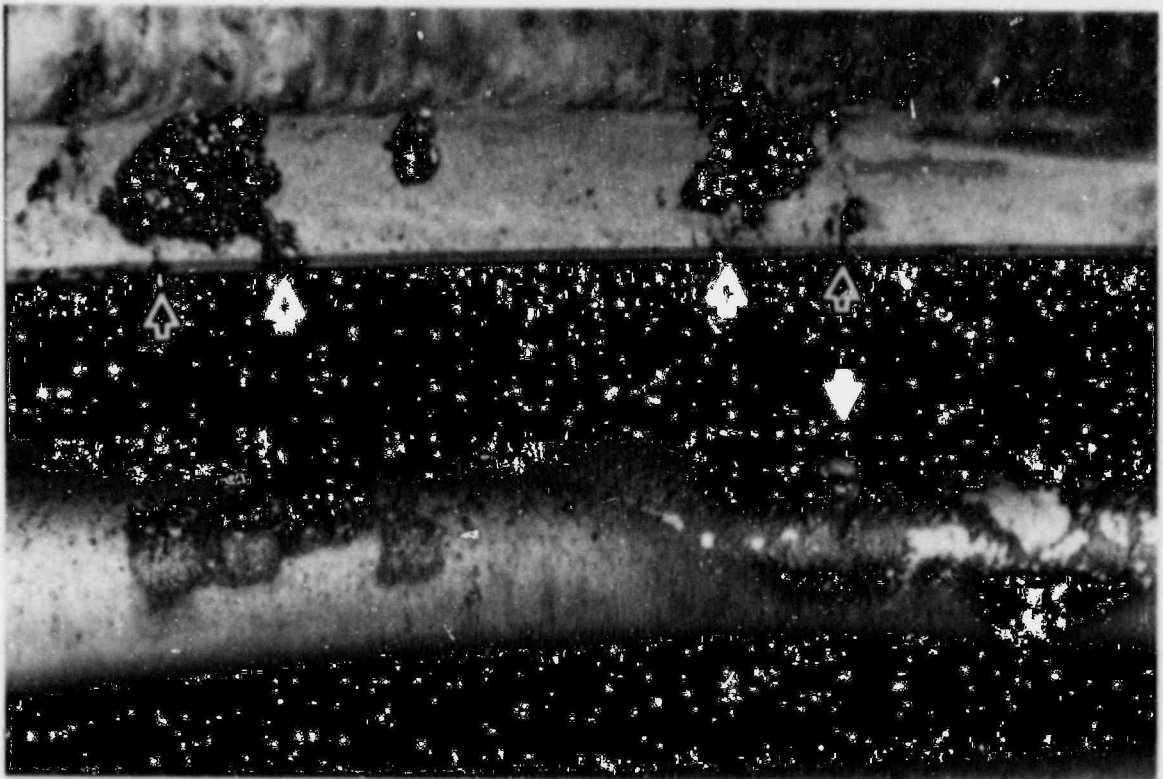
fell off during saw cutting of a section containing the seam weld. Figures 5(b) and (c) show this area surrounding the seam weld after flattening the convolution. The outside surface around the perforated hole and the corroded seam weld showed colonies of brown rust. The metal with rust cracked when the convolution was flattened (Figure 6). The same phenomena occurred on the outside surface of the corrosion nodule shown in Figure 3. The holes in Figure 7(a) and (b) are the perforation caused by pitting corrosion in the two black areas marked by the arrows in Figure 3(a). The rusted areas cracked when flattened (Figure 7).

- (a) Preferential crystallographic corrosion attack to the weld metal (Figures 10 and 11).
- (b) Brown and black corrosion products with nodule formation (Figure 3).
- (c) Corrosion and cracking in colonies on the outside surfaces where perforation occurred (Figures 6 and 7).
- (d) Concentration of corrosion pits in the welds.

Figure 3 Corrosion on the inside of Bellows No. 1. The solid arrow points to a nodule and the hollow arrows to cracks. (b) is a closeup view of an area in (a).

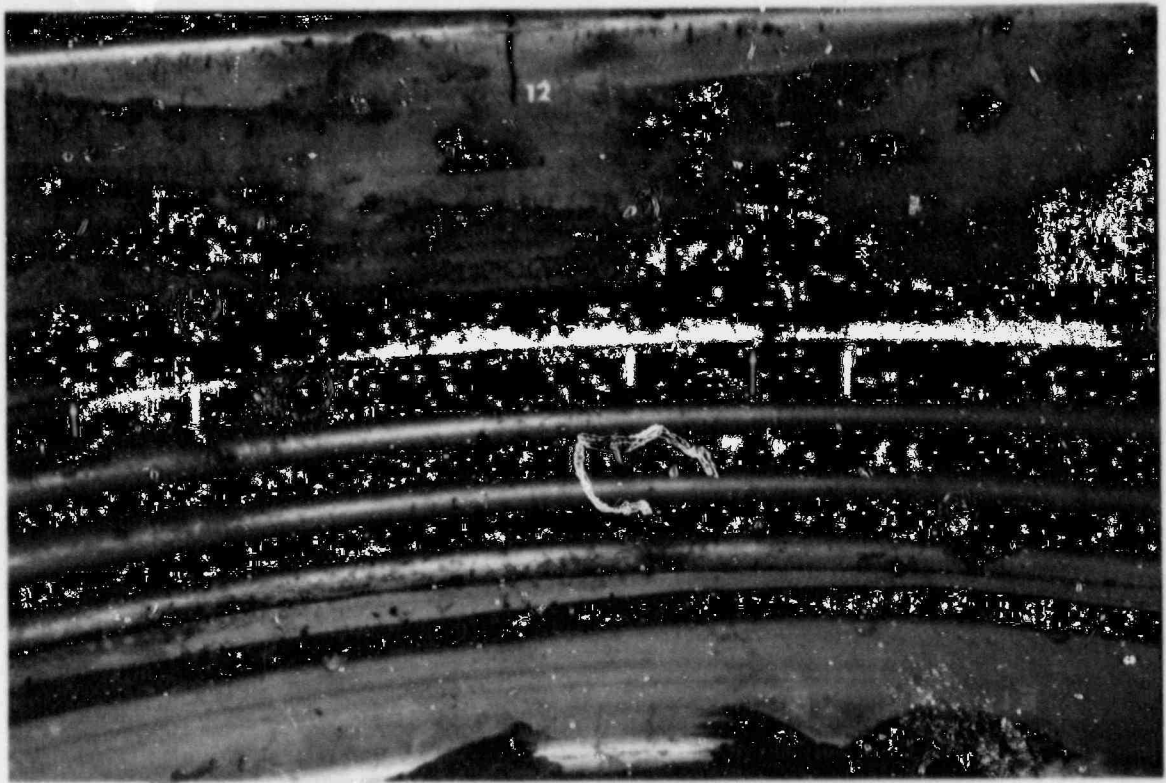
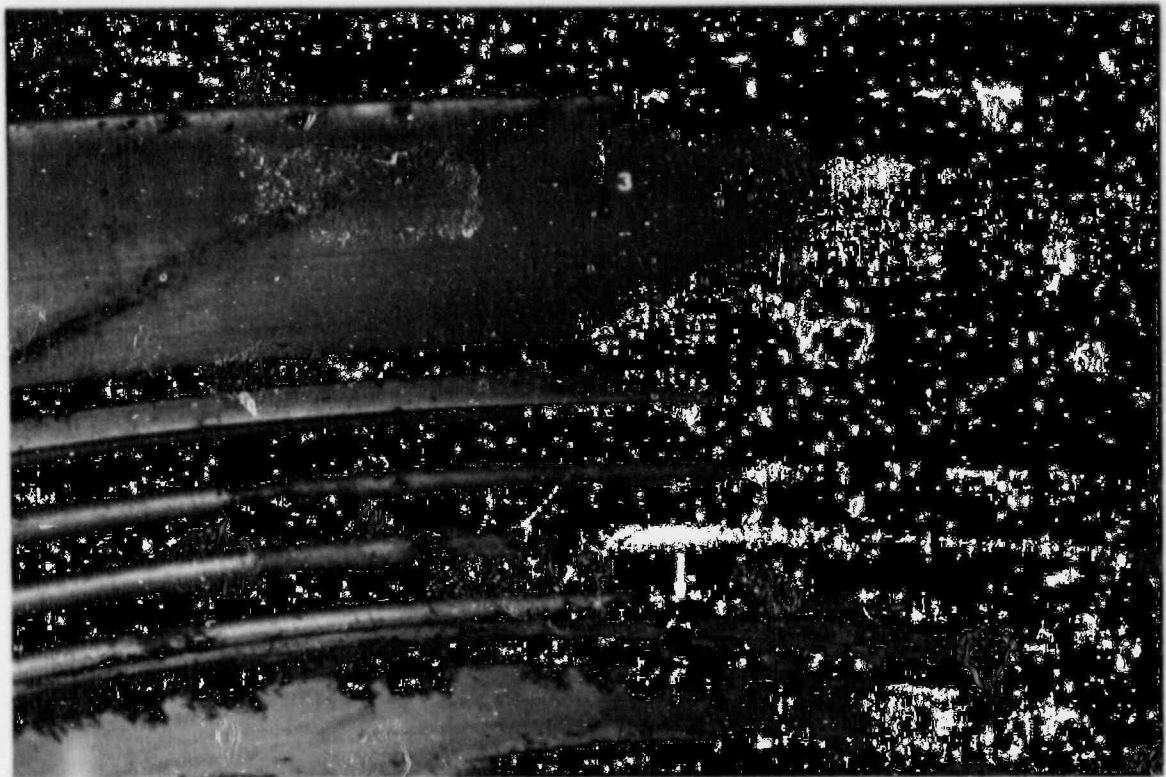
Figure 4 Corrosion on the inside of Bellows No. 1. The arrows point to cracks.

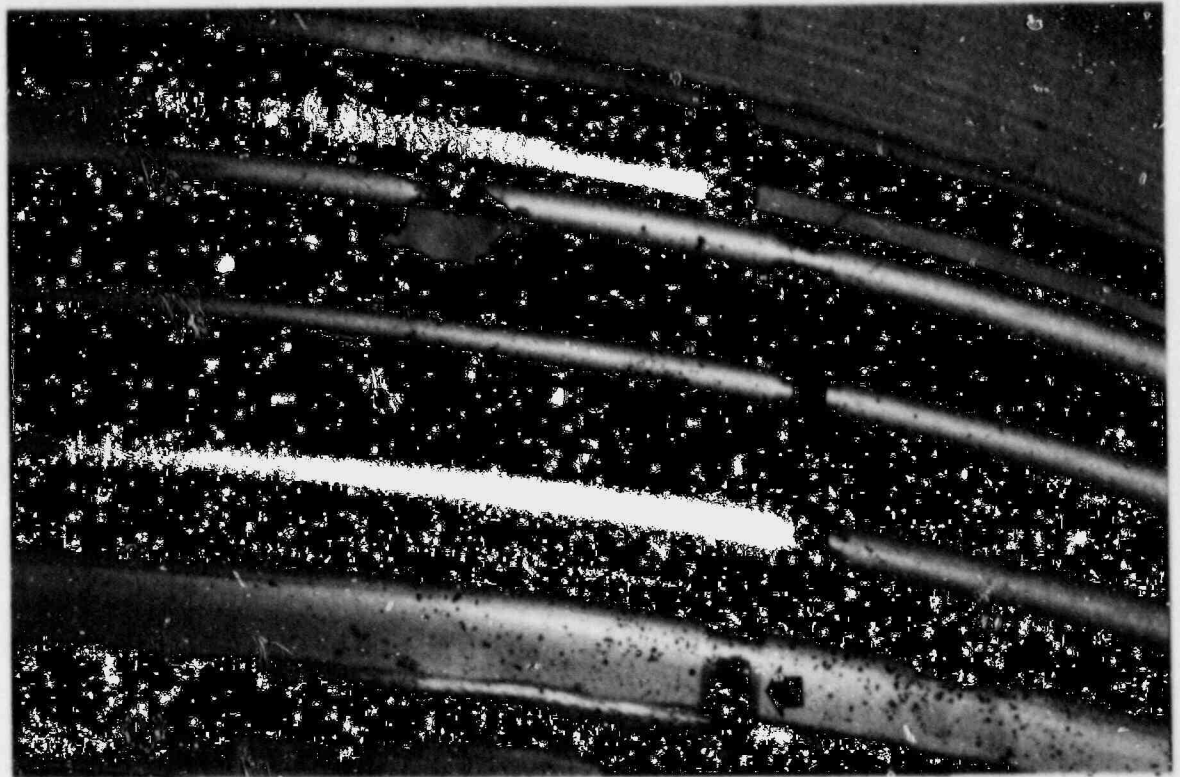
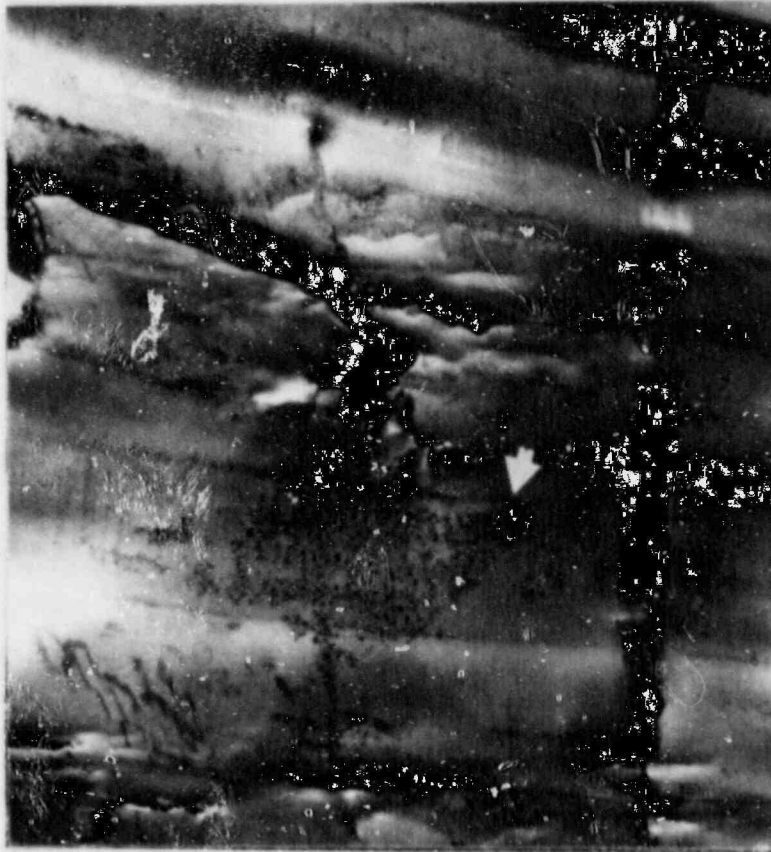
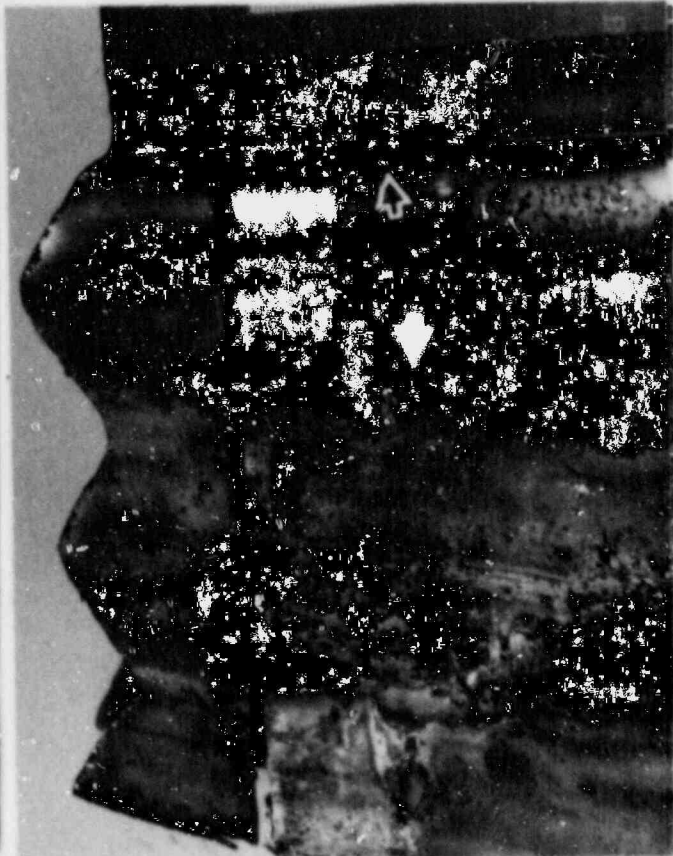
A closeup view of the perforation in the convolution of Bellows No. 1 is shown in Figure 5(a). In addition to a hole, about 1/2 inch diameter, the seam weld in the convolution was preferentially attacked. Much of the weld metal

Figure 5(a) shows preferential corrosion attack to the seam weld in the Bellows No. 1 convolution. The bottom area of the seam weld was saw cut for metallographic examination. During saw cutting, the corroded weld metal fell off as can be seen in Figure 10(a). This specimen was flattened, mounted in a molding material, polished and etched on a plane parallel to the inside surface. Figure 10(c) is a micrograph showing the seam weld with its top and bottom portions consumed by corrosion. Figure 11 presents micrographs of selected areas from Figure 10(c). These micrographs show that the corrosion preferentially attacked the weld metal, following the interdendritic solidification pattern, and that numerous transgranular cracks developed. Figure 12 shows examples of transgranular cracks in and around corrosion pits in the base metal near the seam weld. Figure 13 shows extensive branching in one of the cracks along the edges of the end pieces which were welded to the bellows convolution.

Figure 5 The holes in Bellows No. 1. (a) As received. (b) and (c) after cutting and cleaning.

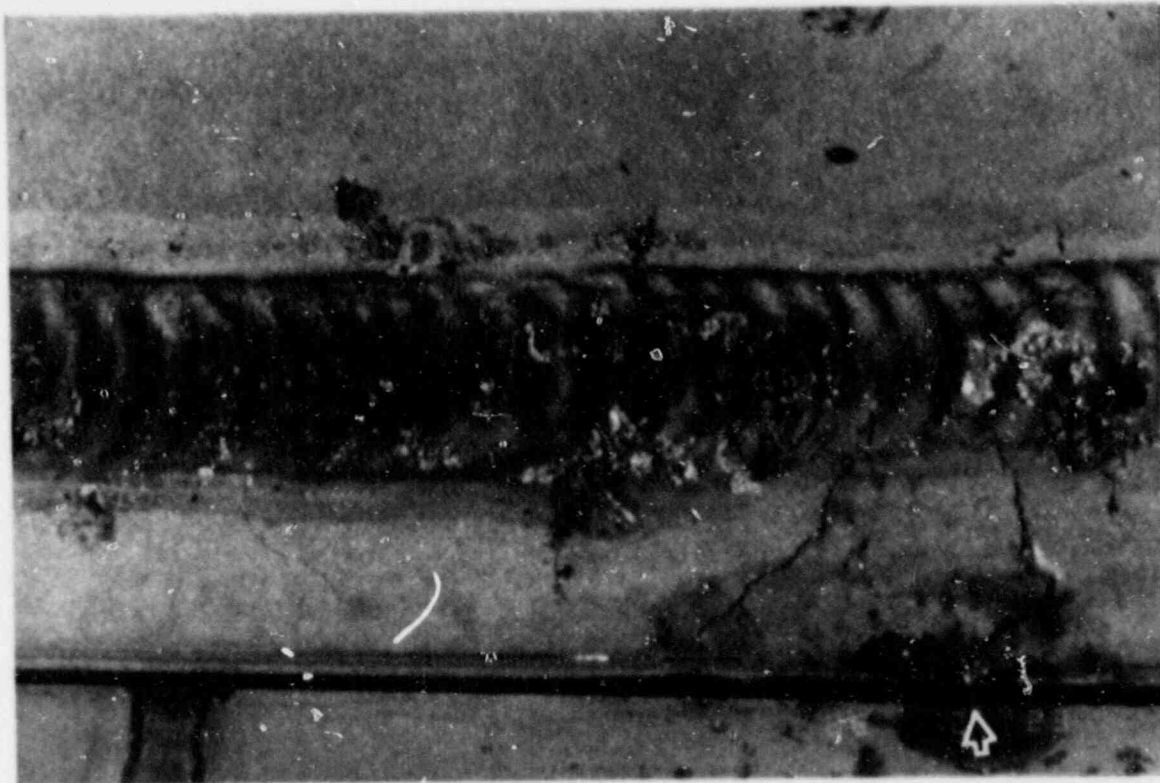
Figure 8(a) shows an example of corrosion pits in the weld metal and cracking in the top end piece of the bellows. Figure 8(b) is the area where the corrosion perforated the convolution wall. Numerous cracks can also be seen in the corroded area.

Figure 8 Corrosion pits and cracks in the area marked by the arrows in Figure 5(c).

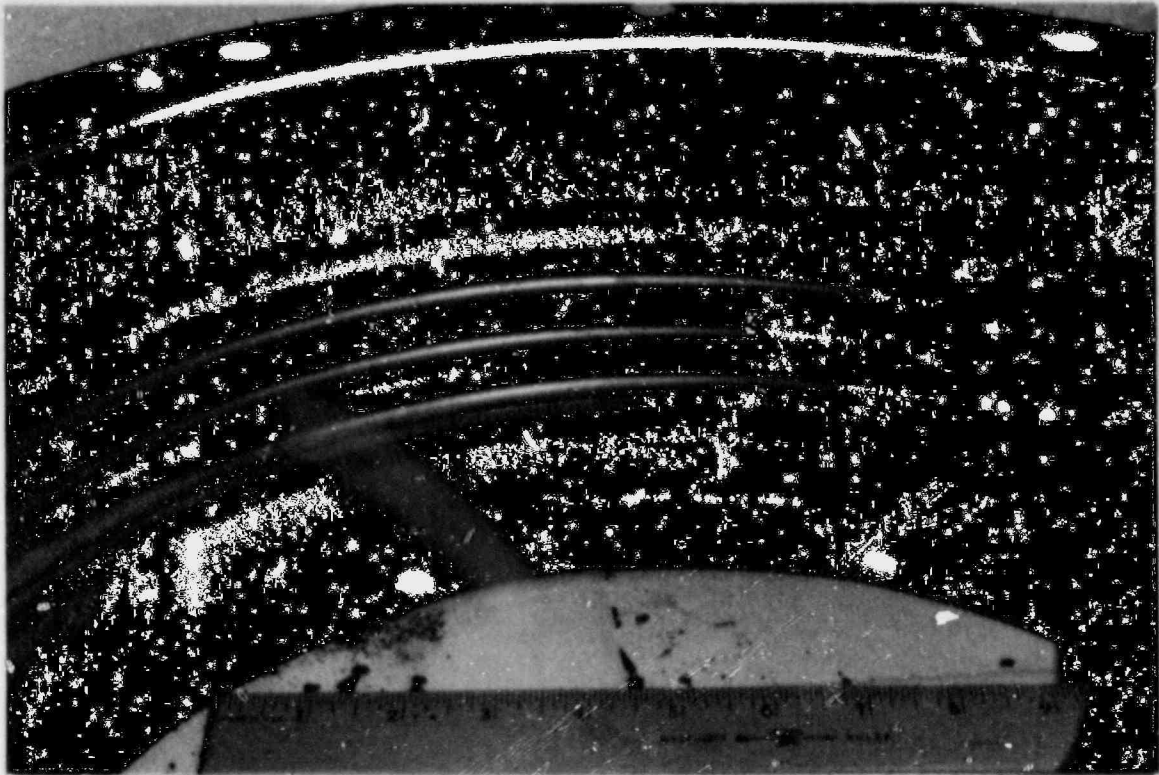
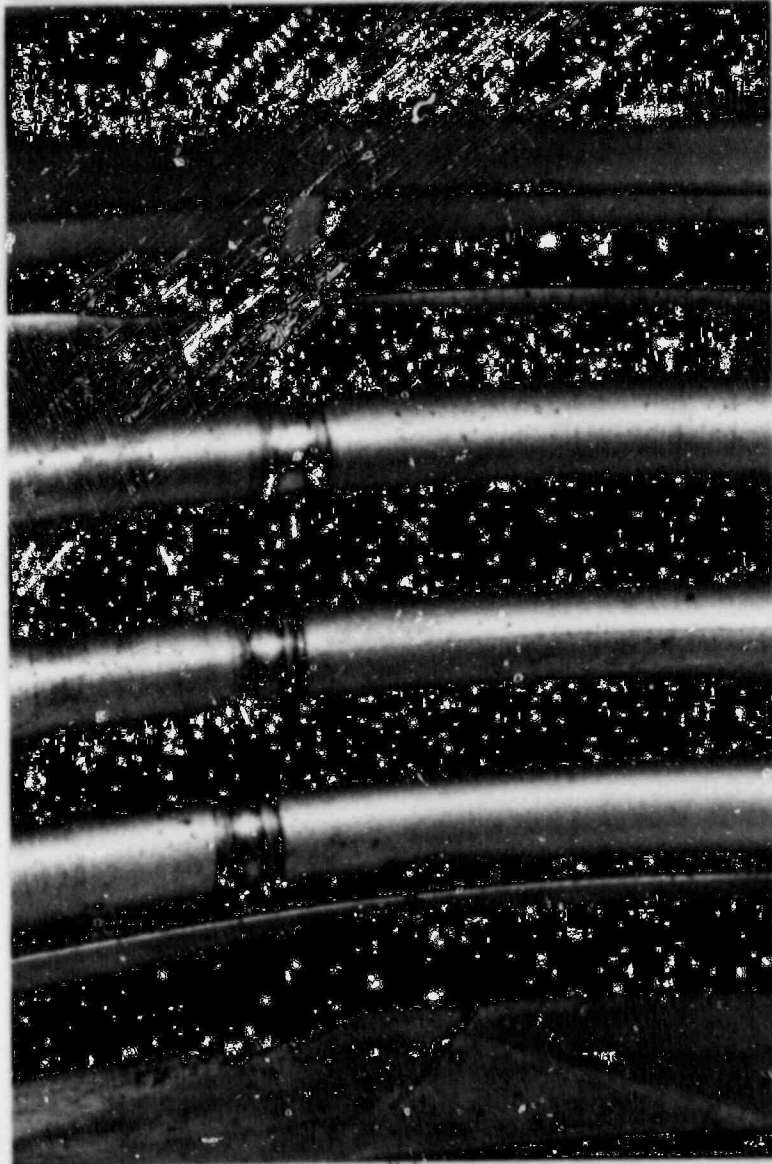
Figure 9

<u>Specimen No.</u>	<u>Location</u>	<u>Findings</u>
2-1	Brown film at the bottom corner below the drain hole (Figure 9a)	Short Gallionella filaments

The inside of Bellows No. 2.
(b) shows a closeup view of the
weld.

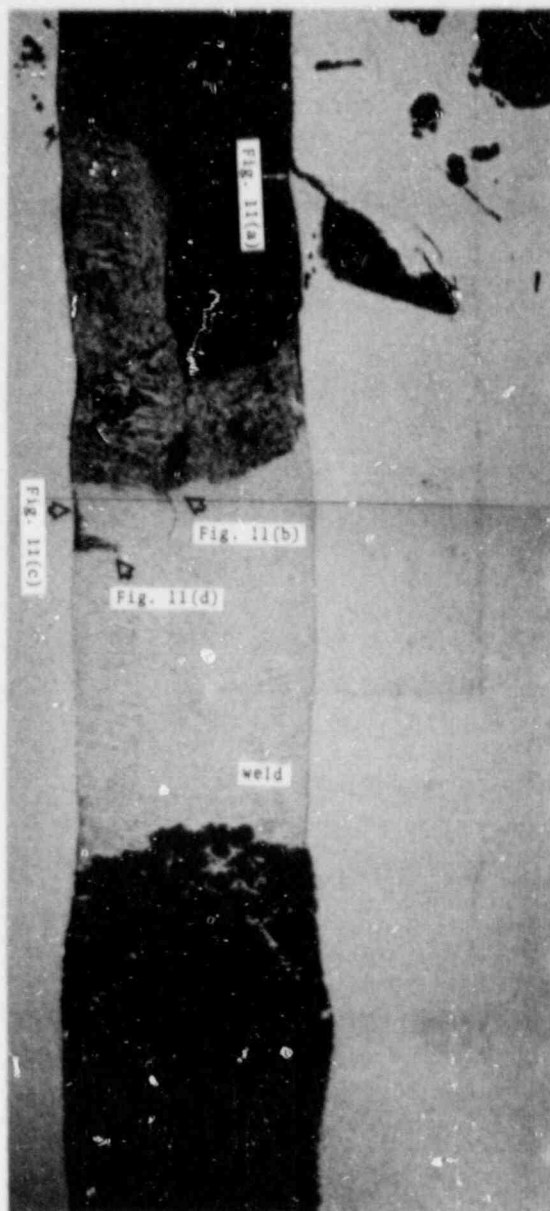
Figure 10 The lower end of the convolution weld marked by the arrow in Figure 5(a). (c) is a mirror image of (a) after polishing and etching.

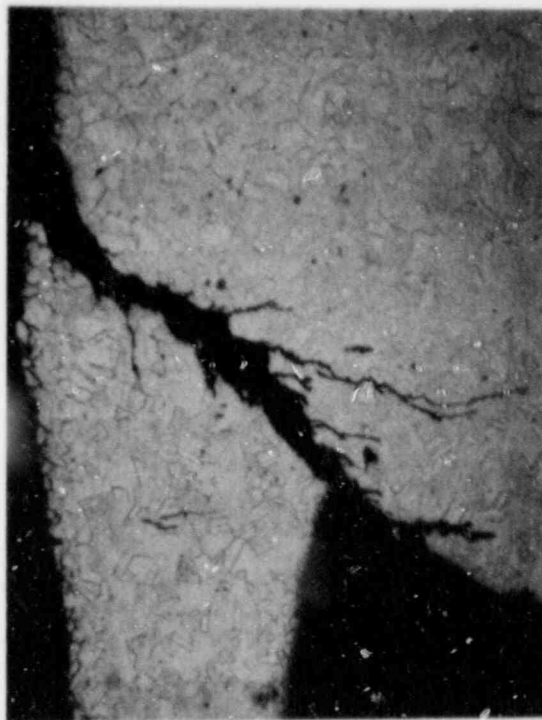
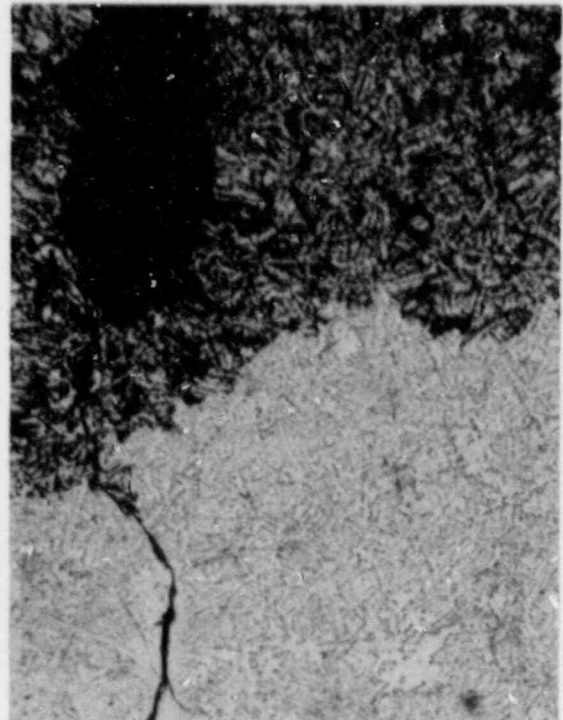
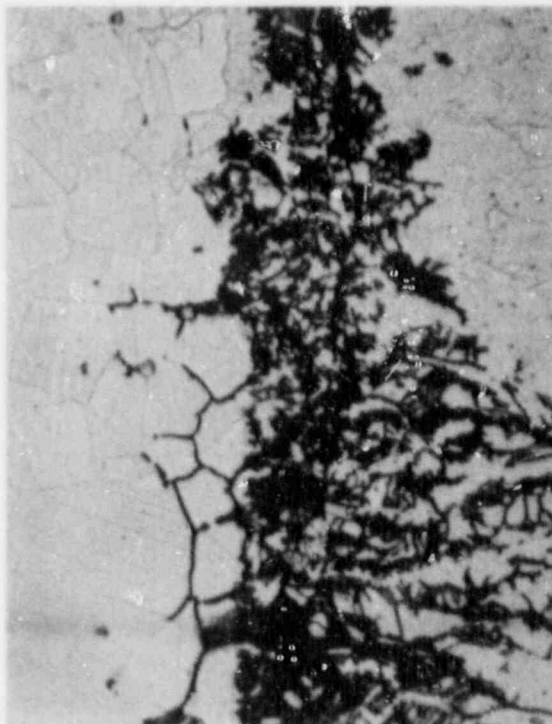
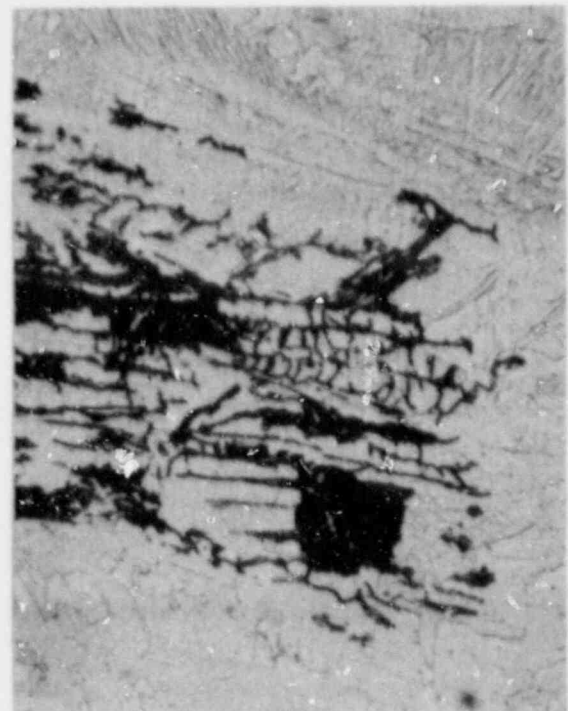
Figure 11 Micrographs showing the areas marked in Figure 10(c).

(a) transgranular cracks

(b), (c), & (d) interdendritic corrosion attack in the weld

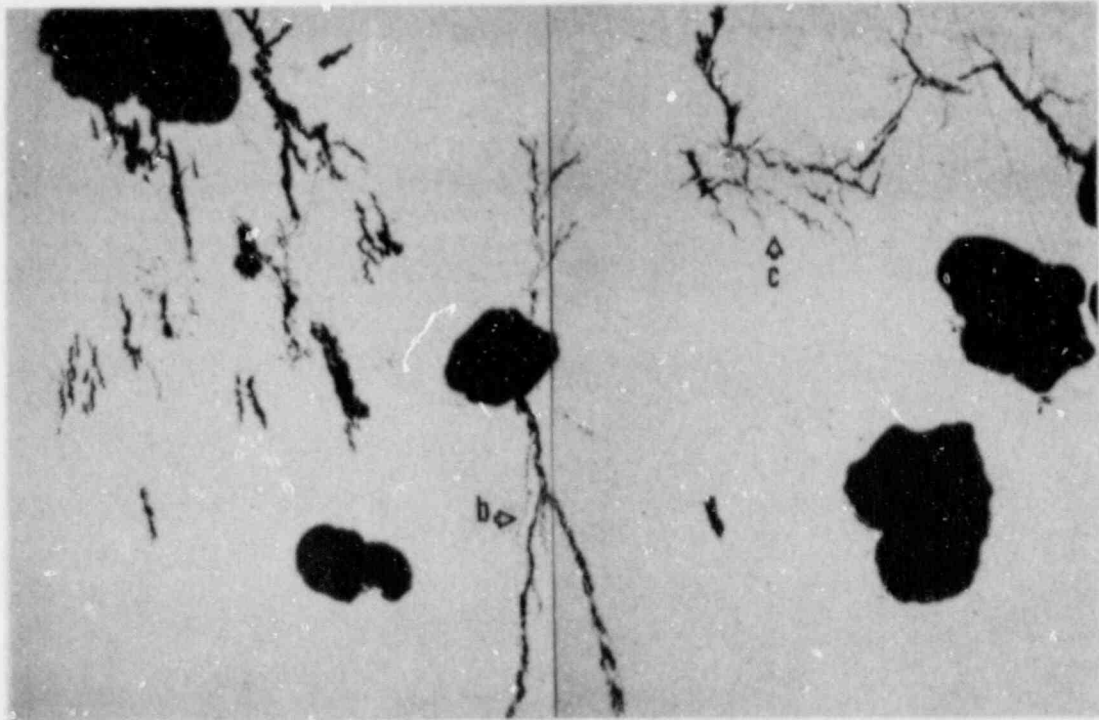
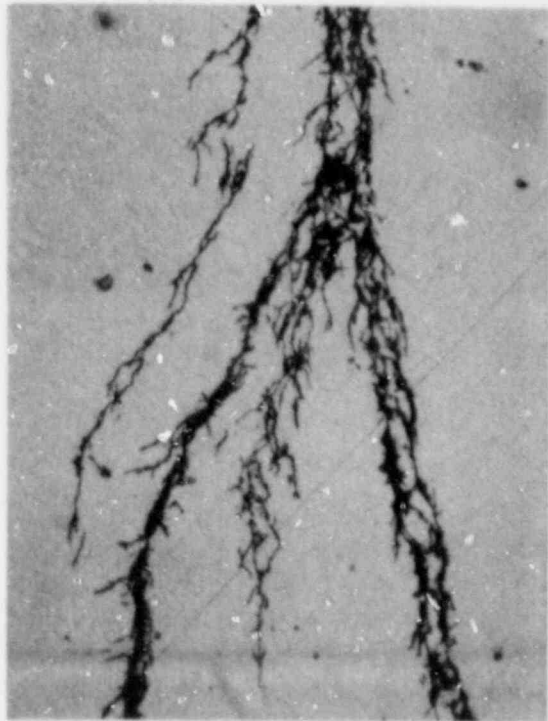
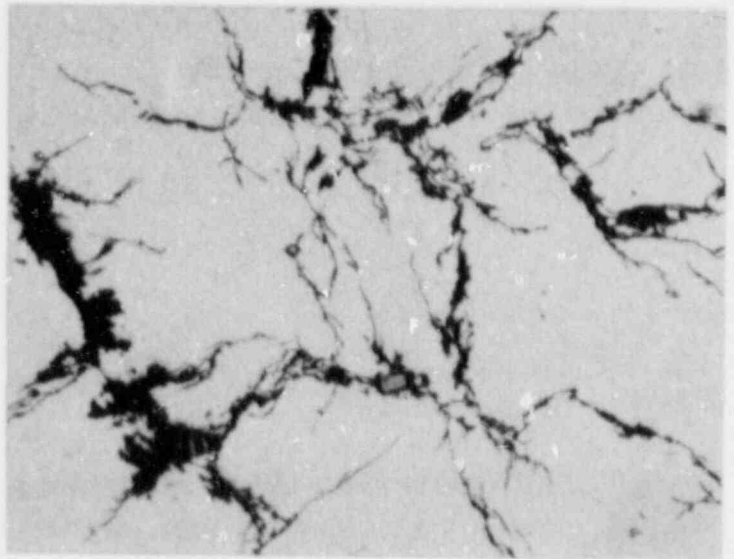
Figure 12 Corrosion pits and transgranular cracks in the bellows element as seen on a plane parallel to the inside surface.

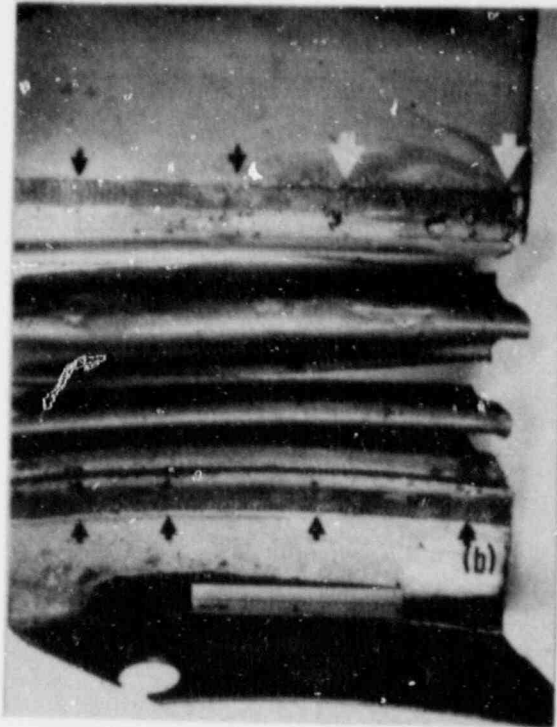
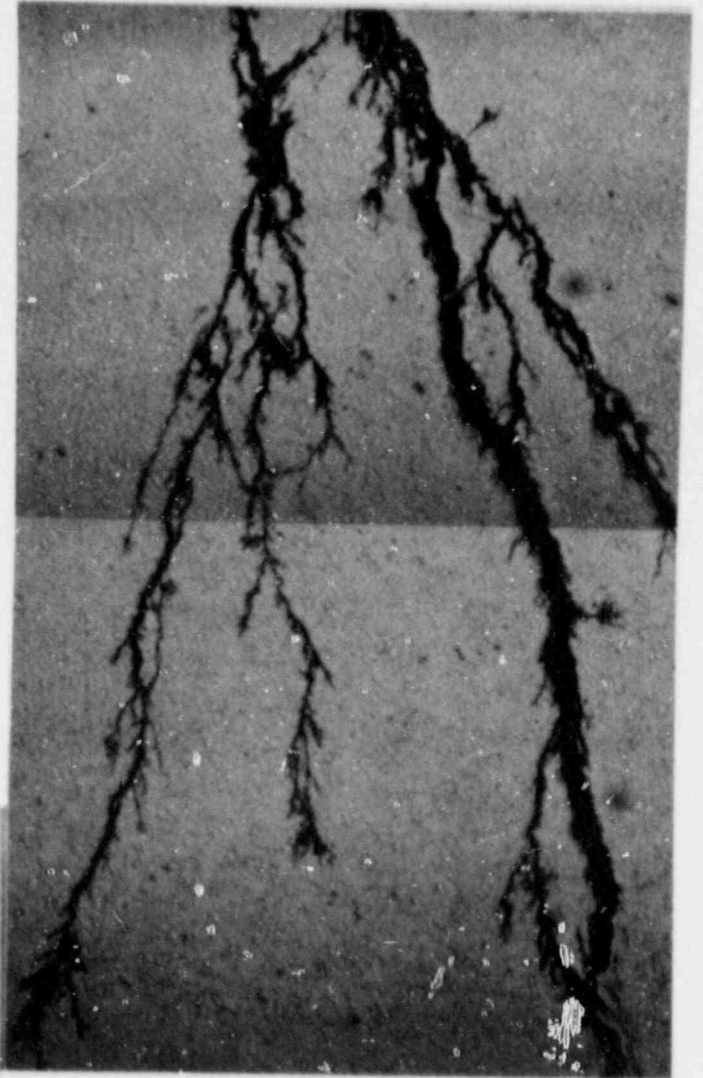
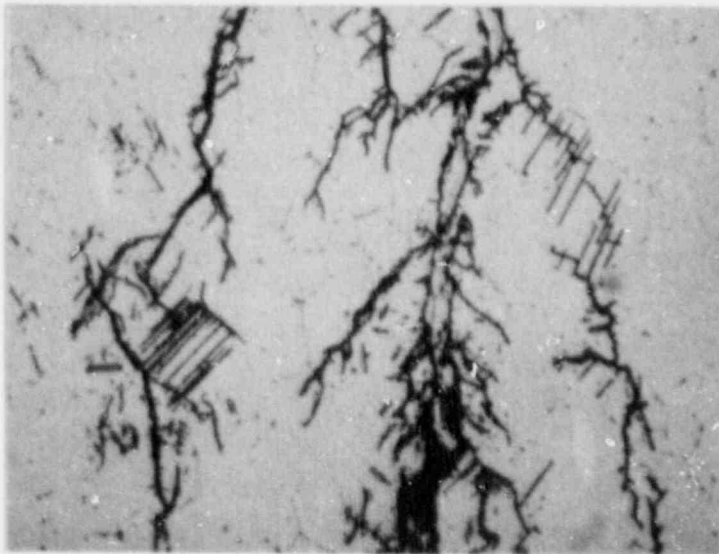
Figure 13 (a) The section of the bellows shown in Figure 3. The arrows mark cracks in the end pieces.
(b) Micrograph showing transgranular cracks
(c) Micrograph showing the area marked in (b).
