LICENSEE EVENT REPORT (LER)

FACILITY NAME (1)
Sequoyah Nuclear Plant (SQN) Unit 2

TITLE (4)
Turbine and Reactor Trips Resulting From a Failure of the 'B' Phase Main Transformer Sudden Pressure Relay.

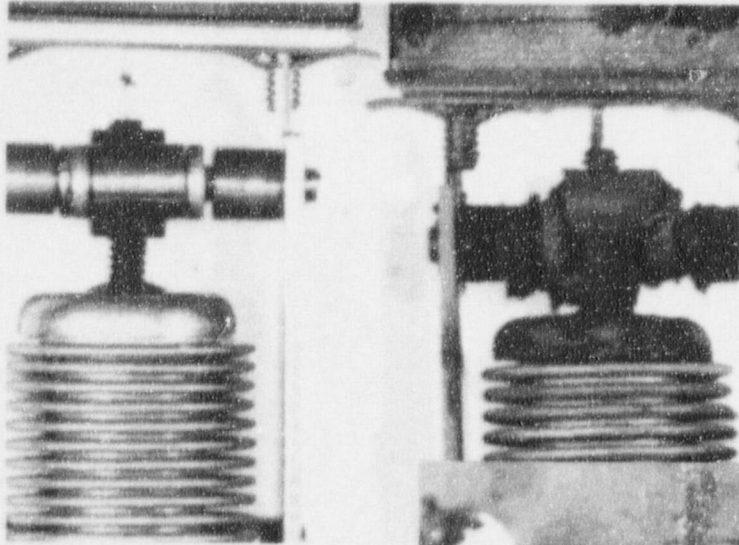
The root cause of the event was the failure of a sudden pressure relay located on the 'B' phase main transformer. Troubleshooting, following the unit trip, found that the sudden pressure relay had not reset as would be expected. Field examination of the device found the housing interior oily and covered with a dark residue. Disassembly of the relay determined that one rocker arm pin had worn to the degree that proper

operation of the device was prevented (the device was in a constant trip condition). The pin failure mechanism appears to be wear (fretting) resulting from vibration. Oil leakage into the relay housing resulted from either an inadequate factory assembly torque between the protective shield and the relay mechanism to prevent transformer oil leakage or leakage of the silicon fluid from the relay mechanism due to a failure of the bellows assembly.

Left: Side-by-side comparison of a rocker pin assembly from the new relay (left) and the failed relay (right). Note that each relay has two assemblies and bellows.

Subsequent to the event, several Qualitrol sudden pressure relays located on other transformers were removed and inspected. Of the 21 total Unit 1 and 2 installed devices, 20 relays have been inspected with 13 requiring replacement (3 due to oil leakage and 10 for fretting). The one remaining device that has not

been inspected is located on a transformer that is not currently in service and has not been in service since initial installation. Discussions with the manufacturer determined that the acceptable "break-away" torque, between the protective shield and the relay mechanism, is between 900 to 1,200 inch-pounds. To prevent oil leakage into the relay housing and ensure reduced mechanism vibration, "break-away" torque is being verified on each of the devices, both new and old. Of the 17 new devices that were examined, 9 met the vendor torque criteria. Where unacceptable torque values are found, the device is being retorqued to 1,200 inch-pounds before installation.

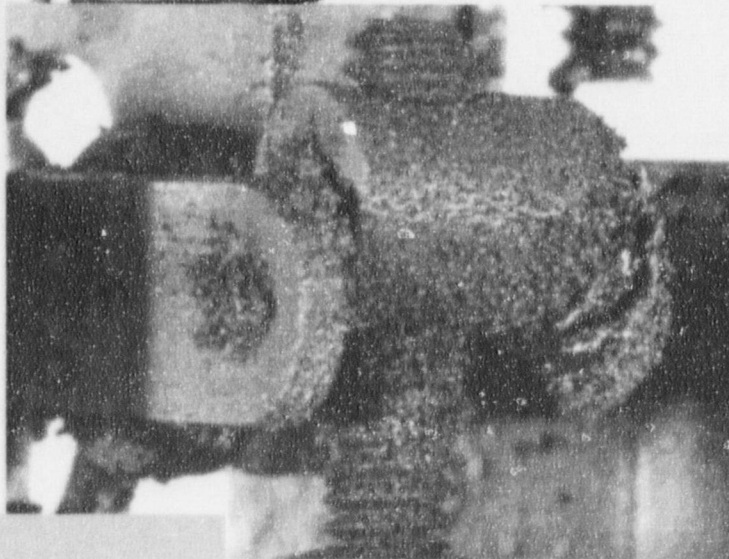
Right: One of the pin assemblies was out of alignment on one rocker in the failed relay. Brass corrosion deposits were all around this area.

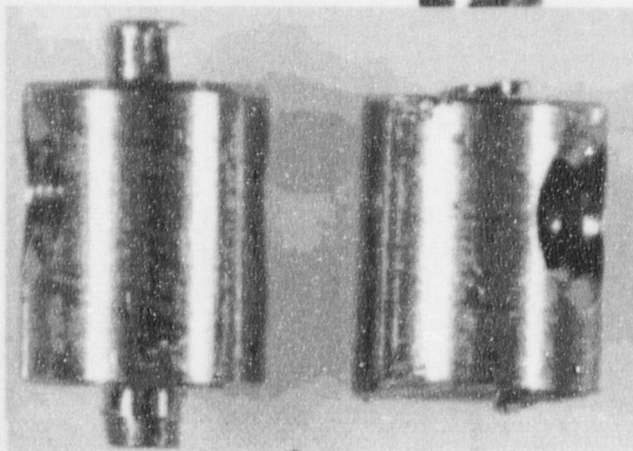
The sudden pressure relay, Qualitrol Corporation Model No. 900-003-01, was examined and found to have failed (the device was in a constant trip condition). Detailed inspection of the component identified significant wear on the rocker arm pins. One of the rocker arm pins had worn to the degree that proper operation of the device was prevented. In addition to this failure mechanism, the wear products (particles of metal [brass with a high percentage of copper content]) were accumulated and trapped in an oil film around the exposed electrical switch wiring as it attached to the connector. This condition could have lead to arcing and subsequent actuation of the auxiliary trip relays within the plant. The oil within the electrical switch enclosure is attributed to either a low torque on the protective shield, resulting in an incomplete seal on the o-ring that seals the relay mechanism or failure of the bellows assembly and leakage of the silicon fluid into the housing.

Left: Pins from each rocker (from the failed relay) after cleaning. The pin on the left still had nubs on each end which fit into the rocker arms; however, some evidence of wear was present. The pin on the right is the same one shown above.
