L I C E N S E E E V E N T R E P O R T (L E R)

FACILITY NAME (1) Arkansas Nuclear One, Unit Two DOCKET NUMBER (2) PAGE (3)
01510101 31 61 8110F1019

TITLE (4) Unisolatable Reactor Coolant System Leak Caused By Vibration Induced Fatigue Failure of A
Reactor Coolant Pump Seal Instrumentation Line

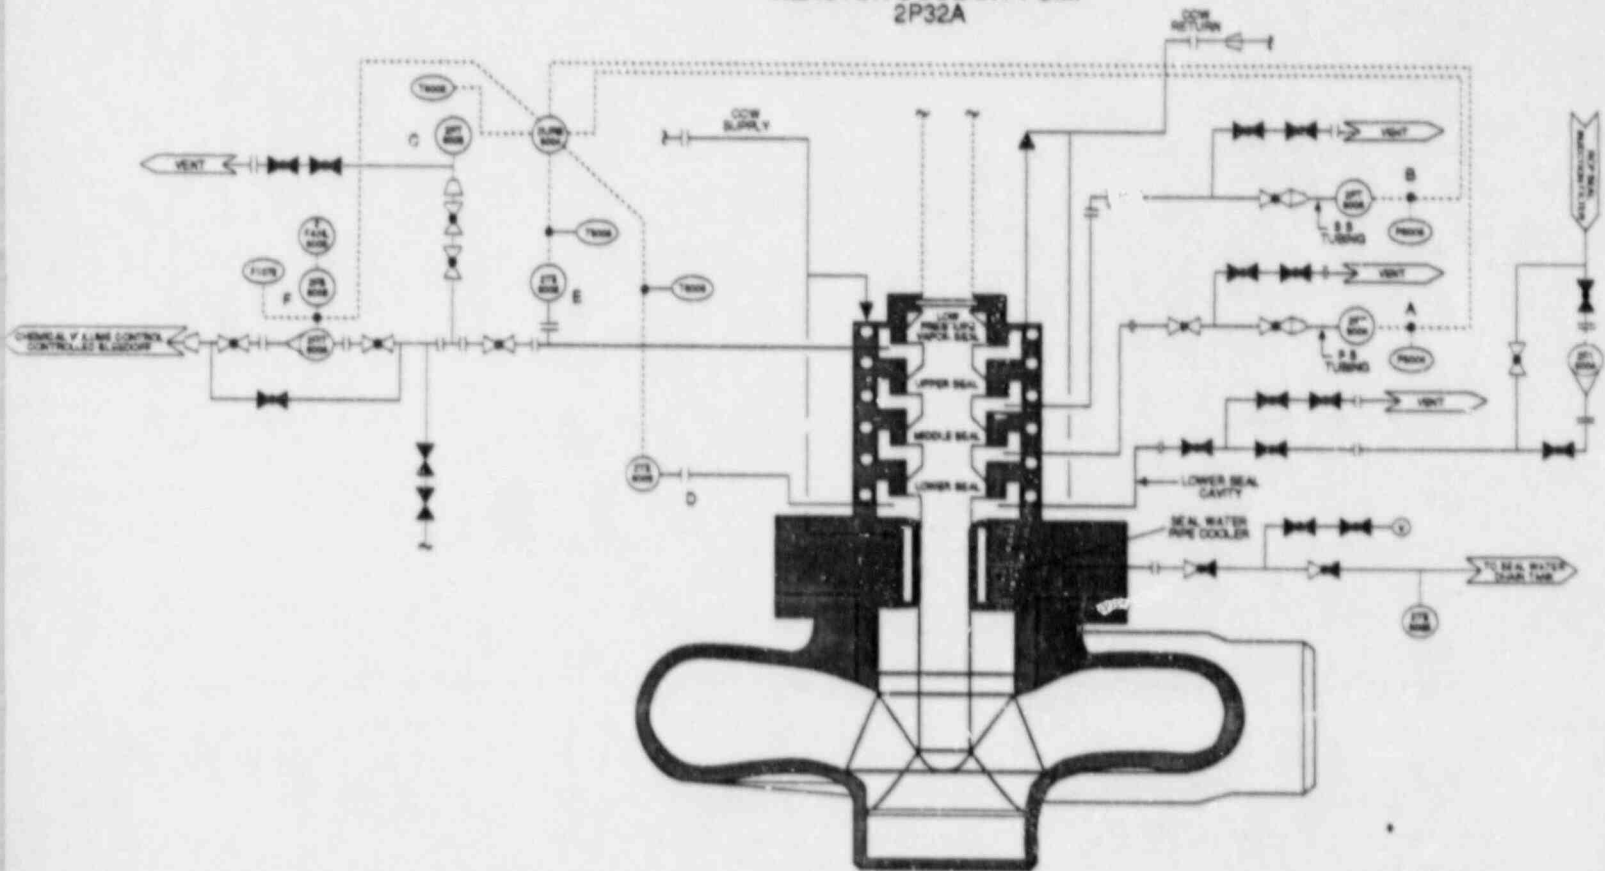
FIGURE 1

This event involves the failure of reactor coolant pump (RCP) 2P32A middle seal cavity pressure sensing instrument line. The failure occurred in 3/8 inch instrumentation tubing (ITB) at the fusion line of a tubing to piping reducer socket weld. The tubing/reducer assembly allows connection of a pressure transmitter (PT) to a 3/4 inch ASME Section III Class III pipe connected to the middle seal cavity of the shaft seal for the RCP. The transmitter is used to provide remote indication of middle seal cavity pressure in the control room. The transmitter also provides an input signal to the plant computer.

2P32A middle seal cavity pressure sensing line weld failure on 8/1/88.

The cause of the failure of the 2P32A middle seal cavity pressure sensing line was determined to be low stress, high cycle, fatigue failure of the weld material, induced by vibration associated with the operating reactor coolant pump. Investigations of the failure also showed that during a modification made to this line in 1984, field personnel had installed a tubing to pipe connection with an elbow which deviated from standard details and was an unapproved method of routing instrumentation tubing for this application. This was considered to be a significant contributing factor to the failure.

REACTOR COOLANT PUMP
2P32A

The 2P32A shaft seal was removed and replaced. Work activities undertaken on the seal piping and tubing systems for all four RCPs consist of system configuration reviews and restoration, modifications, and weld betterments.
