LICENSEE EVENT REPORT (LER)

San Onofre Nuclear Generating Station (SONGS) Unit 3

TITLE (4): CCW Relief Valve Inoperable - Wrong Set Spring Installed Due to Vendor Data Error

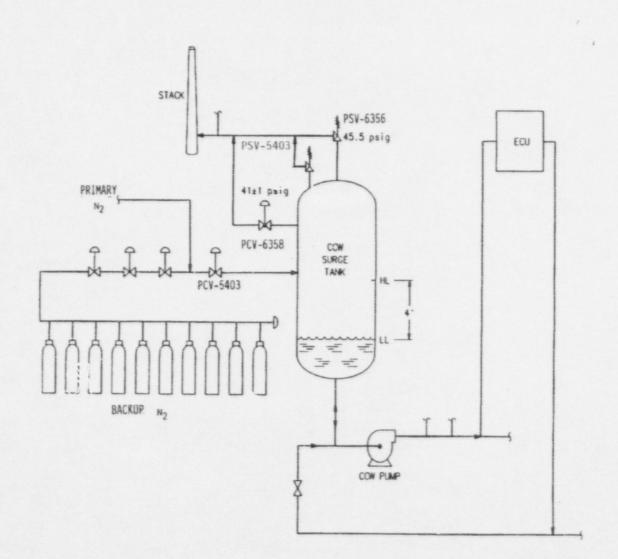
Figure 1

The component cooling water (CCW) (CC) system for Units 2 and 3 consists of two independent trains, each train equipped with a 6,658 gallon (approximate) surge tank (TK). See Figure 1. As originally designed, each surge tank is pressurized to about 32 pounds per square inch gauge (psig) with nitrogen gas to prevent void formation at high points in the system and to minimize the potential for water hammer in the event of a rapid drawdown in surge tank level together with a CCW pump trip and restart transient. Each surge tank is equipped with a nitrogen back pressure control valve (PCV) (Unit 3 valves 3PCV-6358 or 3PCV-6361) designed to vent the tank if pressure increases above the control valve set point of approximately 41 psig. This back pressure control valve can modulate nitrogen pressure without requiring the pressure safety relief valve (RV) (3PSV-6356 or 3PSV-6359) to open. However, its relief capacity is not sufficient to prevent system overpressurization.

When CCW system leakage causes surge tank level to decrease, nitrogen gas expands into the tank to maintain system pressure. During makeup, the nitrogen gas is compressed by the rising water level, and is vented by the back pressure control valve. The surge tank is also provided with a pressure safety relief valve to prevent CCW train failure by venting the surge tank at 45.5 psig. This setpoint will prevent the CCW system downstream of the pump discharge from exceeding its system design pressure of 150 psig. Although the CCW system has thermal relief valves located within the critical and non-critical piping loops, the relief capabilities of these valves are not sufficient to prevent overpressurization by failure of the nitrogen pressure regulator valve {PCV}.

To ensure availability of nitrojen pressure following a seismic event, in 1992 the surge tank design was upgraded to include a safety-related, seismically qualified backup nitrogen system (LK). During this upgrade, in February 1992, a second safety relief valve on each CCW surge tank (3PSV-5403 or 3PSV-5404) was added with a pressure setting of 56 psig.
