February 28, 1986

NRC DOCKET 50-321
OPERATING LICENSE DPR-57
EDWIN I. HATCH NUCLEAR PLANT UNIT 1
PRESERVICE INSPECTION DISCREPANCIES

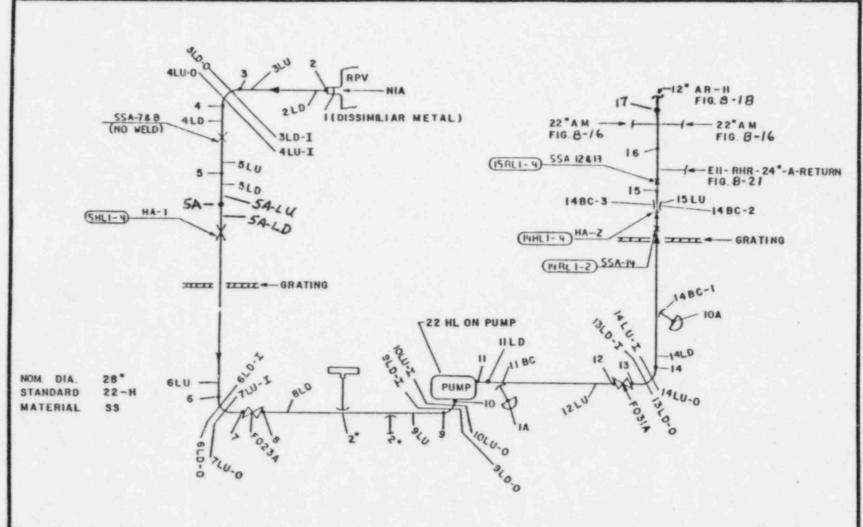
FIGURE 1

As previously discussed with the NRC, during the course of Hatch Unit 1 inservice inspection and IGSCC mitigation activities, plant personnel discovered an additional 28" diameter circumferential shop weld in the "A" Recirculation (Recirc) system loop. The subject shop weld is located between welds 1B31-1RC-28A-5 and 1B31-1RC-28A-6 (Refer to Figure 1, attached) and has been designated as weld 1B31-1RC-28A-5A (weld 5A).

Welds 5A, 5A-LU, and 5A-LD were not inspected in service until the current outage. Ultrasonic examination of the subject welds revealed that the welds were free of any rejectable indications. Subsequent to the ultrasonic examinations, weld 5A was treated using induction heating stress

improvement (IHSI). The weld was examined again post-IHSI and was found to fully meet appropriate acceptance criteria, with no rejectable indications. It should be noted that insulation removal from this section of piping for normal or augmented inservice inspection had not been required since the existence of the subject circumferential weld was unknown. The insulation was removed during the current outage to facilitate mounting of equipment to perform IHSI on weld 1B31-1RC-28A-5.
