PACIFIC GAS AND ELECTRIC COMPANY - DIABLO CANYON UNIT NO. 1
DOCKET NO. 50-275

Report of Inspection

CO Report No. 50-275/70-5

Licensee: Pacific Gas & Electric Company
Diablo Canyon Unit No. 1
Construction Permit No. CPPR-39
Category A

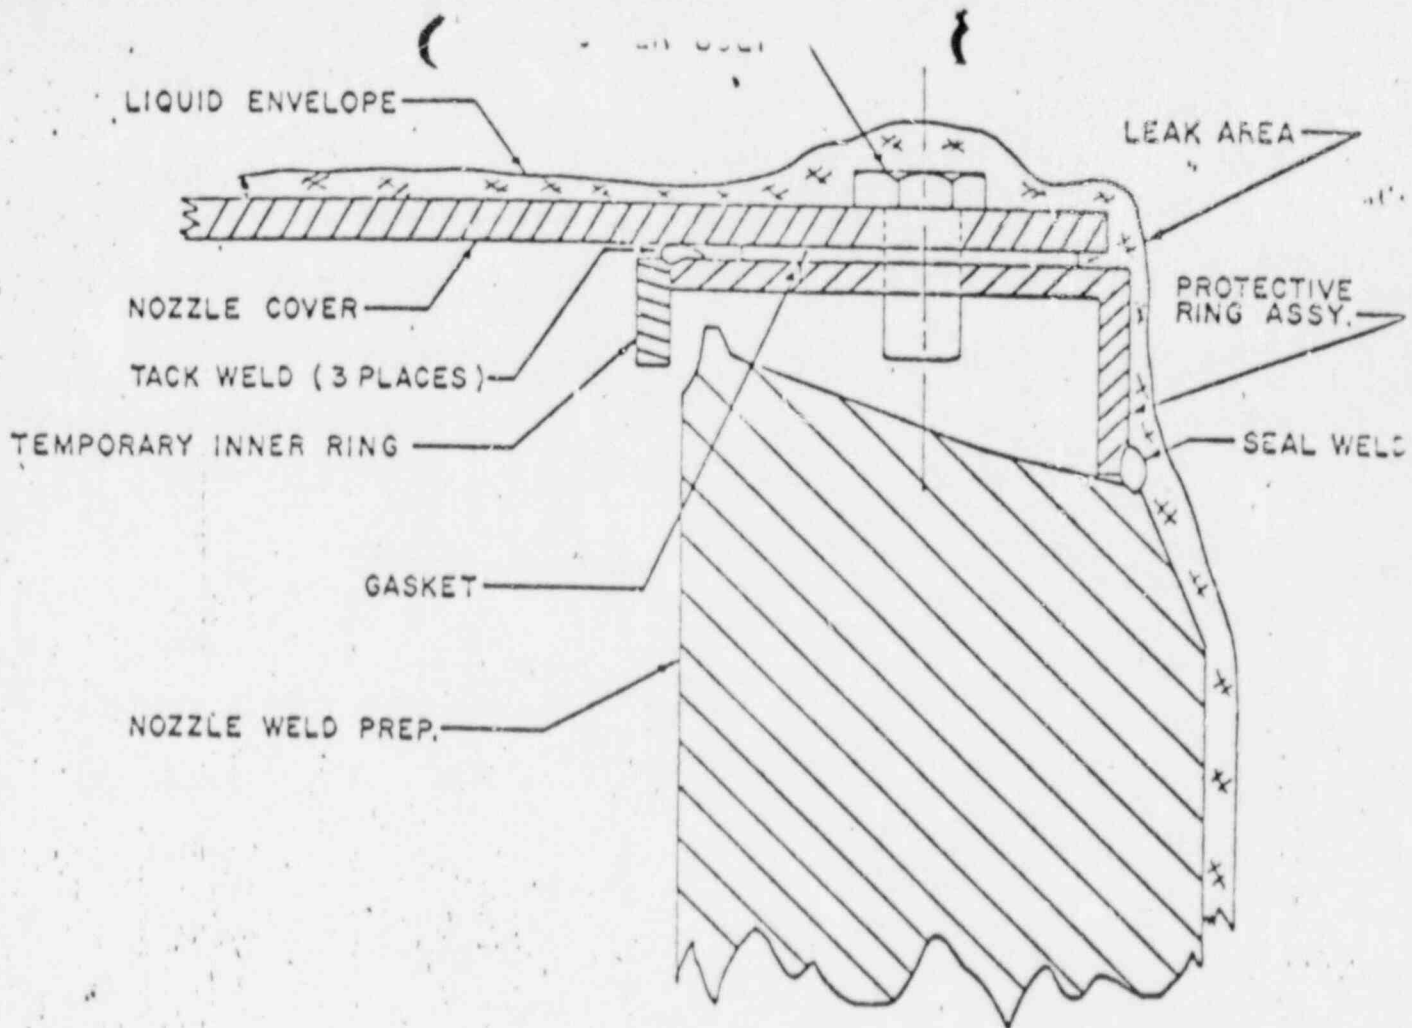
A report of a meeting between Westinghouse and PG&E personnel discussed the design of the shipping closure of the steam generator channel nozzles and why they failed. (Appendix B shows a diagram of the problem area.) The nozzle weld preparations were protected by an angle iron ring seal-welded to the end of the nozzle outside of the weld preparations. Another ring was tack welded to this ring, inside it and the weld preparations, for further

protection during manufacture. When the steam generators were prepared for shipment, the tack welded inner rings were to have been removed and gasketed covers bolted to the seal welded rings. However, the inner rings were not removed, and the covers were prevented from seating as intended, resulting in leakage paths past the tack welded joints. Plastic coatings were sprayed on the outside of the bolted closures, but the coating failed. There was no procedure requiring removal of the temporary rings, although there was a note calling for their removal on a drawing. The procedure has now been revised to call for this step. Westinghouse stated to PG&E that they had such confidence in the closure design that they conducted no tests of the integrity of the shipping preparation.

THE SALT WATER INTRUSION OCCURED BECAUSE:

- 1- THE SHOP FAILED TO REMOVE THE TEMPORARY INNER RING PRIOR TO SHIPMENT OF STEAM GENERATORS.
- 2- THE TACK-WELDS PROJECTED SUFFICIENTLY TO PREVENT THE SHIPPING COVERS FROM SEATING ON THEIR GASKETS.
- 3- THE "LIQUID ENVELOPE" FAILED DURING THE BARGE TRIP ALLOWING SEA WATER TO CONTACT THE METAL SURFACES.

The corrective action proposed by Westinghouse was to wash the channels with deionized water until a one ppm chloride level was reached in the wash water and then swab with alcohol to dry. They believed that this would prevent any future damage from the sea water and was all that was required. It was the same procedure proposed for the Indian Point generators which had greater leakage. Mr. Baulig, Westinghouse, said that 1/10 ppm chloride was relatively easy to achieve in the field, and it was his stated intention to wash to this level, not just to the 1 ppm level required by the AEC.
