U. S. ATOMIC ENERGY COMMISSION  
DIVISION OF COMPLIANCE  
REGION V

Report of Inspection

CO Report No. 50-275/70-2

Licensee: Pacific Gas & Electric Company  
Construction Permit No. CPPR-39  
Category A

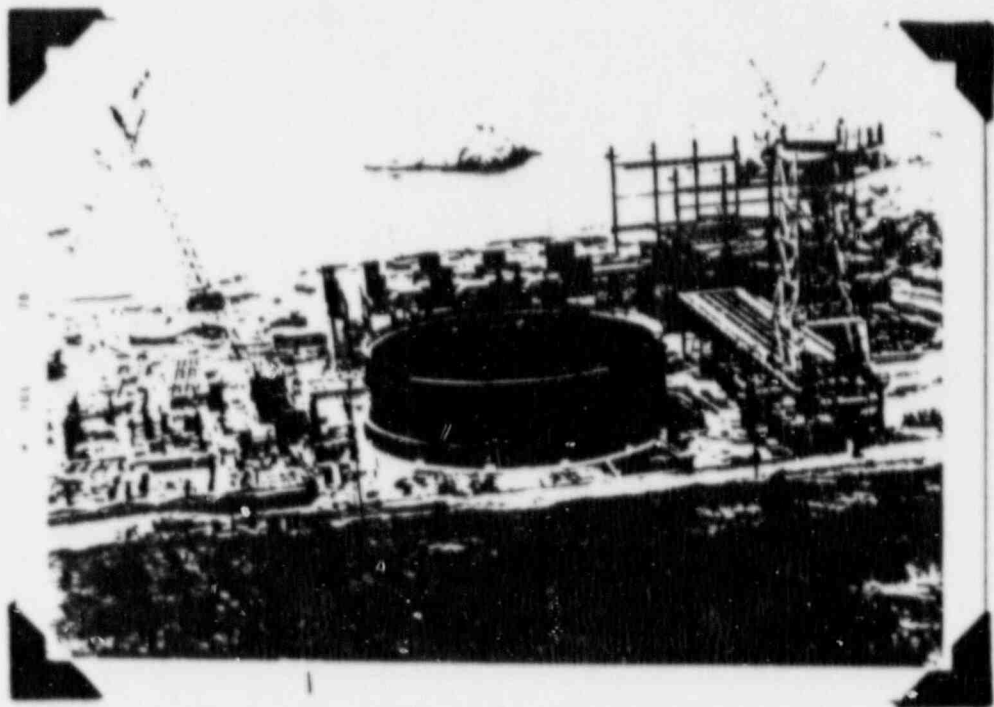
Considering the close proximity of the Diablo Canyon site and the Pismo Beach storage yard to the ocean; the inspector asked to what extent potential contamination of stainless steel materials by a salt-air environment had been evaluated. Specific reference was made to such item as core internals, etc.

FIGURE 4 - Diablo Canyon Construction Site. (Note Close Proximity to Ocean)

Mr. Hersey stated that stainless steel materials at the Diablo Canyon site are to be stored either inside a warehouse or covered with plastic or other suitable materials.

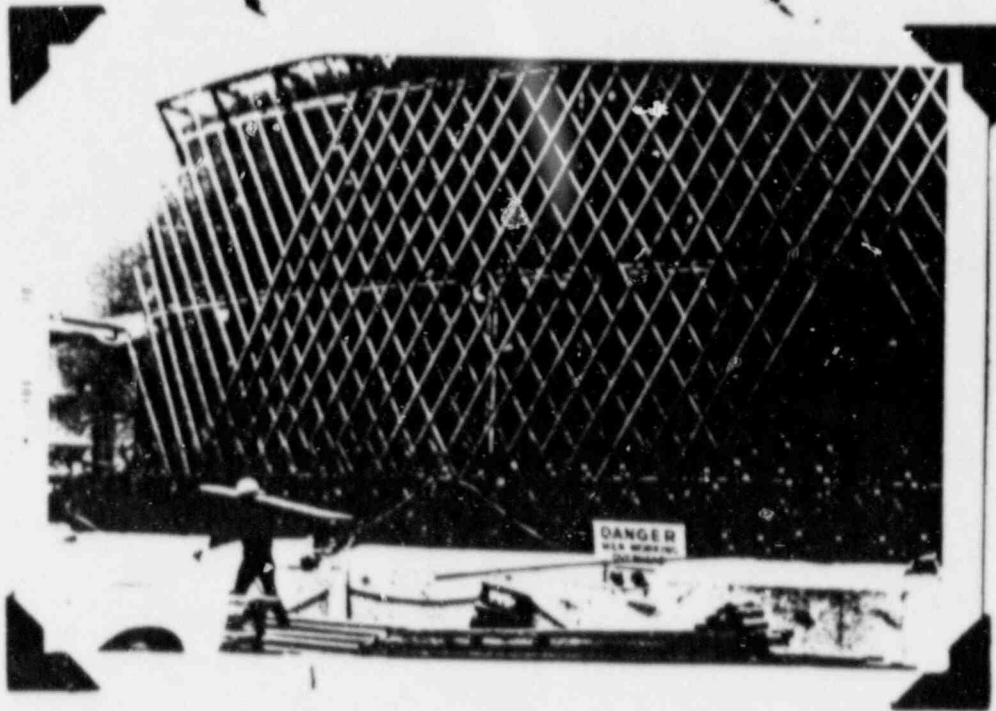
FIGURE 1 - Diagonal Reinforcing Steel for Diablo Canyon Unit No. 1 Containment Building

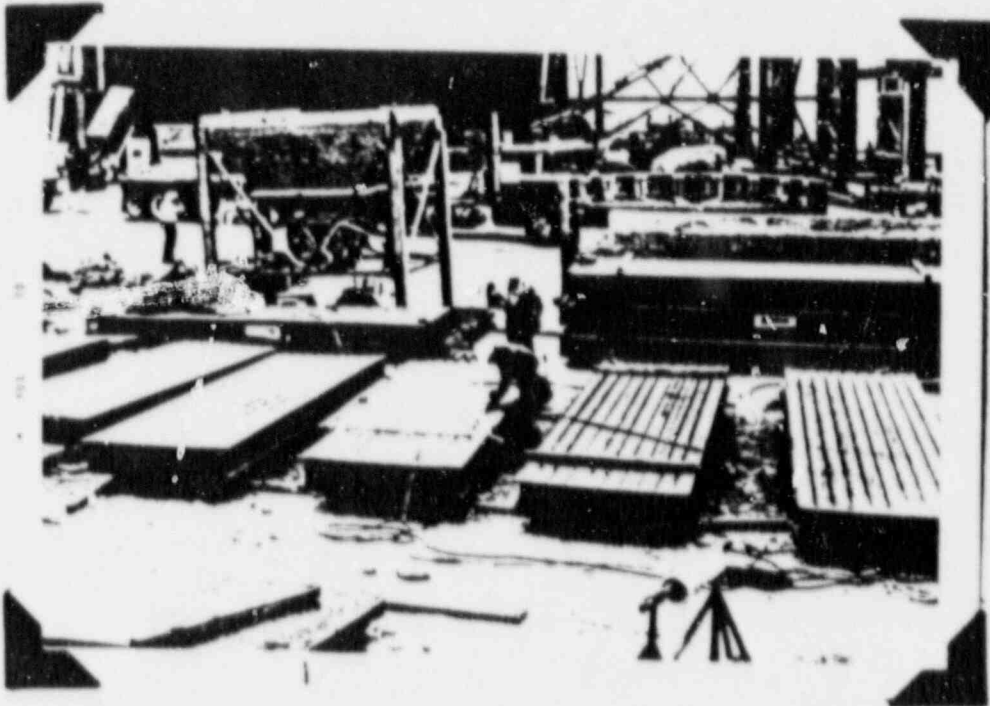
The first section of the vertical side walls of the containment are to be constructed by installing 12 inch wide flange beams (20 feet long) circumferentially around the containment liner. The beams are positioned vertically and rest on the base mat. (Figure 5 shows the beams) The edge of the beams are to be located a distance of 12 inches from the liner plate. The concrete to be installed between the liner wall and the beams will be reinforced circumferentially with steel hoop and diagonally by helicoidal bars (No. 18 reinforcing steel).

The licensee has approved a special concrete mix to be placed in the space between the flanges and the containment liner. The mix was designed for a strength of 3000 psi; with the slump specified as 5 inches. The maximum aggregate size was specified to be 3/4 inch.

FIGURE 5 - Wide Flange Beams to be Installed in the Base Section of the vertical walls of the Containment Building.

Subsequent to the discussions and during the management interview, Friedrichs stated that consideration would be given as to whether or not to build a mockup section of the area and make a pour so that the resulting concrete could be analyzed.
