TELETHERAPY FACILITY SURVEY
VETERANS ADMINISTRATION HOSPITAL
EAST ORANGE, NEW JERSEY

K. David Steidley
K. David Steidley, Ph.D., C.H.P.

8/18/85

I. GENERAL

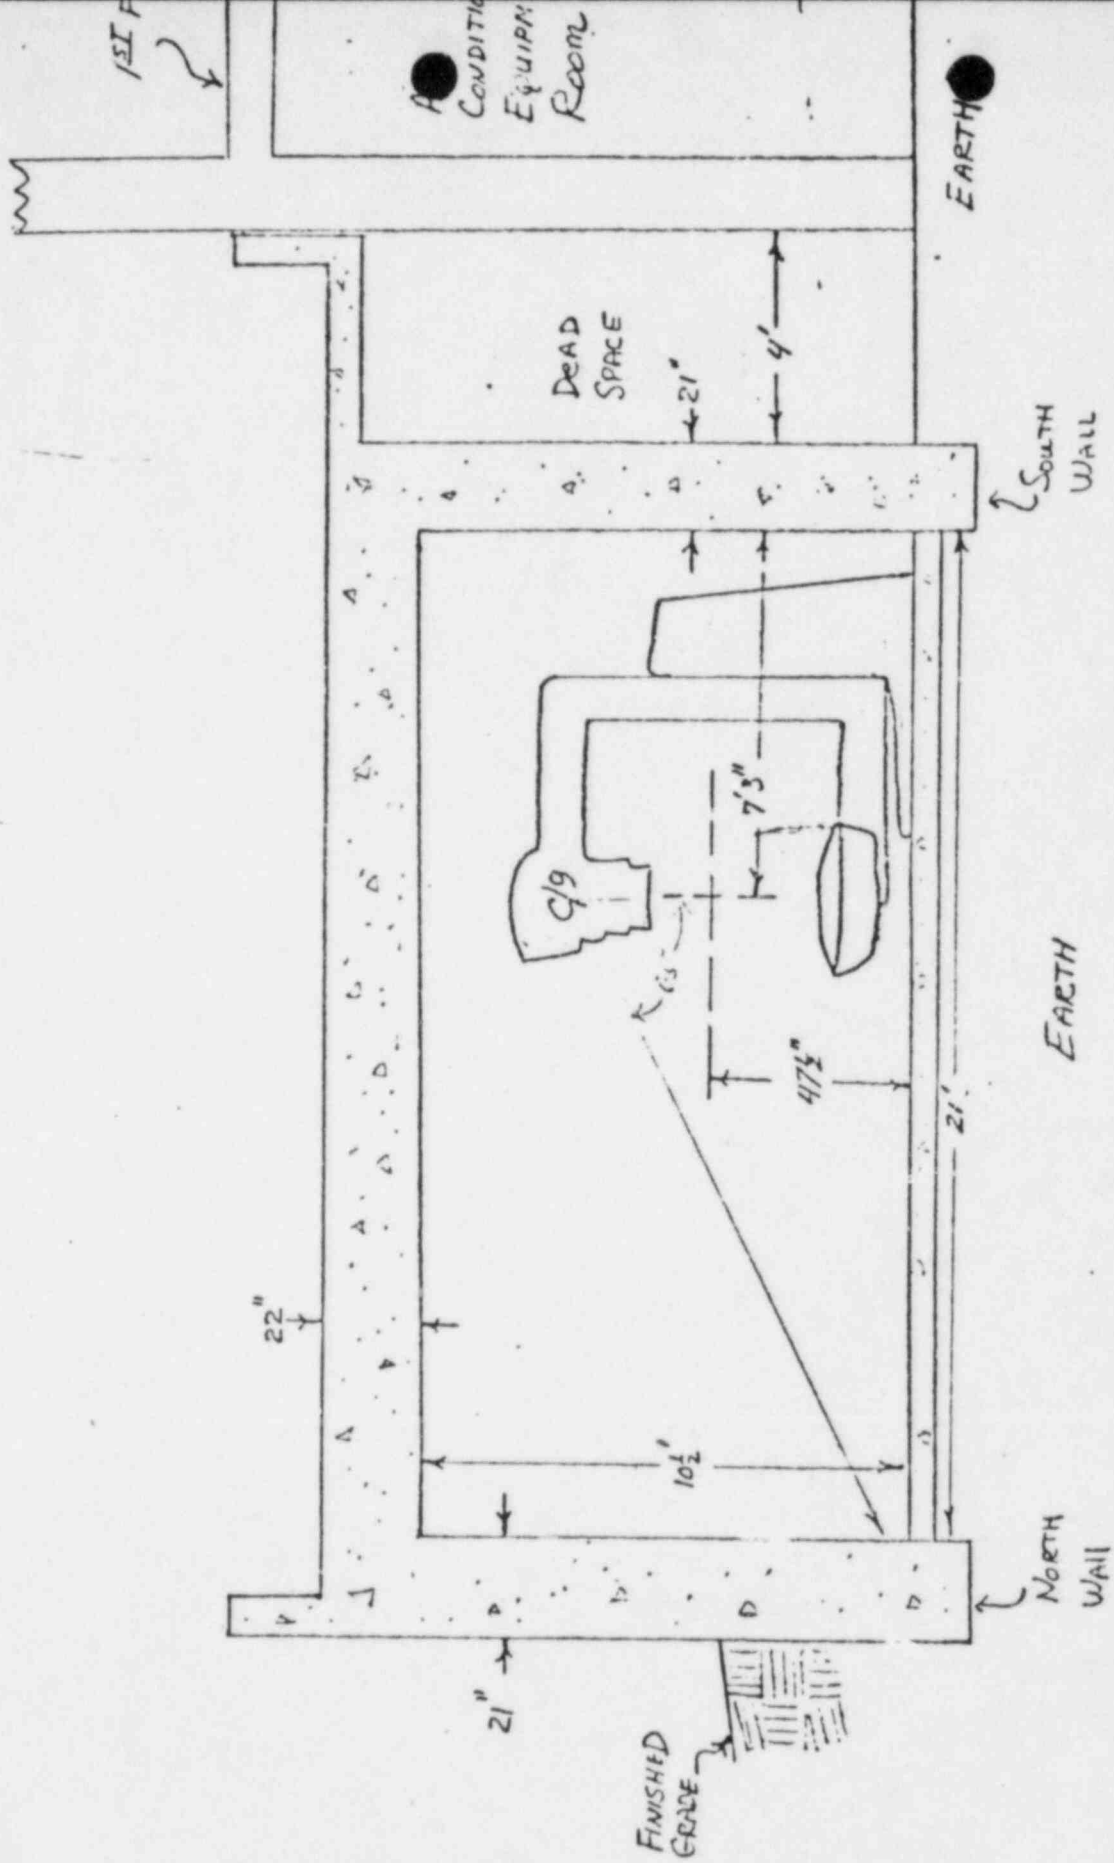
Fig. 1b.
 SCALE $\frac{1}{4}'' = 1'$

Electrical stops that have been installed to limit the orientation of the teletherapy head with the source "ON" were tested and found to function properly. The head may be rotated off the beam stopper in the plane of rotation such that it is angled 8 degrees away from the vertical toward the east wall or 95 degrees away from the vertical toward the west wall (see Figure 1a). The head is so limited that it can rotate off the beam stop from 0 degrees to 65 degrees from the plane of rotation toward the north wall (see Figure 1b).

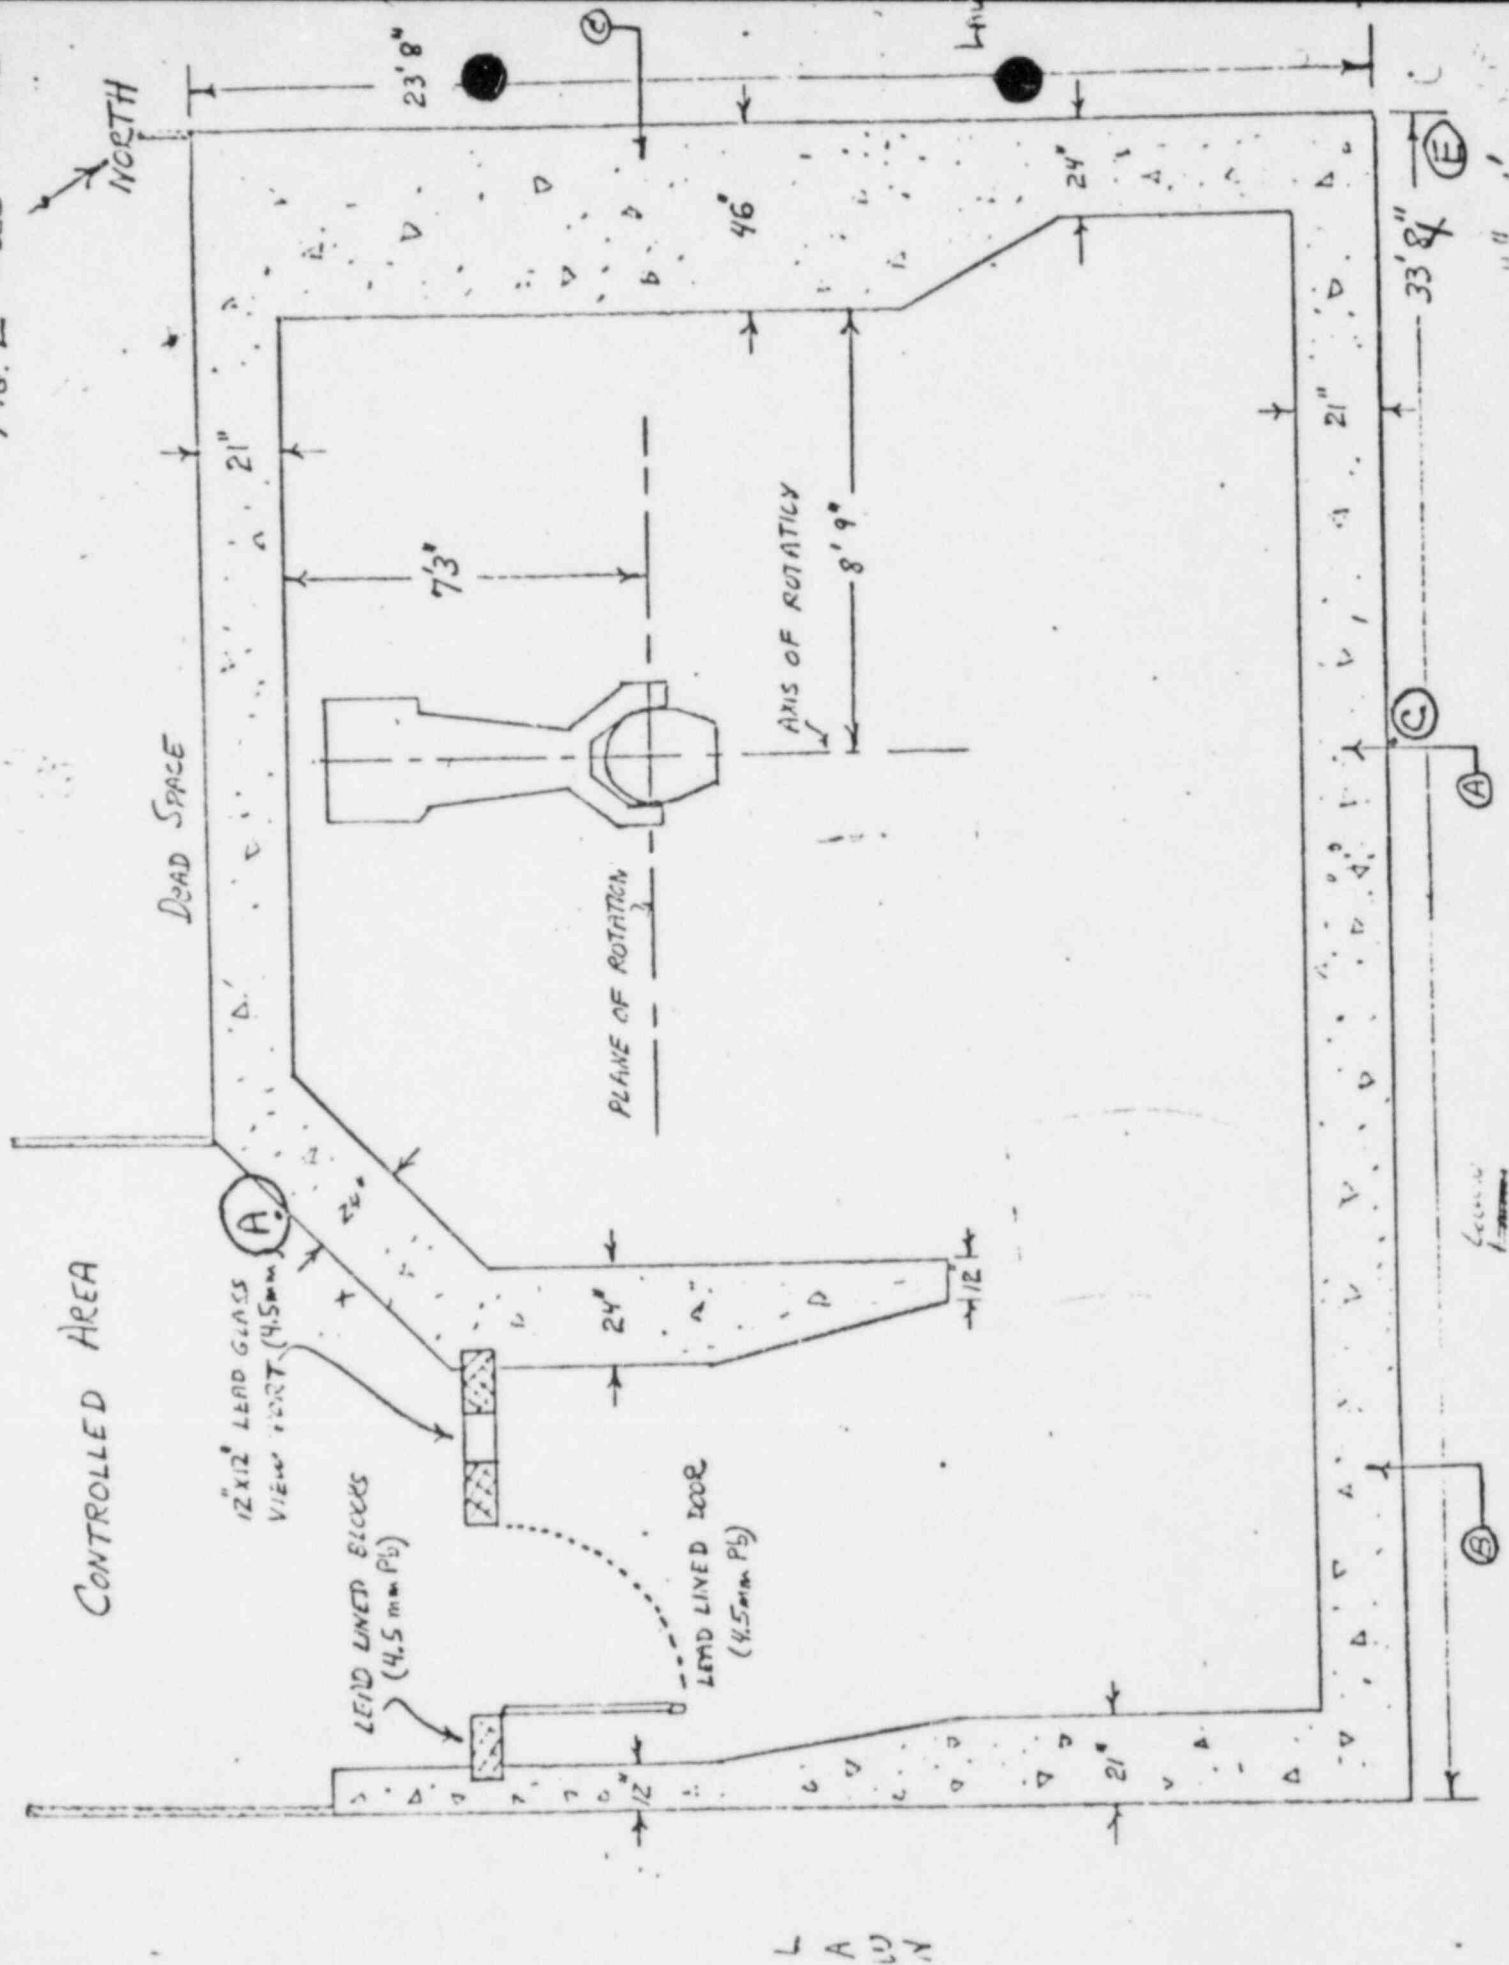
Fig. 2 - See Notes

Inspection of Figures 2, 3, 4, 5, and 6 show the layout of the teletherapy room. The survey of radiation levels about the facility was made at various locations along each wall and the roof by scanning carefully with a Keithley (Model 36100, serial number 12174) portable ionization (calibration--July 1985) instrument for any "hot" spots.

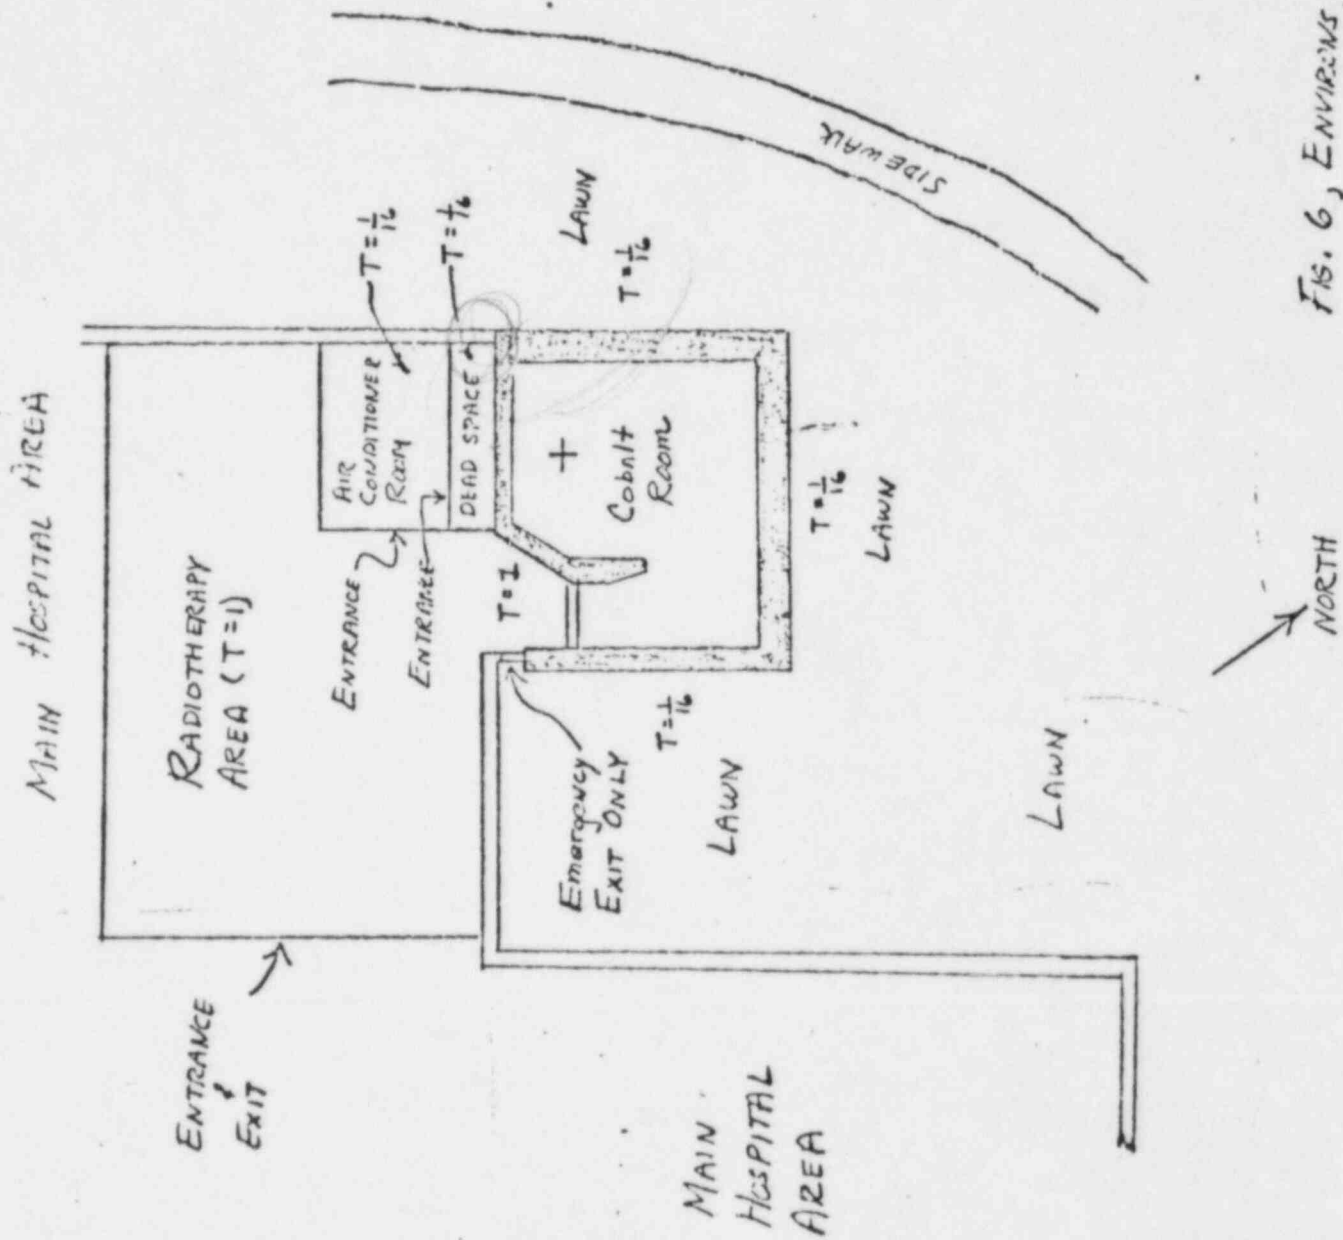
FIG. 6, ENVIRONS OF THERAPY ROOM
 SCALE: ROUGHLY 1"=20'
 T = OCCUPANCY FACTOR

10. Northwest Corner

With beam toward northwest corner--no beam stop:

215 mR/hr at ground level at ~4" from wall

60 mR/hr at waist level at ~1 meter from wall

23 mR/hr at waist level at edge of bushes

In the case of the 60 mR/hr dose rate, it should be noted that this would only be used for whole body irradiations of ~20 given rads, a clinical situation of some rarity (about once a year). The dose rate at 3 meters would be about 9.8 R/min and two minutes of time would be necessary. Thus, the dose to this point would be 2/60 of 60 mR/hr or 2 mR. This complies with 20.105(b).
