LICENSEE EVENT REPORT (LER)

| FACILITY NAME (1) Peach Bottom Atomic Power Station - Unit 2 | DOCKET NUMBER (2) 0 5 0 0 0 2 7 7 | PAGE (3) 1 OF 0 7 |

TITLE (4)
Shutdown Cooling Isolation as a Result of Procedural Inadequacy

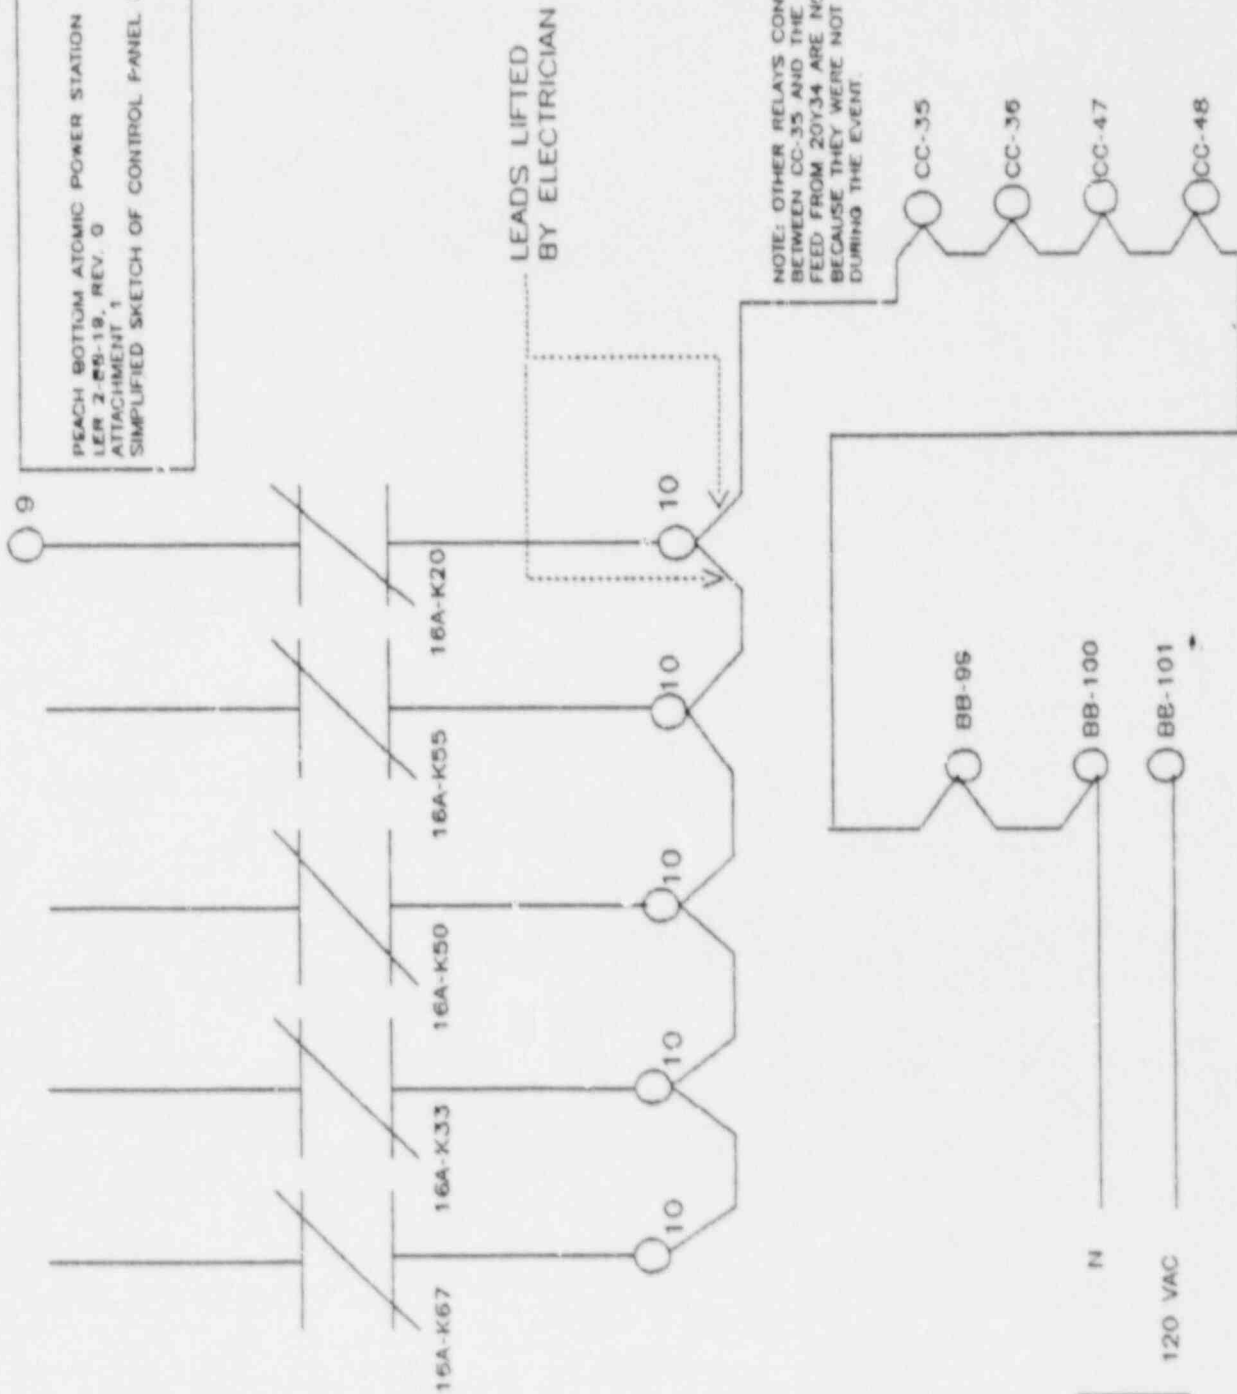
PEACH BOTTOM ATOMIC POWER STATION
LER 2-85-19, REV. 0
ATTACHMENT 1
SIMPLIFIED SKETCH OF CONTROL PANEL 20C42

The 16A-K20 relay is the drywell floor drain isolation valve alarm relay. At the time of the event, a maintenance electrician was lifting the 16A-K20 leads in the 20C42 control room panel to replace the relay for preventive maintenance. Lifting the 16A-K20 relay leads interrupted the neutral side of several other relays within the circuit which were not within the scope of the blocking permit, resulting in the unexpected isolation (See Attachment 1). The following actuations occurred due to lifting the 16A-K20 leads:

| <u>Relay No.</u> | <u>Effects of Circuit Interruption</u> |
|---|--|
| 16A-K50 | Relay de-energized generating a false high reactor pressure signal. Also, relays 16A-K29 and 16A-K54 de-energized, providing an isolation signal to the SDC inboard isolation valve (MO-2-10-18) and the Head Spray inboard isolation valve (MO-2-10-32). |

Relays 16A-K30 and 16A-K55 de-energized to provide an isolation signal to the SDC outboard isolation valve (MO-2-10-17) and the Head Spray outboard isolation valve (MO-2-10-33).

All valves isolated to the closed position and the "C" Residual Heat Removal (RHR) pump tripped.

Contacts opened to provide an isolation signal to the drywell 2-inch inboard vent valve (AO-2509). No valve motion occurred because it was in closed position prior to the event.

Contacts opened to provide an isolation signal to the drywell 2-inch outboard vent valve (AO-2510). No valve motion occurred because it was in the closed position prior to the event.

PCIS is designed as a "fail safe" type system. Thus when the 16A-K20 relay leads were lifted which interrupted power to the other affected relays, the isolation valves associated with these relays received closure signals and the "C" RHR pump tripped. Therefore, any potential release of radioactive material would have been precluded.

The cause of the event was procedural deficiency. Blocking permits are procedures for the removal and return to service of Plant equipment. The procedure (blocking permit) was deficient in that following the steps caused the interruption of the neutral side of relays which were not within the scope of the blocking sequence.

The maintenance electrician immediately replaced the leads upon actuating the relays and notified Operations. Operations reset the isolation and returned SDC to service within five minutes. Application of the permit was suspended pending further review and revision to correct the deficiencies.

On August 15, 1988, a letter was issued to personnel normally assigned as permit writers and reviewers concerning the preparation of permits which deal with safety-related equipment logic circuitry. The letter states that all of the appropriate prints which illustrate the logic circuitry (M-1-S) terminal connections (M-1-EE) must be consulted during permit preparation. In addition, the letter requires a review of selected previous Peach Bottom LERs which exemplify events related to handling logic circuits. Finally, the letter encourages "walkdowns" of the applicable panels/components, whenever practical, to verify that the permit is in agreement with actual conditions.
