U.S. NUCLEAR REGULATORY COMMISSION
REGION I

Facility Name: Beaver Valley Power Station Unit No: 1

Conference: Environmental Qualification (EQ) enforcement conference held to discuss the significance of concerns about the environmental qualification of continental cable, containment High Range Radiation Monitors and wiring inside Limatorque motor operated valves.

DUQUESNE LIGHT COMPANY
HANDOUT MATERIAL

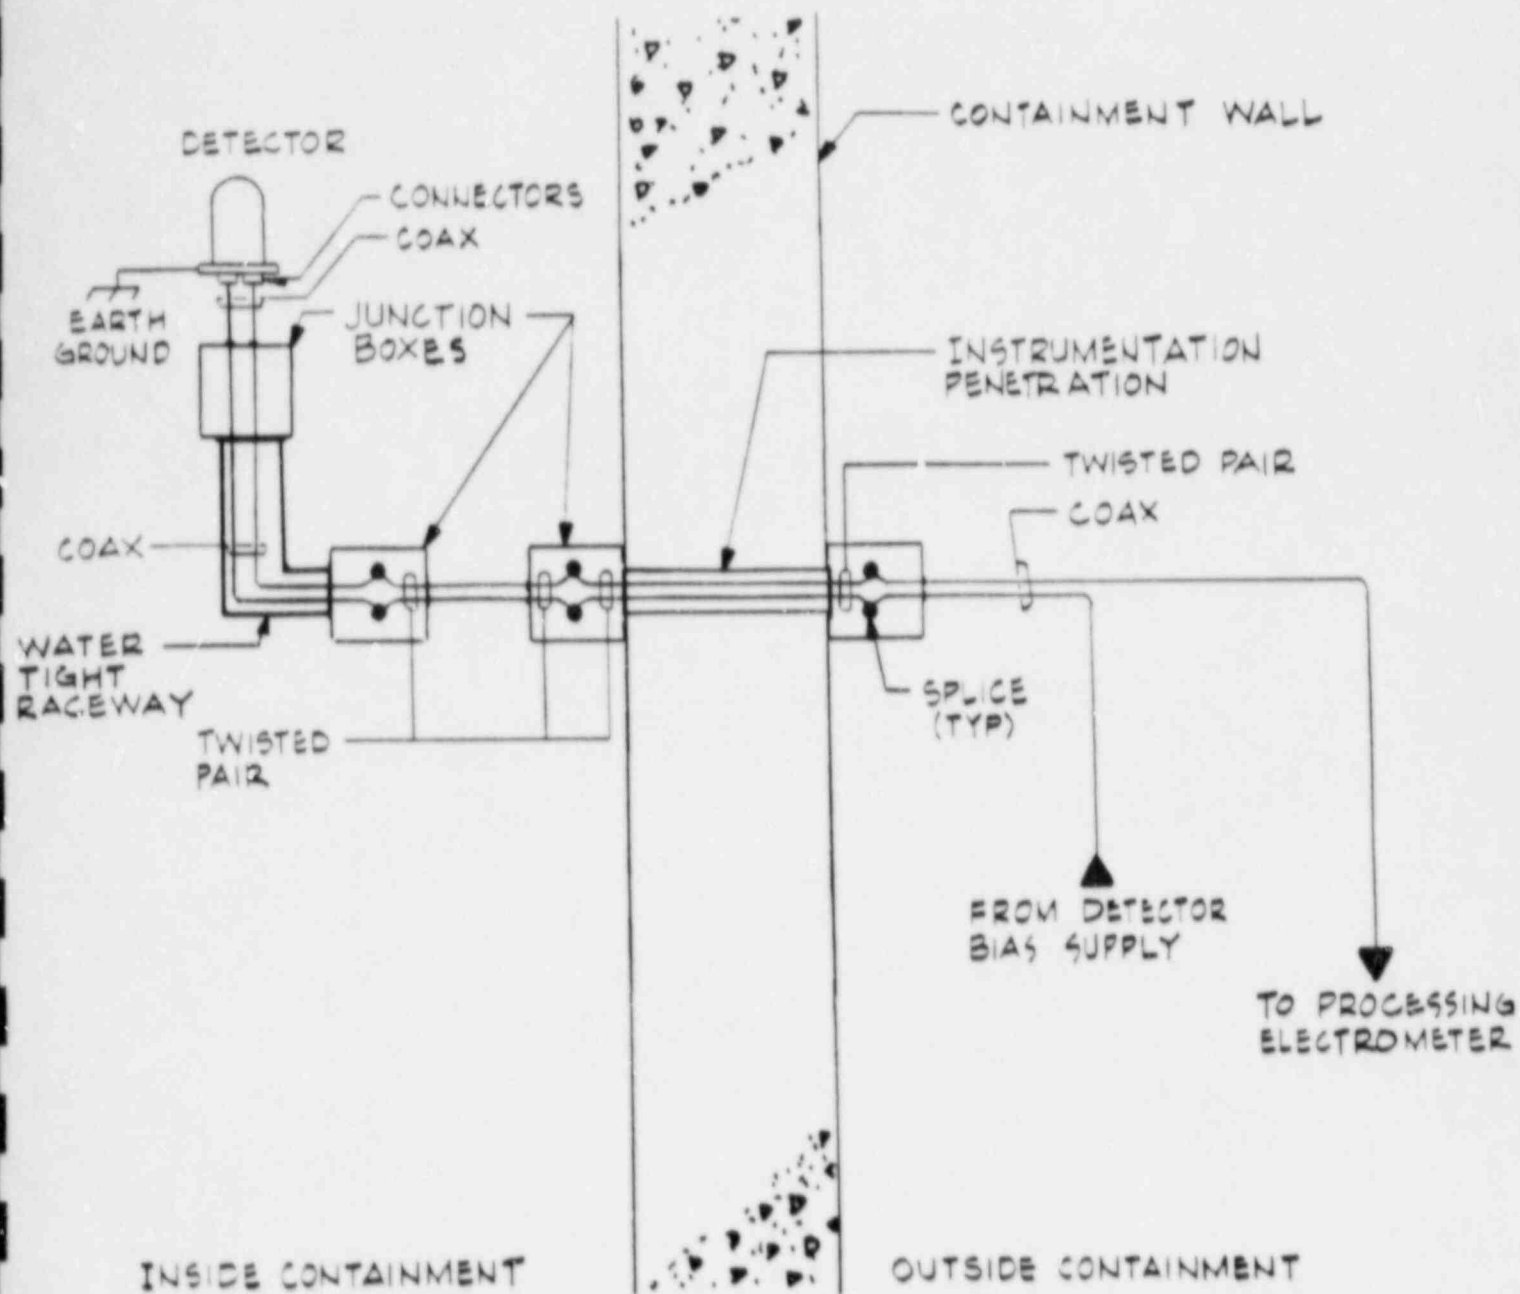
AS BUILT CONFIGURATION

The timing of the implementation deadline date for the post TMI modifications and outage schedule of BVPS-1 caused the containment HRRM to be installed with a qualified containment penetration module consisting of a shielded, twisted instrumentation cable. DLC was unable to secure a qualifiable coaxial cable penetration during the outage window. The existence of 60 inches of the twisted pair at the penetration was not considered to invalidate the operation of the HRRM system. The HRRM provides indication of radiation field density through eight orders of magnitude. The intent of the modification and the design of the device does not allow a precise reading to be taken due to the low level signal.
