LICENSEE EVENT REPORT (LER)

FACILITY NAME (1) Sequoyah, Unit 1	DOCKET NUMBER (2) 0 5 0 0 0 3 2 7	PAGE (3) 1 OF 10
---------------------------------------	--------------------------------------	---------------------

Control Room Emergency Ventilation System Single Failure Criteria Violated Due To A Design Error Which Could Result In Exceeding Allowable Dose To Operators

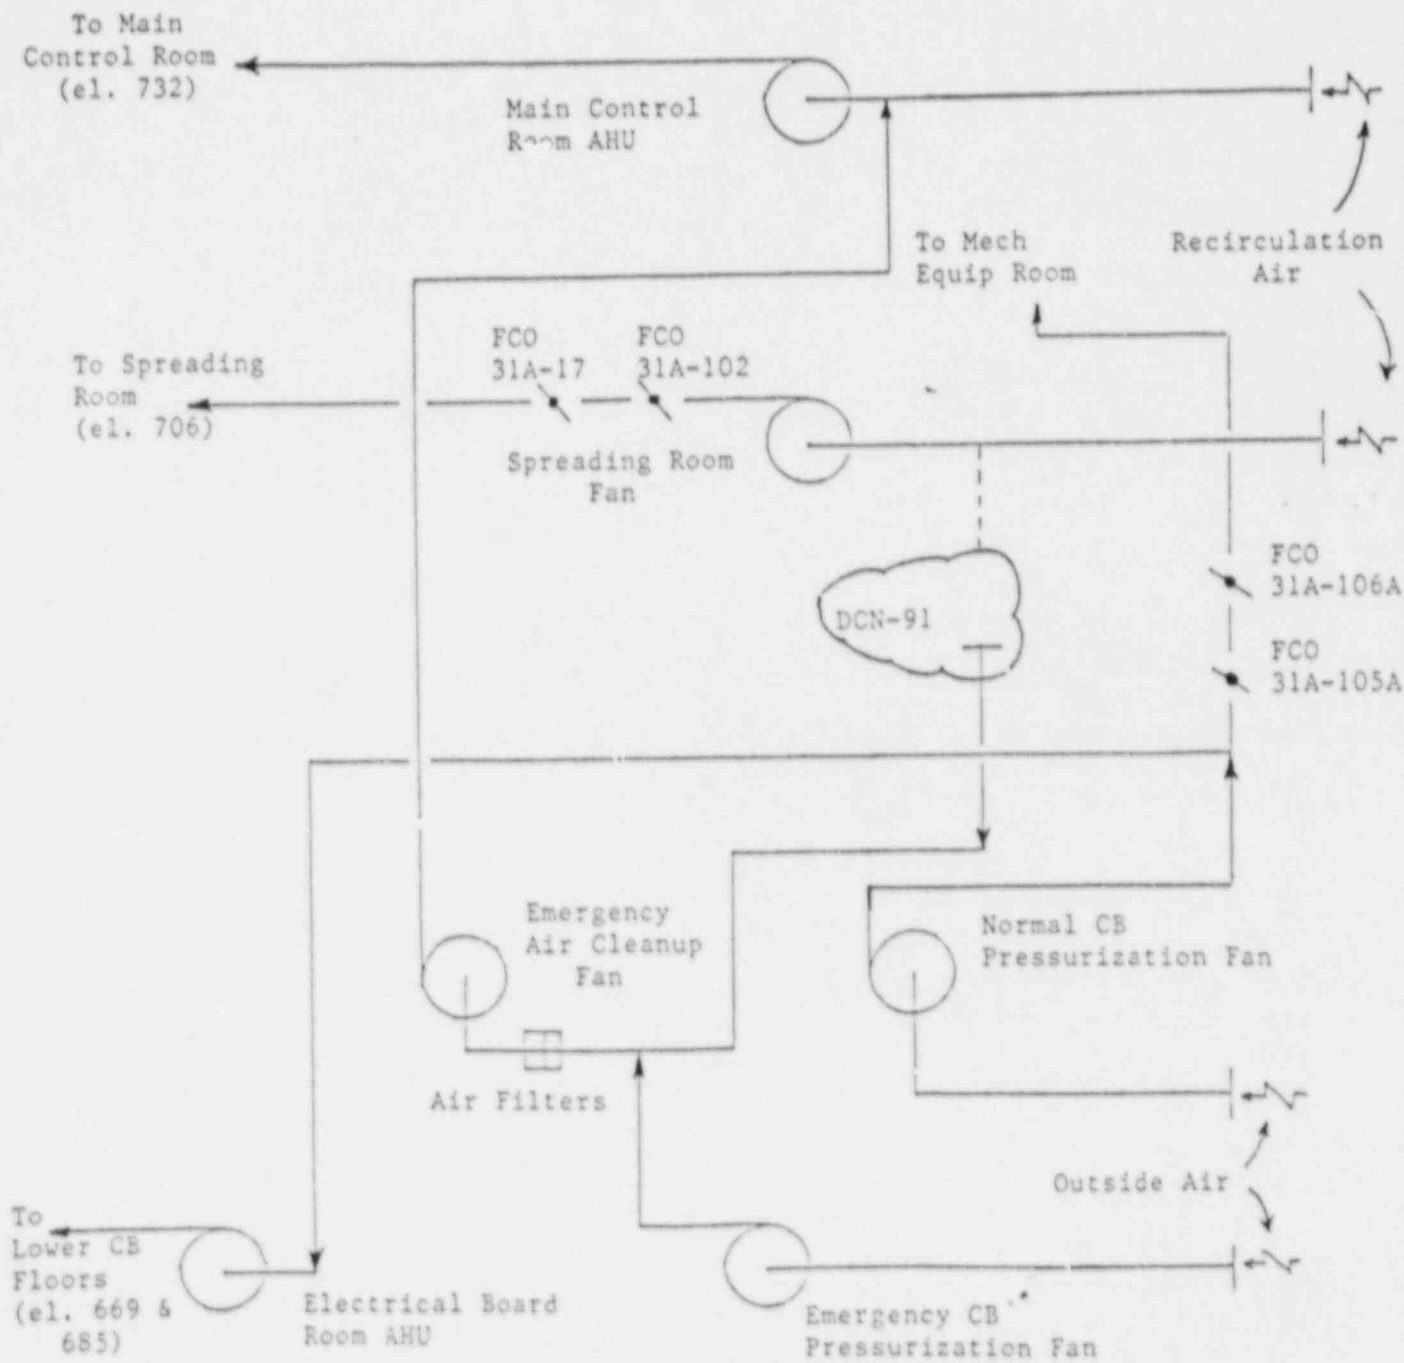
FIGURE 1: SIMPLIFIED CONTROL BUILDING VENTILATION SCHEMATIC

In addition to the deficiencies discussed above, CAQR SQP 871606 identified a previously unknown source of inleakage to the suction of the emergency air cleanup fan. This inleakage increased the amount of outside air being used by CREVS to pressurize the MCR. As illustrated in Figure 1, the spreading room supply fan and the emergency air cleanup fans take suction from the same section of ductwork in the mechanical equipment room. A CRI signal stops the spreading room supply fan and closes the spreading room supply fan's flow control dampers (31A-17 and 31A-102). In this configuration, operation of CREVS induces a substantial differential pressure across flow control dampers 31A-17 and 31A-102. This differential pressure causes a backflow of air from the spreading room, through the blade-type isolation dampers, through the idle spreading room supply fan, and into CREVS. This backflow serves as additional pressurization air for the CREVS and, until recent testing, was not identified. This additional pressurization air could increase the CREVS makeup flow above the 200 CFM limit allowed by TS SR 4.7.7.e.3 and invalidate the MCR dose calculations described in Final Safety Analysis Report (FSAR) Section 15.5.3.

To minimize the potential backflow through the spreading room fan and flow control dampers 31A-17 and 31A-102, TVA implemented Design Change Notice (DCN)-91 to separate the CREVS recirculation duct from the spreading room fan suction duct. Following a CRI, the CREVS now draws recirculation air from an independent point in the mechanical equipment room at CB elevation 732.
