LICENSEE EVENT REPORT (LER)

FACILITY NAME (1): Davis-Besse Unit 1 DOCKET NUMBER (2): 05000346 PAGE (3): 1 OF 06

TITLE (4): Monthly Test of ARTS and SFAS Used Some Inactive Logic Gates

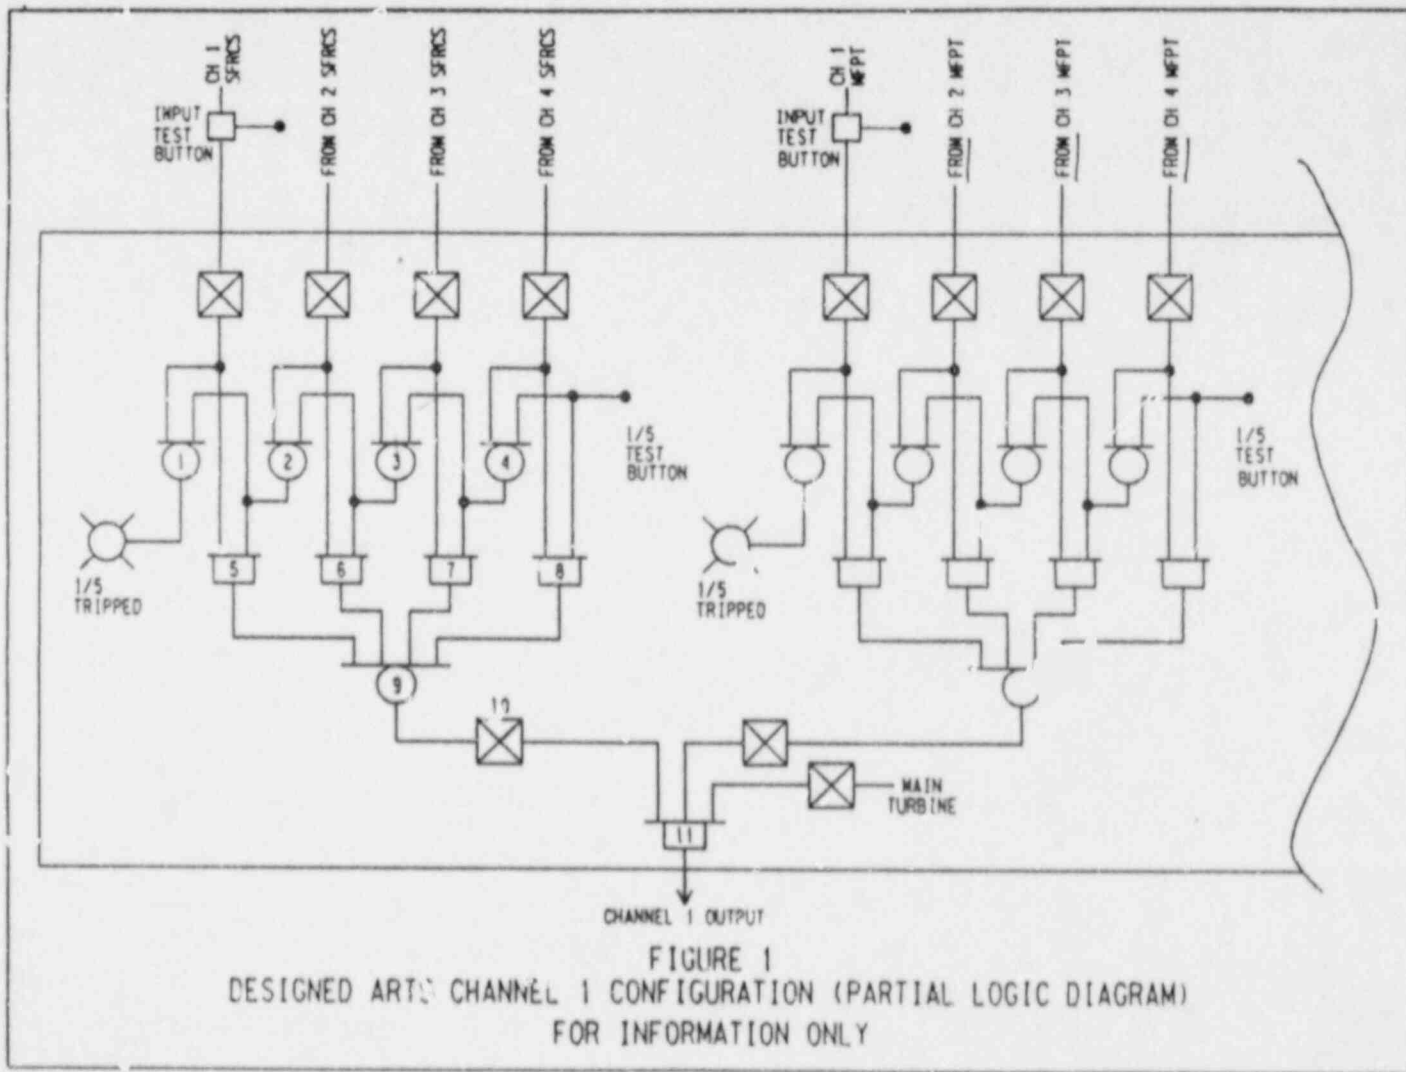
Monthly channel functional testing using the design drawing configuration (Figure 1) completes the logic circuit with the use of AND gate 5. AND gate 5 could also actuate during an actual demand for this system, and is therefore an active gate. Testing using the as-built configuration (Figure 2) completes the logic circuit with the use of AND gate 8. AND gate 8 is only actuated during testing since one half of its required two inputs is the 1/5 Test Button.

This condition was not recognized during the review of vendor drawings. The wiring nonconformance for testing went undetected during testing due to the fact that regardless of the way the logic was wired (Figure 1 or Figure 2), the test indications are the same.

Both the SFAS and ARTS logic wiring will be corrected to allow testing of an active gate, per the original design intent, under MODS 88-0193 and 88-0194, respectively. Corrections will be completed prior to restart from the present refueling outage.
