LICENSEE EVENT REPORT (LER)

FACILITY NAME (1)
Calvert Cliffs, Unit 1

TITLE (4)
Containment Personnel Air Lock Interlock Inoperable

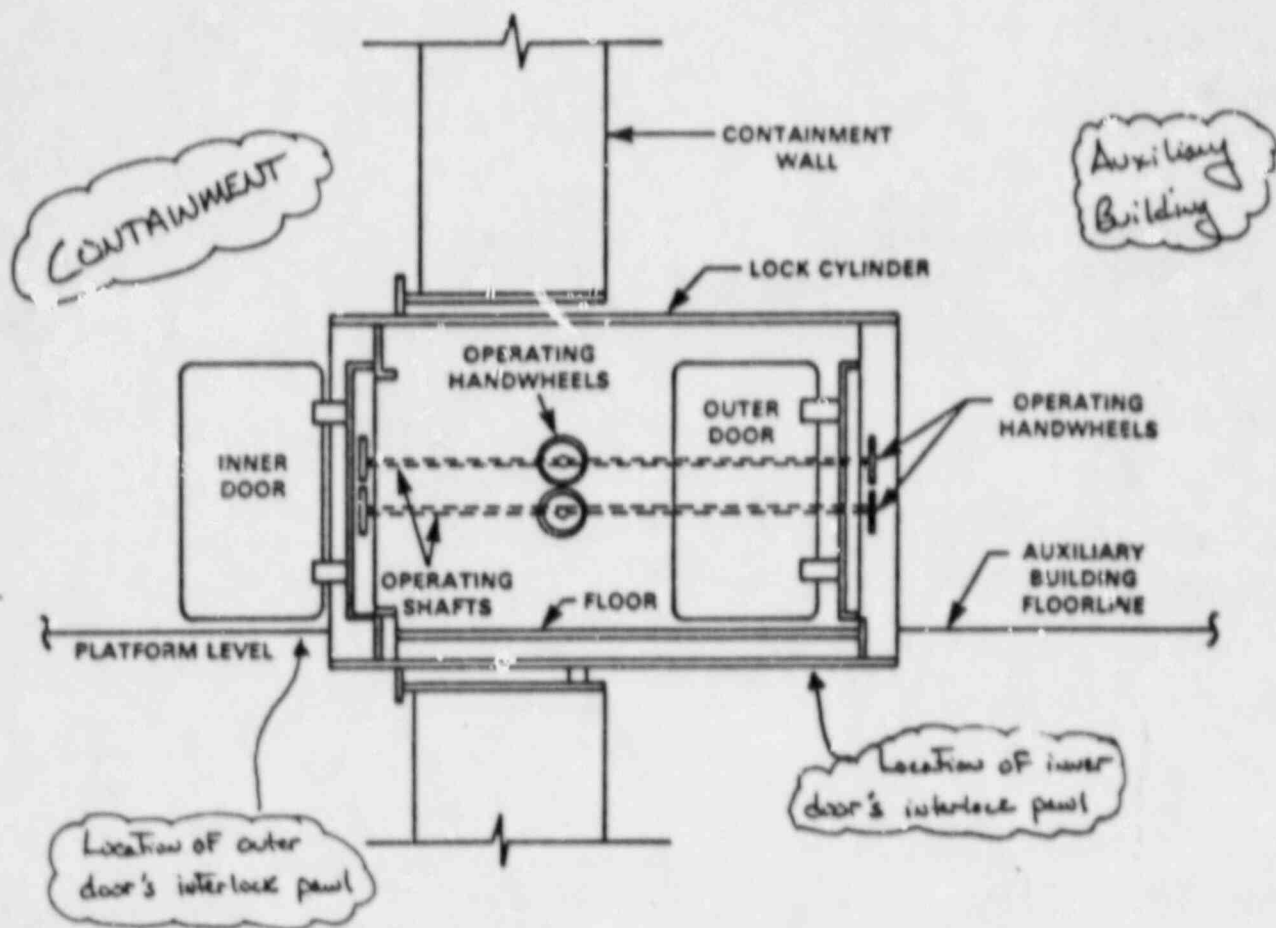
FIGURE 1
PERSONNEL AIR LOCK

The containment personnel air lock is a two door air lock used for normal personnel access through the containment structure (see Figure 1). Mounted on each end of the airlock is an 80 inch by 42 inch wide door. Each door swings toward the containment interior and is sealed with a double gasket (EIIS NH-SEAL). Pressure inside the personnel air lock is equalized with outside pressure by means of two ball valves (EIIS NH-V). Each combination of door and associated equalizing valve is operated by a handwheel (EIIS NH-84) (and arrangement of shafts, gears, etc., see Figure 2) which performs the following sequence when turned in the open direction:

The cause of the event was due primarily to improper use of procedure combined with the lack of clarity of the procedure. Contrary to HE-21, the technician defeated both the inner and outer door's interlocks (on June 22) by inserting a block under each door's interlock pawl. (See Figure 1 for the locations of each). On June 25, 1988, a different technician, using HE-21, restored the inner door's interlock (by removing the block beneath the inner door's pawl). The outer door's interlock was not restored since HE-21 addressed only the inner door's interlock.

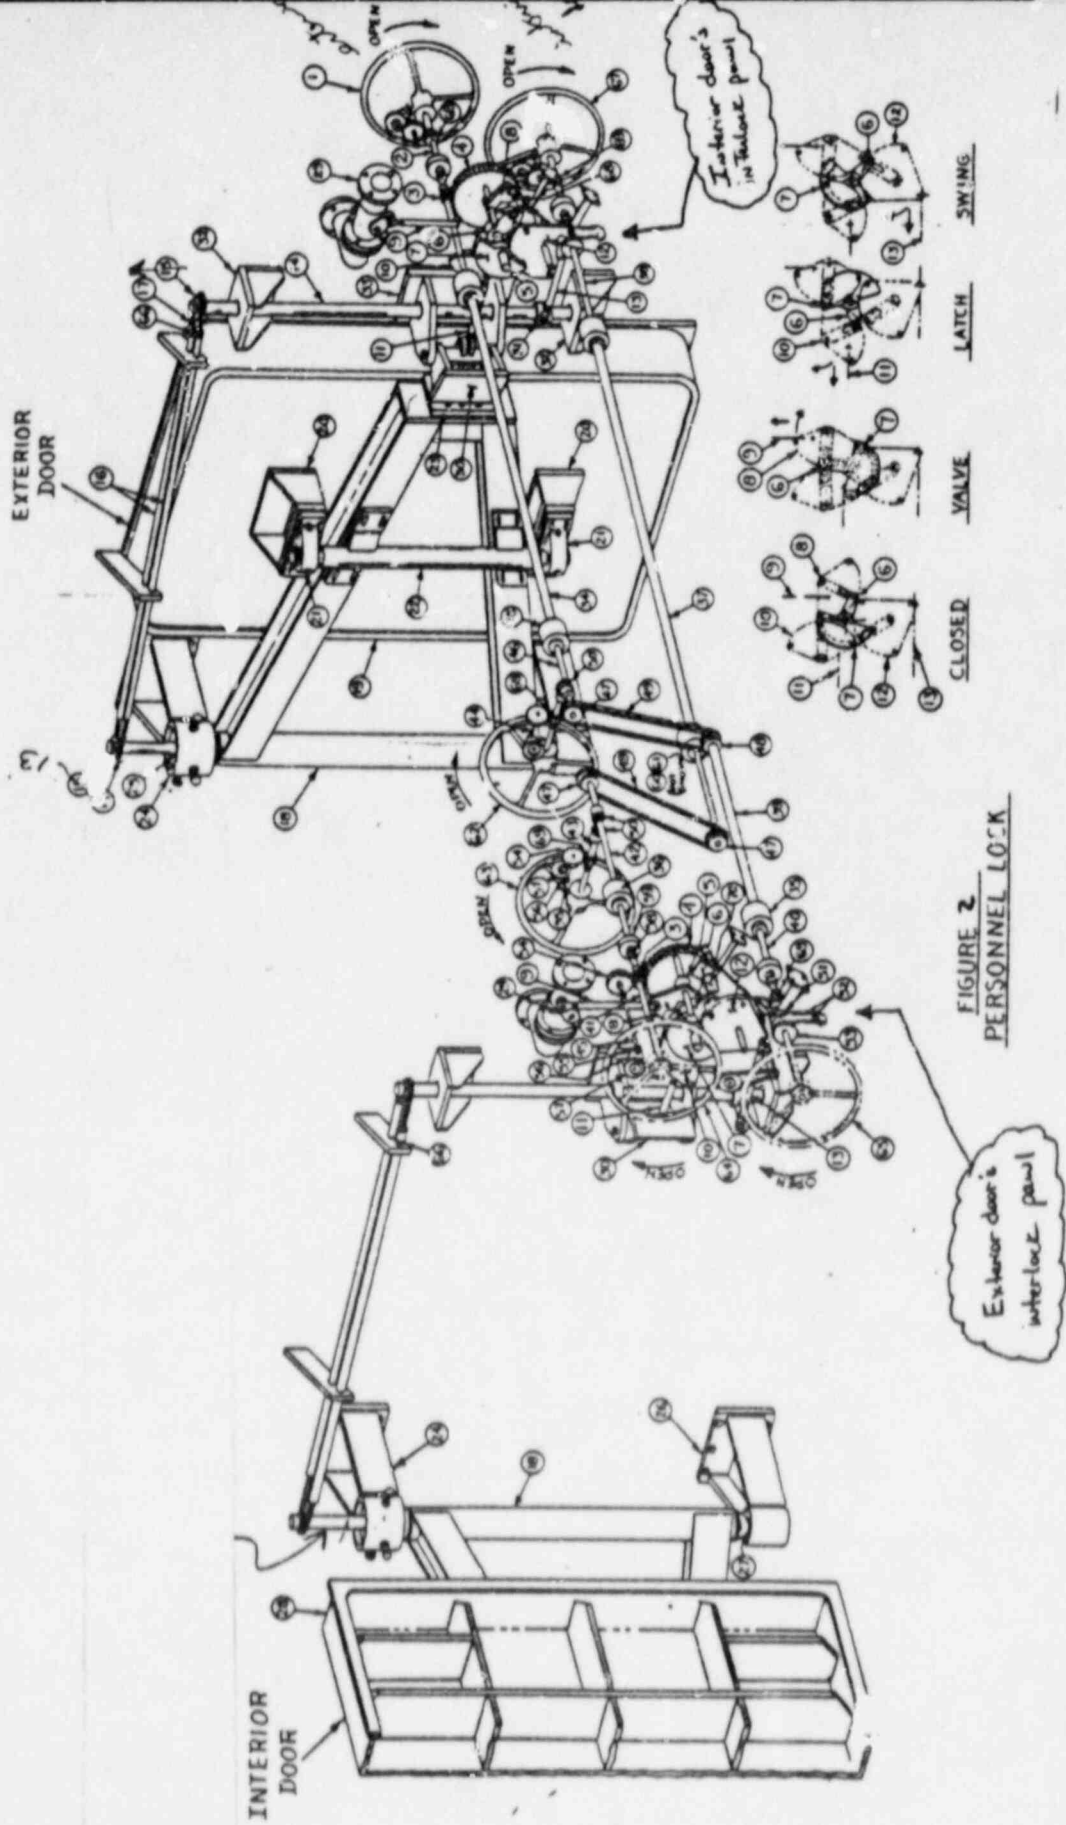
The reverse of the above occurs when the handwheel is turned in the closed direction. An interlock for each door prevents that door from opening if the other door has not gone through the full closed sequence. Each door's interlock is accomplished by a pawl which engages the respective door's operating system and prevents rotation of the gears if the other door is not fully closed.
